Nine-Fatality Apartment House Fire Ludington, Michigan

Nine-Fatality Apartment House Fire Ludington, Michigan (February 28, 1993)

This is Report 072 of the Major Fires Investigation Project conducted by TriData Corporation under contract EMW-90-C-3338 to the United States Fire Administration, Federal Emergency Management Agency.

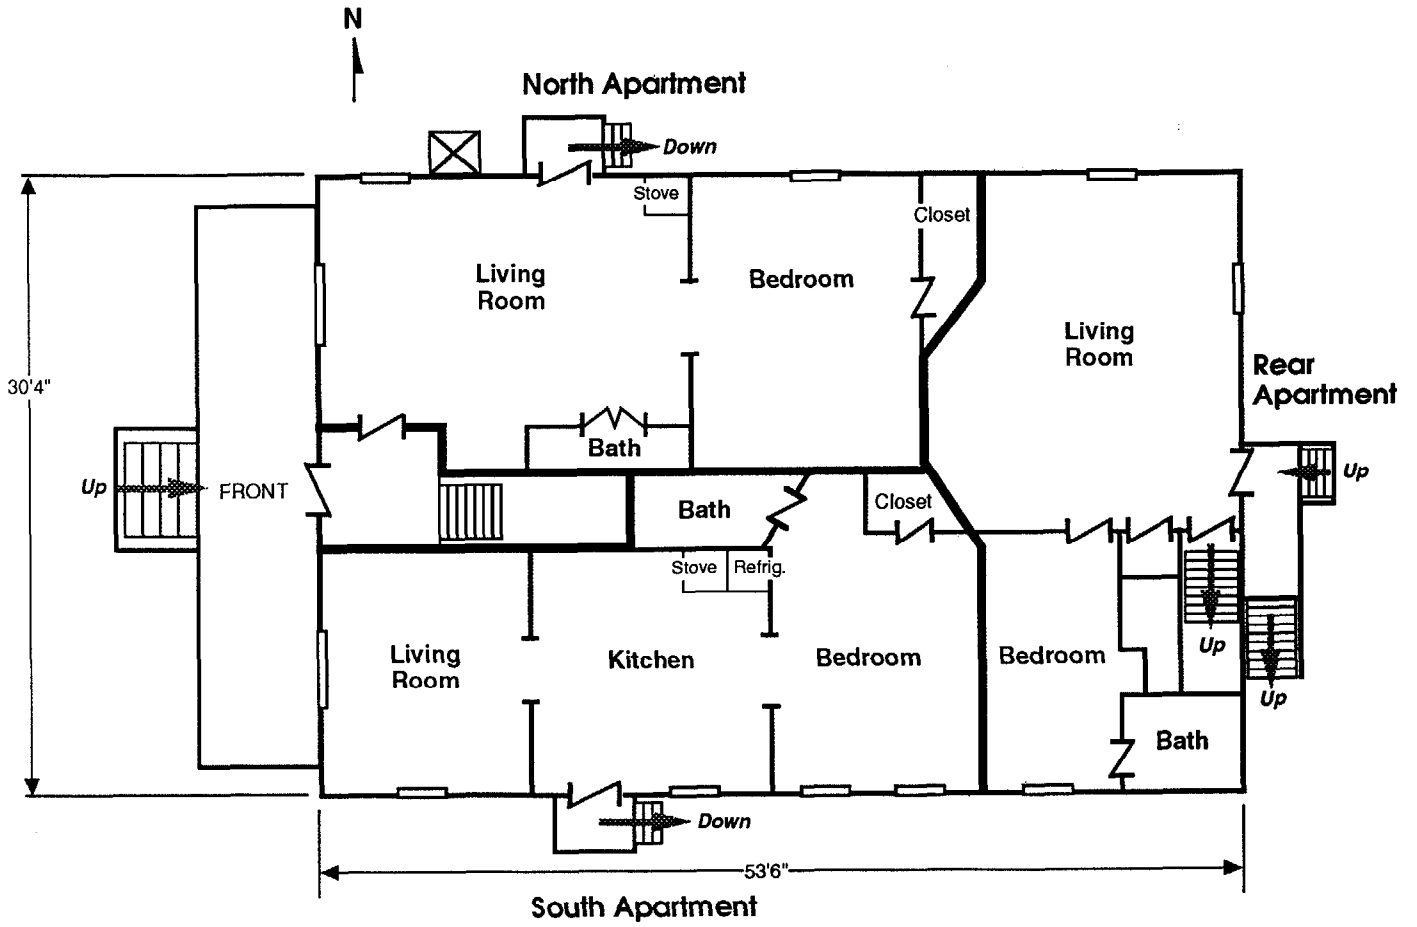
FIRST FLOOR PLAN

Fire damage revealed that the fire originated in the corridor at or below the ceiling level in the vicinity of a light fixture on the south wall. Fire progressed rapidly because of the highly combustible wood paneling and wood fiber ceiling tiles. It was aided by an additional supply of oxygen as a result of the occupant leaving both his apartment door and the front door open when exiting the building. It was allowed to penetrate the north and south apartments at an early stage, burning through wooden doors and through air-transfer grills that were installed in the corridor walls that separated the living units.

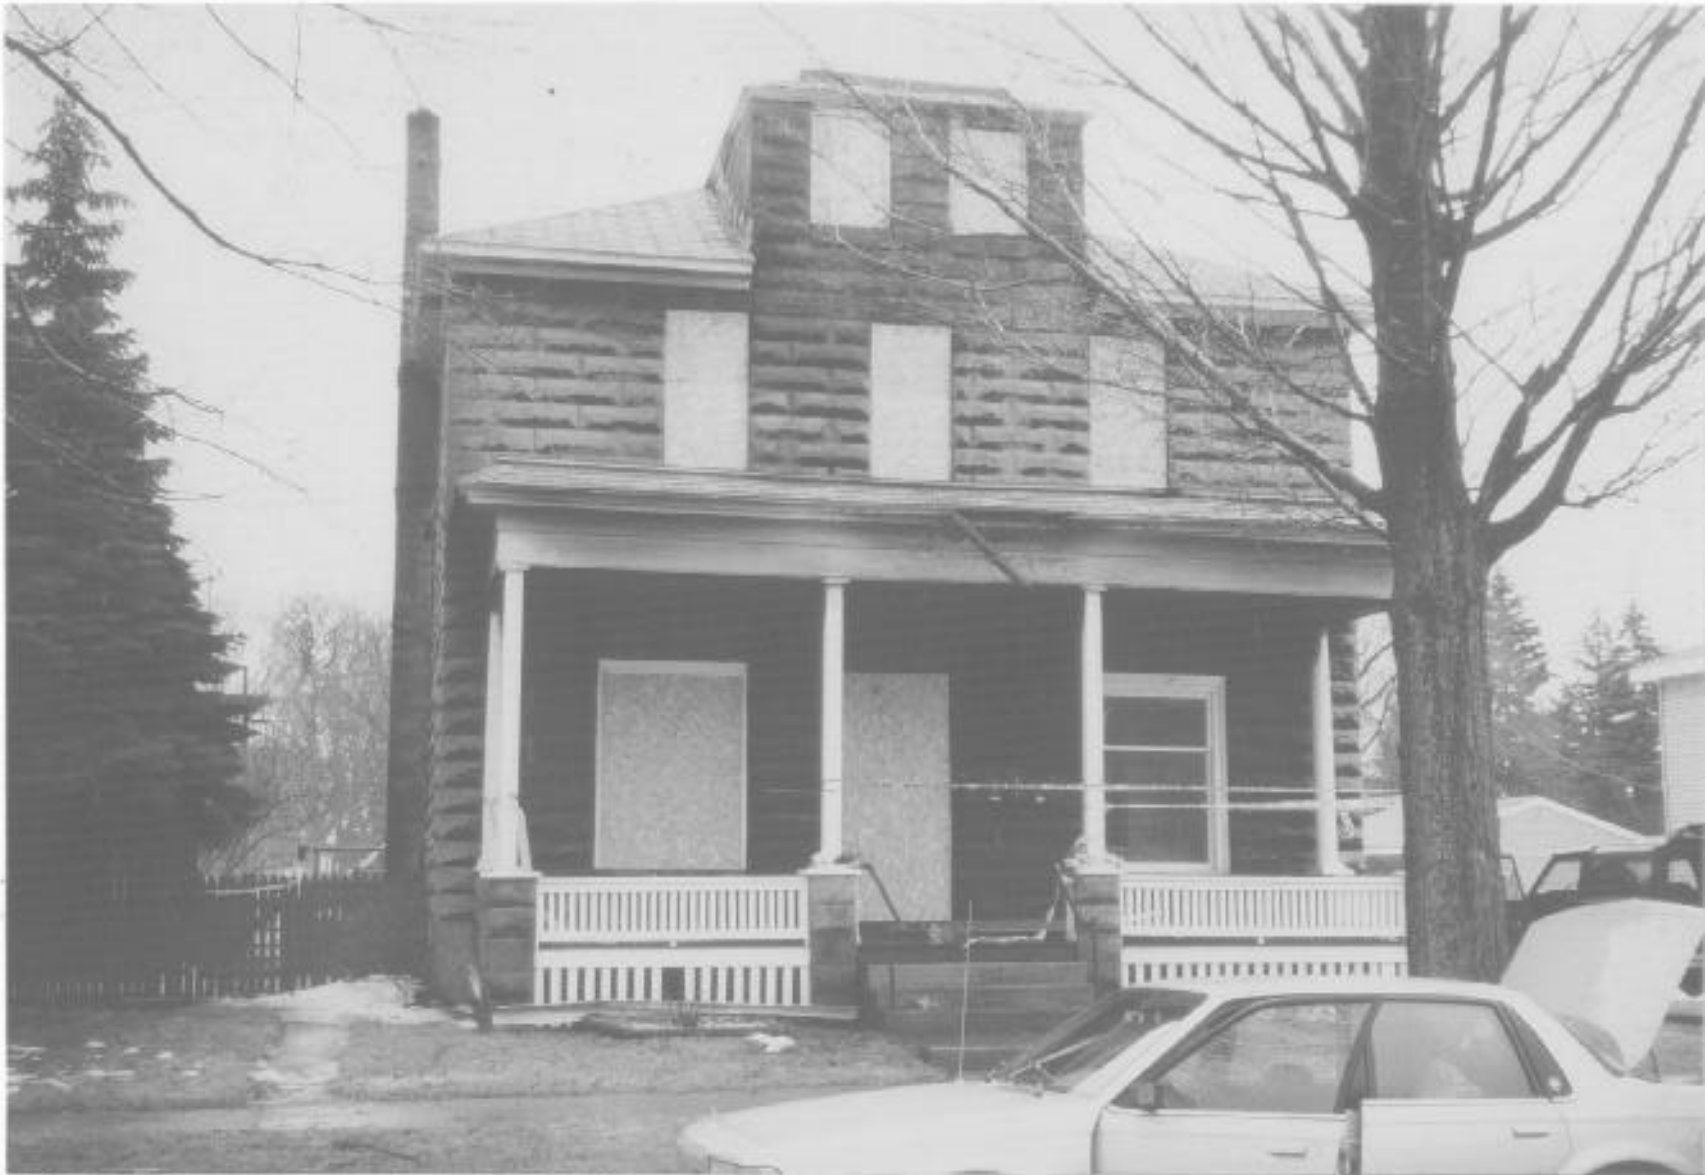
Front of building facing James Street.
