St. George Hotel Complex 16 Alarm Fire

Brooklyn, New York

This is Report 108 of the Major Fires Investigation Project conducted by Varley-Campbell & Associates, Inc. under contract EMW-94-C-4423 to the United States Fire Administration, Federal Emergency Management Agency.

August 26, 1995

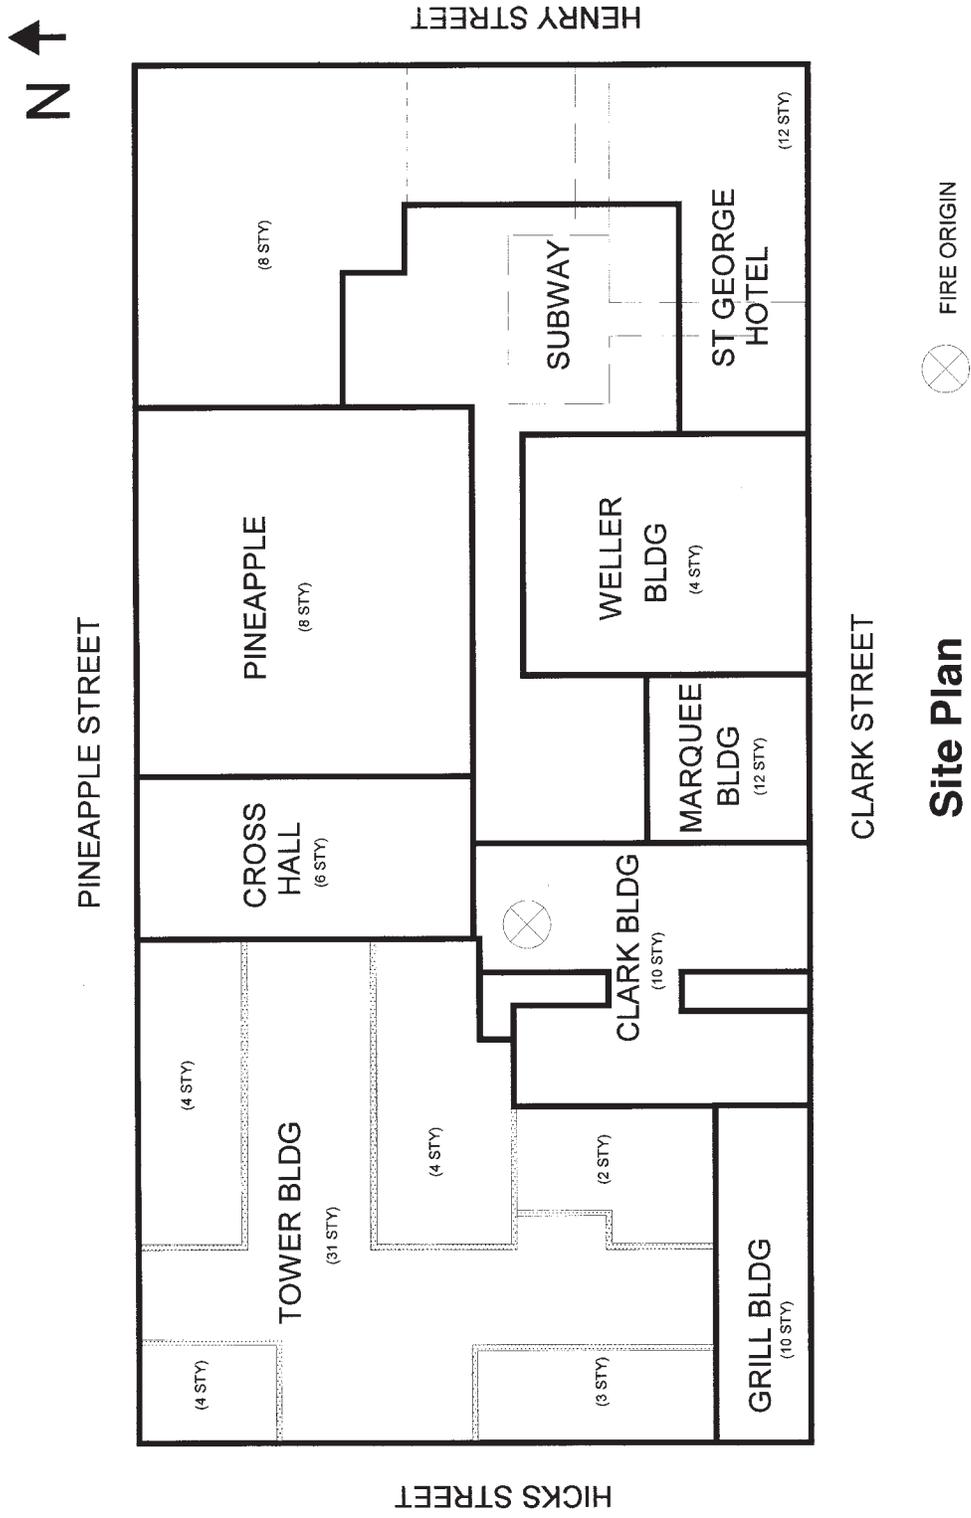
The St. George Hotel was the grandest of New York City's hotels when it opened in 1926. Located in the Brooklyn Heights area of the city, it had a total of 2,632 guestrooms in a complex of eight buildings that occupied an entire city block. (Figure 1). Some of the original buildings dated back to 1885. All the buildings were interconnected at the basement level, and there were numerous connections on various floor levels among the different buildings.

The complex was bordered by Pineapple Street to the north, Clark Street to the south, Hicks Street to the east and Henry Street on the west. Many streets in the Brooklyn Heights area are only 40 feet wide. Parking on the streets in front of the fire building further congested the area. Figure 1 shows the block and the relationships of the buildings to each other.

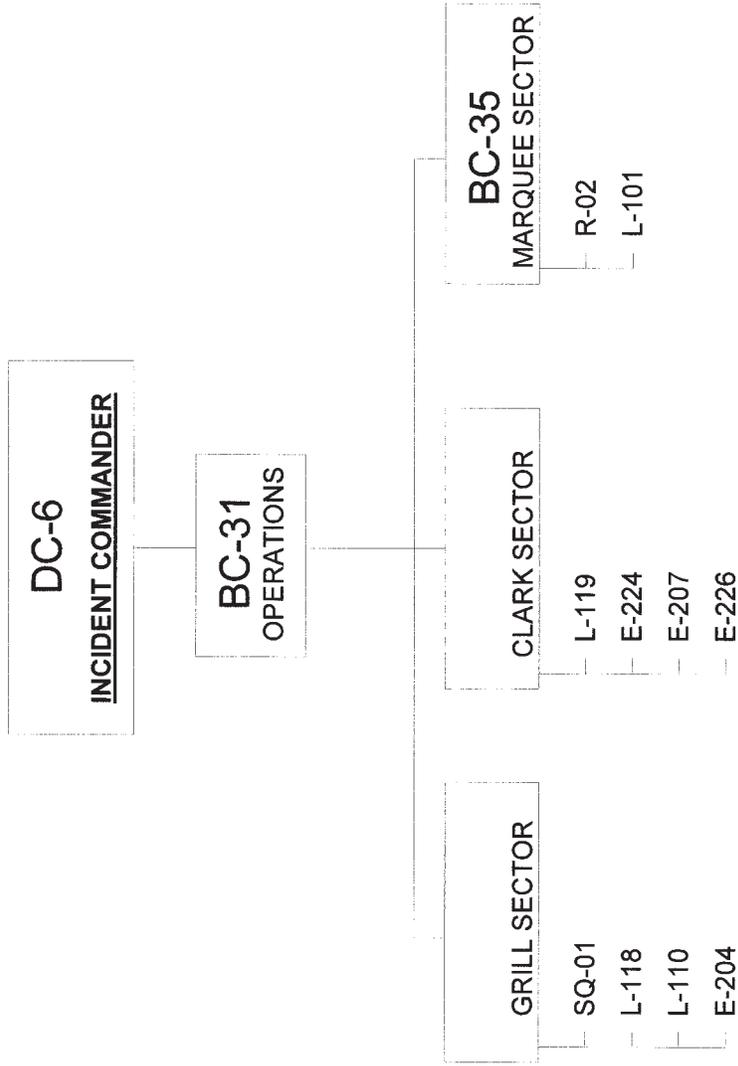
Figure 3

At 4:06 the first arriving Deputy Chief, DC-6, ordered a third alarm and assumed incident command. (Figures 3 and 4) As the fire was beginning to spread to exposure 4, the Marquee Building. The third alarm brought in four engines, 2 trucks, the Air Mask Maintenance Unit and a Medical Command Unit.

INCIDENT COMMAND STRUCTURE AT ABOUT 4:10 AM

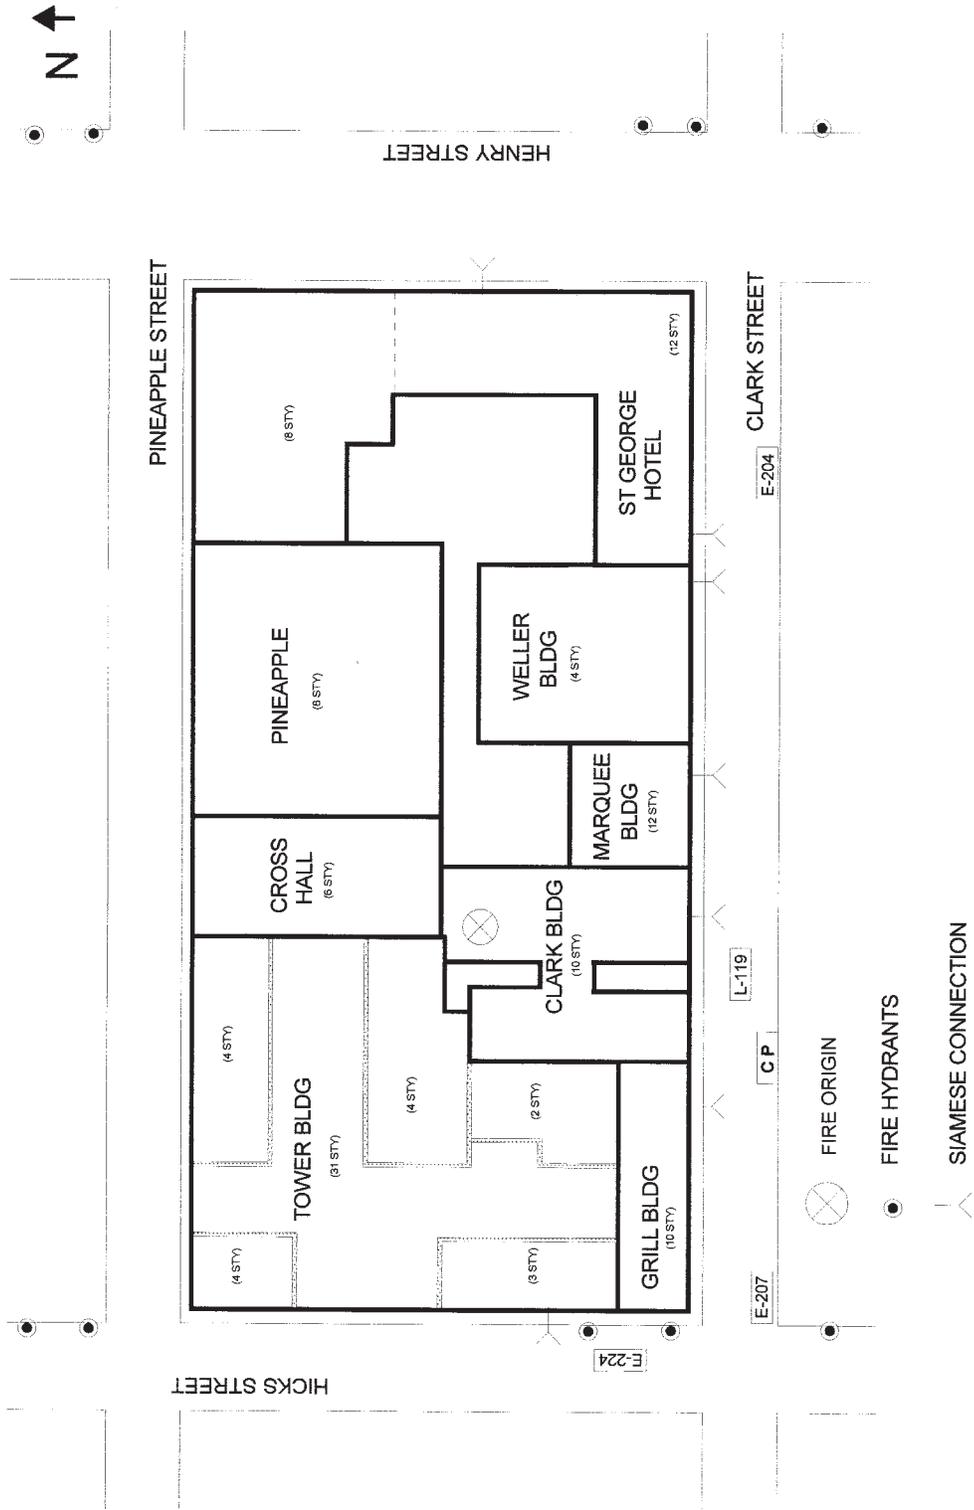
Figure 4

PLACEMENT OF "ALL HANDS" COMPANIES AT ABOUT 4:10 AM

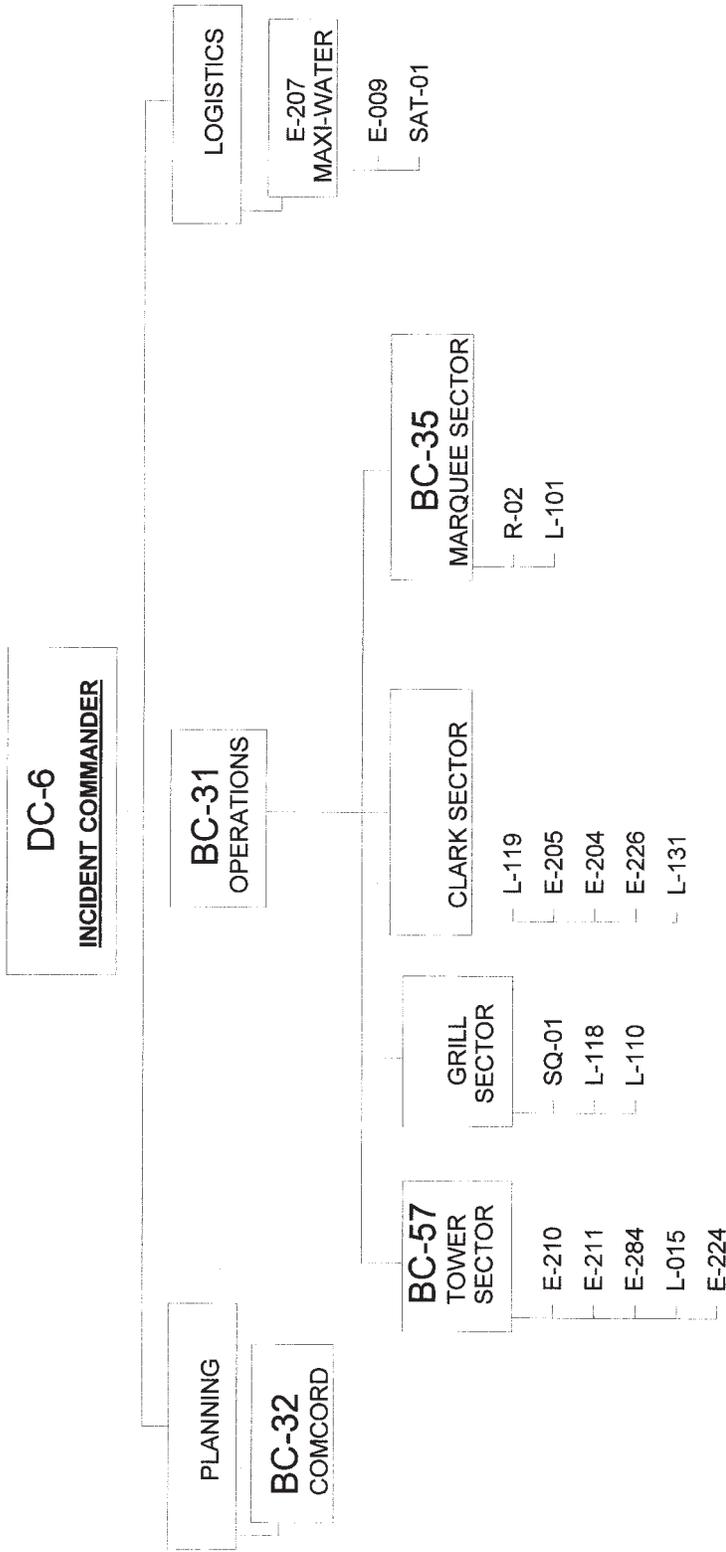
Figure 5

The Citywide Tour Commander FC 1 requested a fourth alarm at 4:11 a.m. while he was still enroute. From the Brooklyn Bridge he had an excellent vantage point to size up the volume of fire and the obvious exposure challenges. By this time the interior portions of the upper floors of the Clark Building were beginning to collapse, adding to the storm of fire brands. (Figures 5 and 6)

INCIDENT COMMAND STRUCTURE AT ABOUT 4:20 AM

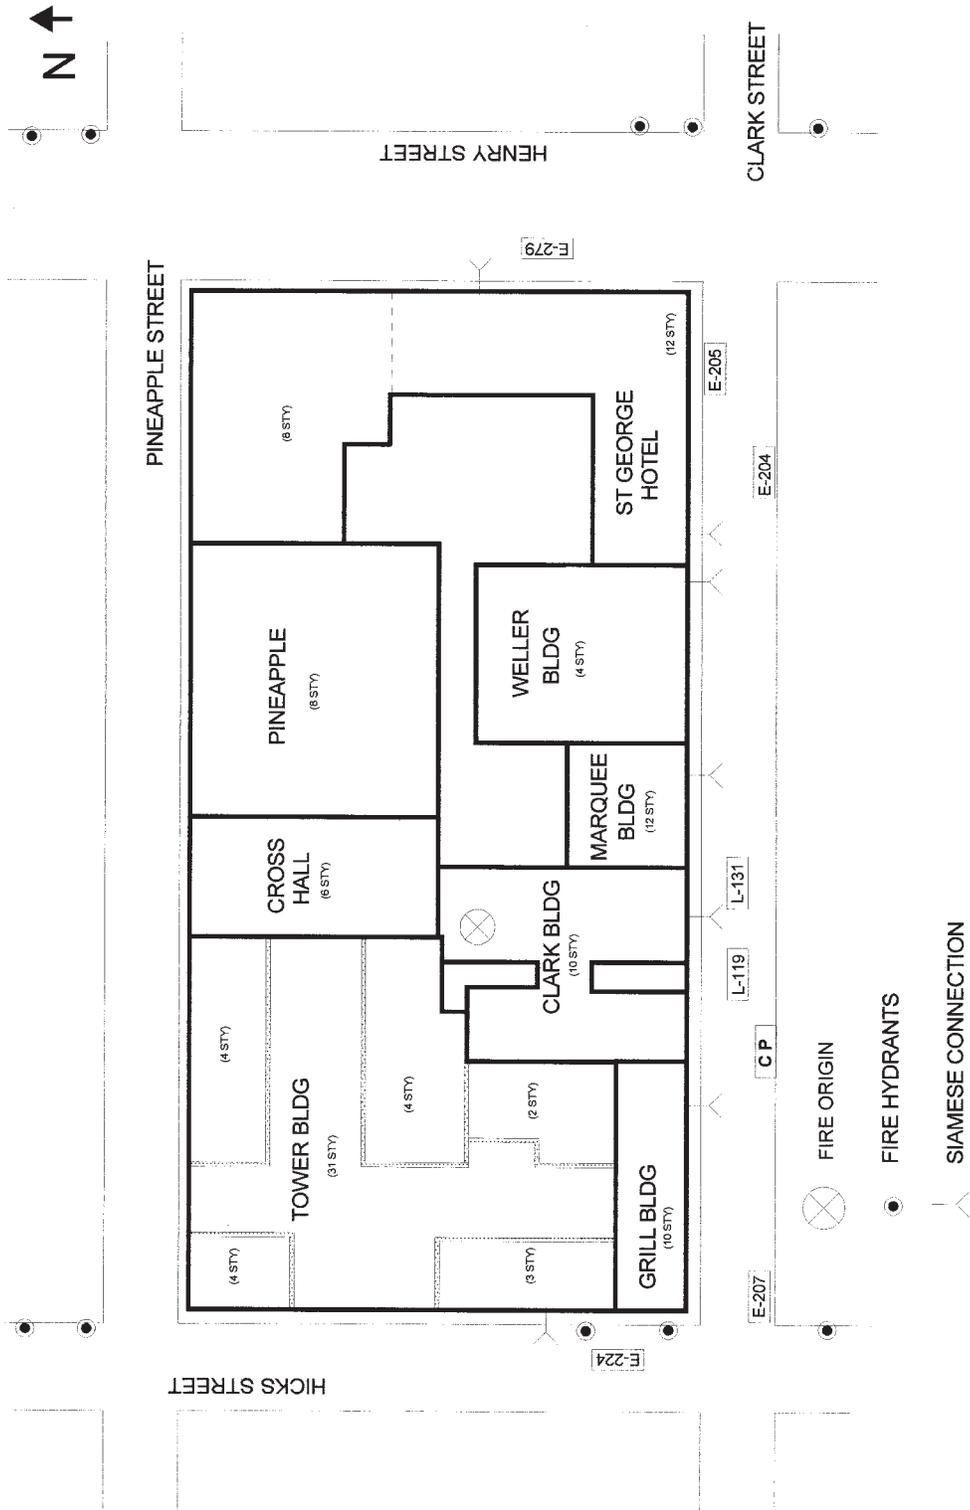
Figure 6

PLACEMENT OF SECOND ALARM COMPANIES AT ABOUT 4:20 AM

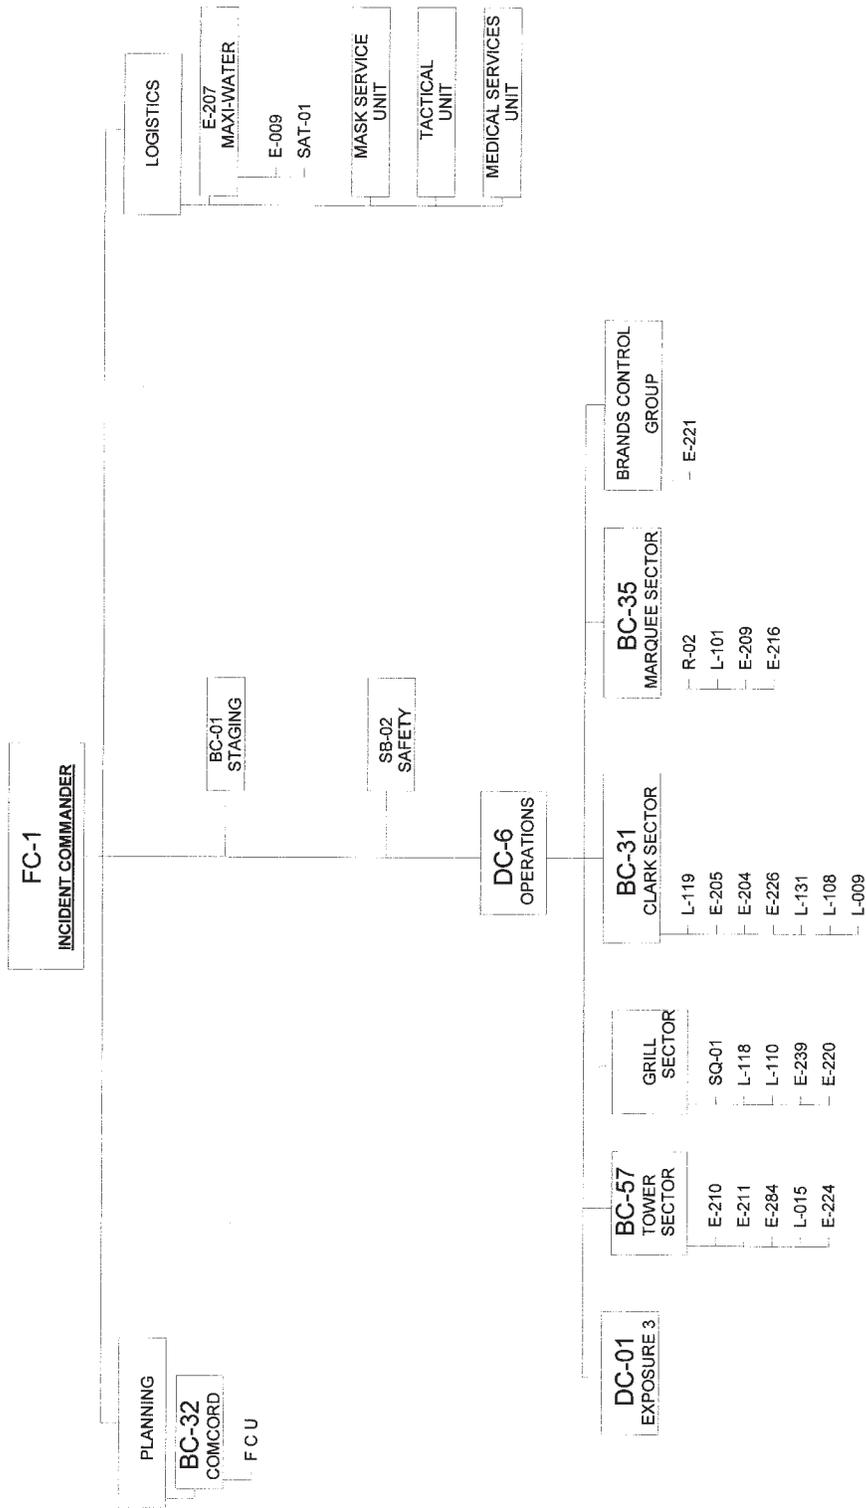
Figure 7

When FC-1 arrived on the scene at 4:18 a.m., he immediately called for a fifth alarm. The interior of the original fire building was well involved and the fire had spread to the upper floors of Exposure 4. A collapse zone was quickly established in front of the Clark and Marquee Buildings. The two tower ladders that had been set up in front of the buildings and the command post were repositioned out of the collapse zone. Battalion Chiefs were assigned to secure the collapse zone. (Figures 7 and 8)

INCIDENT COMMAND STRUCTURE AT ABOUT 4:35 AM

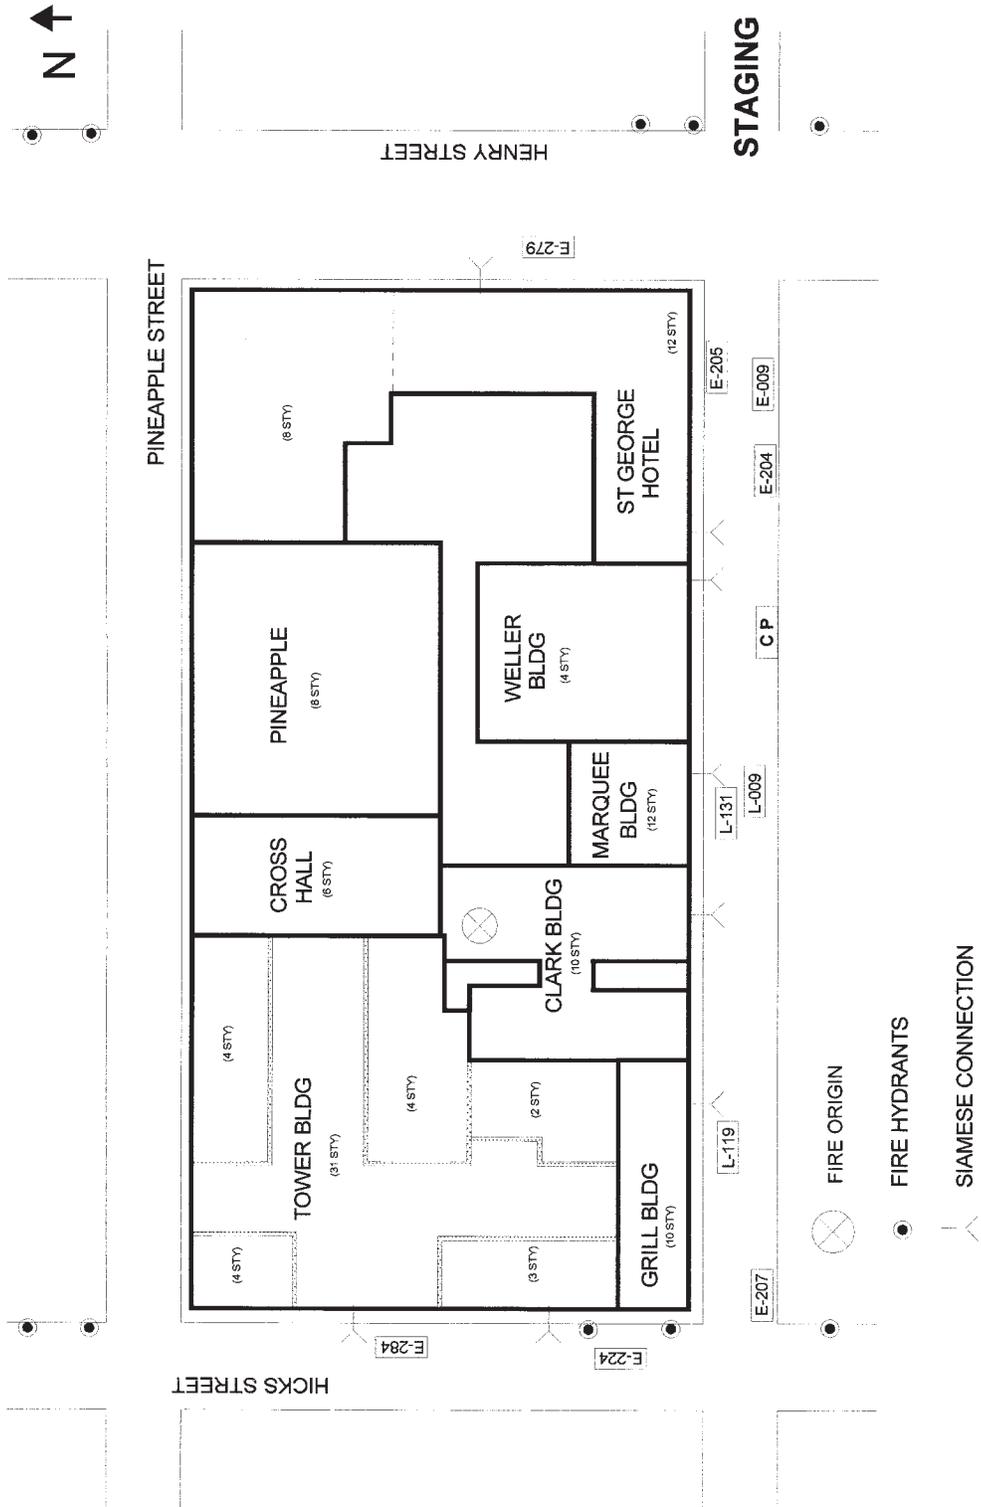
Figure 8

PLACEMENT OF THIRD ALARM COMPANIES AT ABOUT 4:35 AM

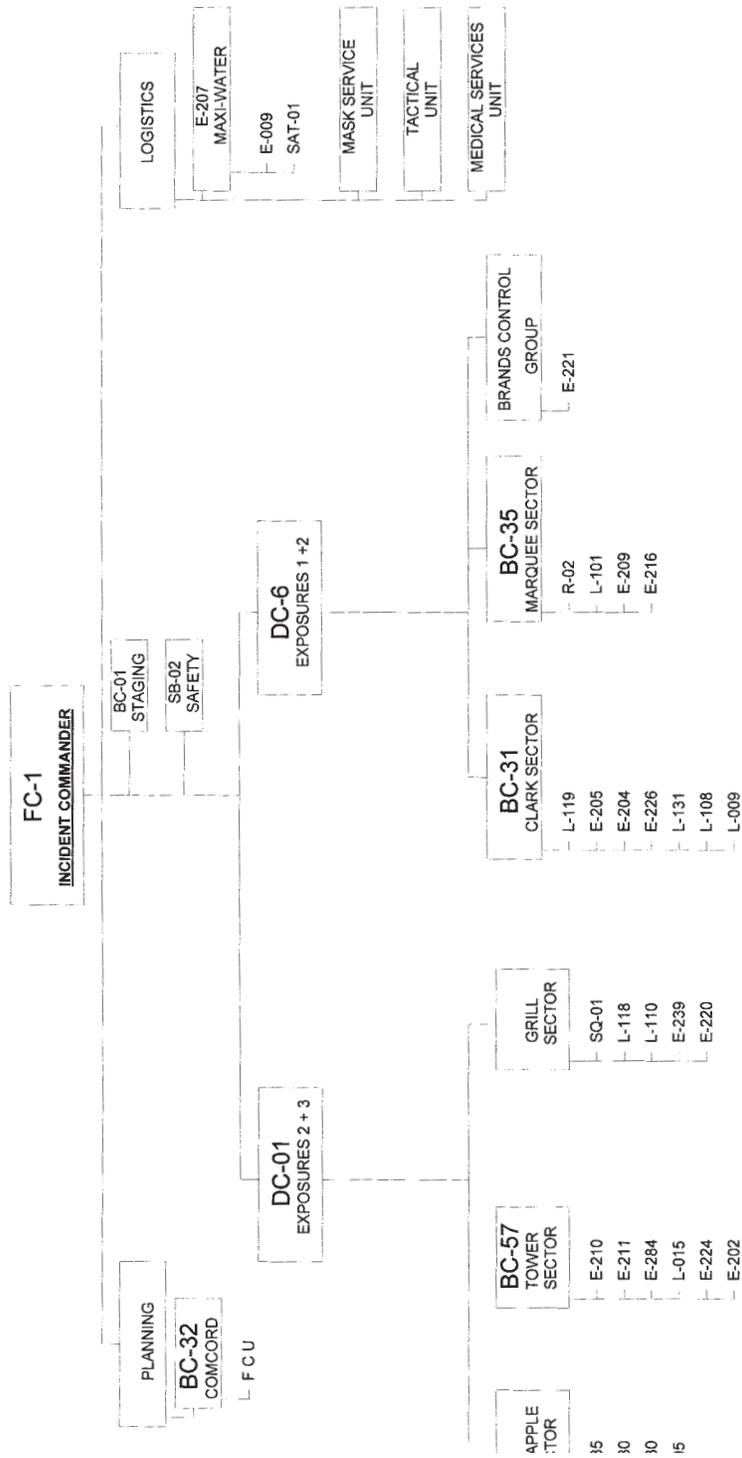
Figure 9

When the Incident Commander received this information he informed DC-1 of the building configuration and directed him to take charge of both Exposures 2 and 3 (Figure 9). The fireground was now divided into the Clark Street Branch, which included Exposures 1 and 2 and the fire building, and the Pineapple Street Branch, which included Exposures 2 and 3. Two Deputy Chiefs were assigned to direct operations in the two branches, DC-6 on the Clark side and DC-1 on the Pineapple side. The Incident Commander directed DC-1 to initiate a separate incident and to communicate directly with Brooklyn Communications to request resources.

INCIDENT COMMAND STRUCTURE AT ABOUT 4:45 AM

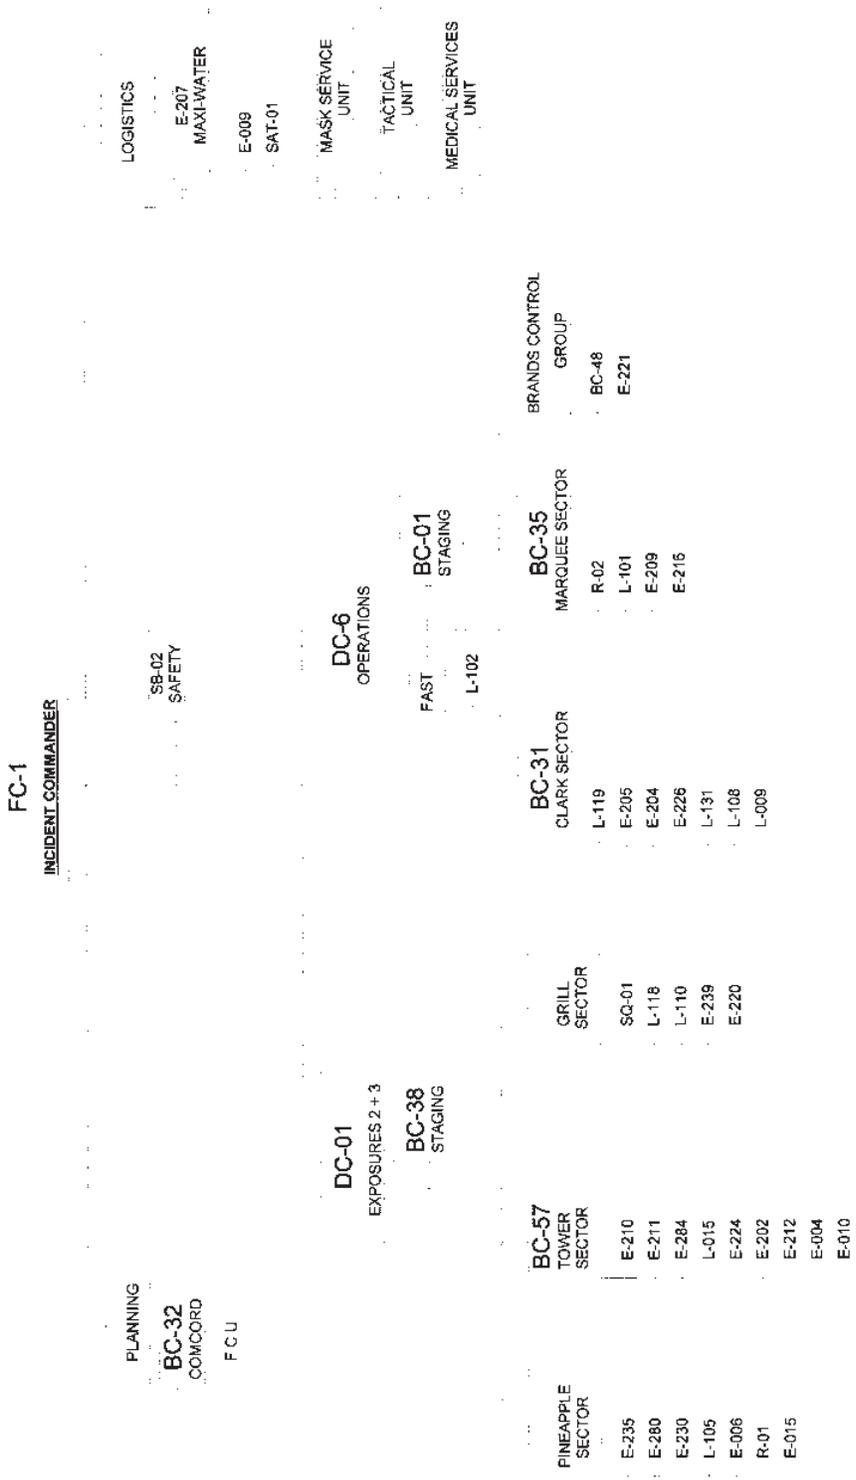
Figure 10

A secondary Command Post was established at the corner of Hicks and Pineapple and a second alarm assignment was requested by DC-1 to report to the Pineapple Sector, which included the Pineapple and Crosshall Buildings. The equivalent of a third alarm was requested to assist the companies that were already operating in the Tower Building. (Figure 10)

INCIDENT COMMAND STRUCTURE AT ABOUT 4:55 AM
