## Hospital Fire Kills Four Patients Southside Regional Medical Center Petersburg, Virginia

**Hospital Fire Kills Four Patients  
Southside Regional Medical Center  
Petersburg, Virginia  
(December 31, 1994)**

This is Report 080 of the Major Fires Investigation Project conducted by Varley-Campbell and Associates, Inc./TriData Corporation under contract EMW-94-C-4423 to the United States Fire Administration, Federal Emergency Management Agency.

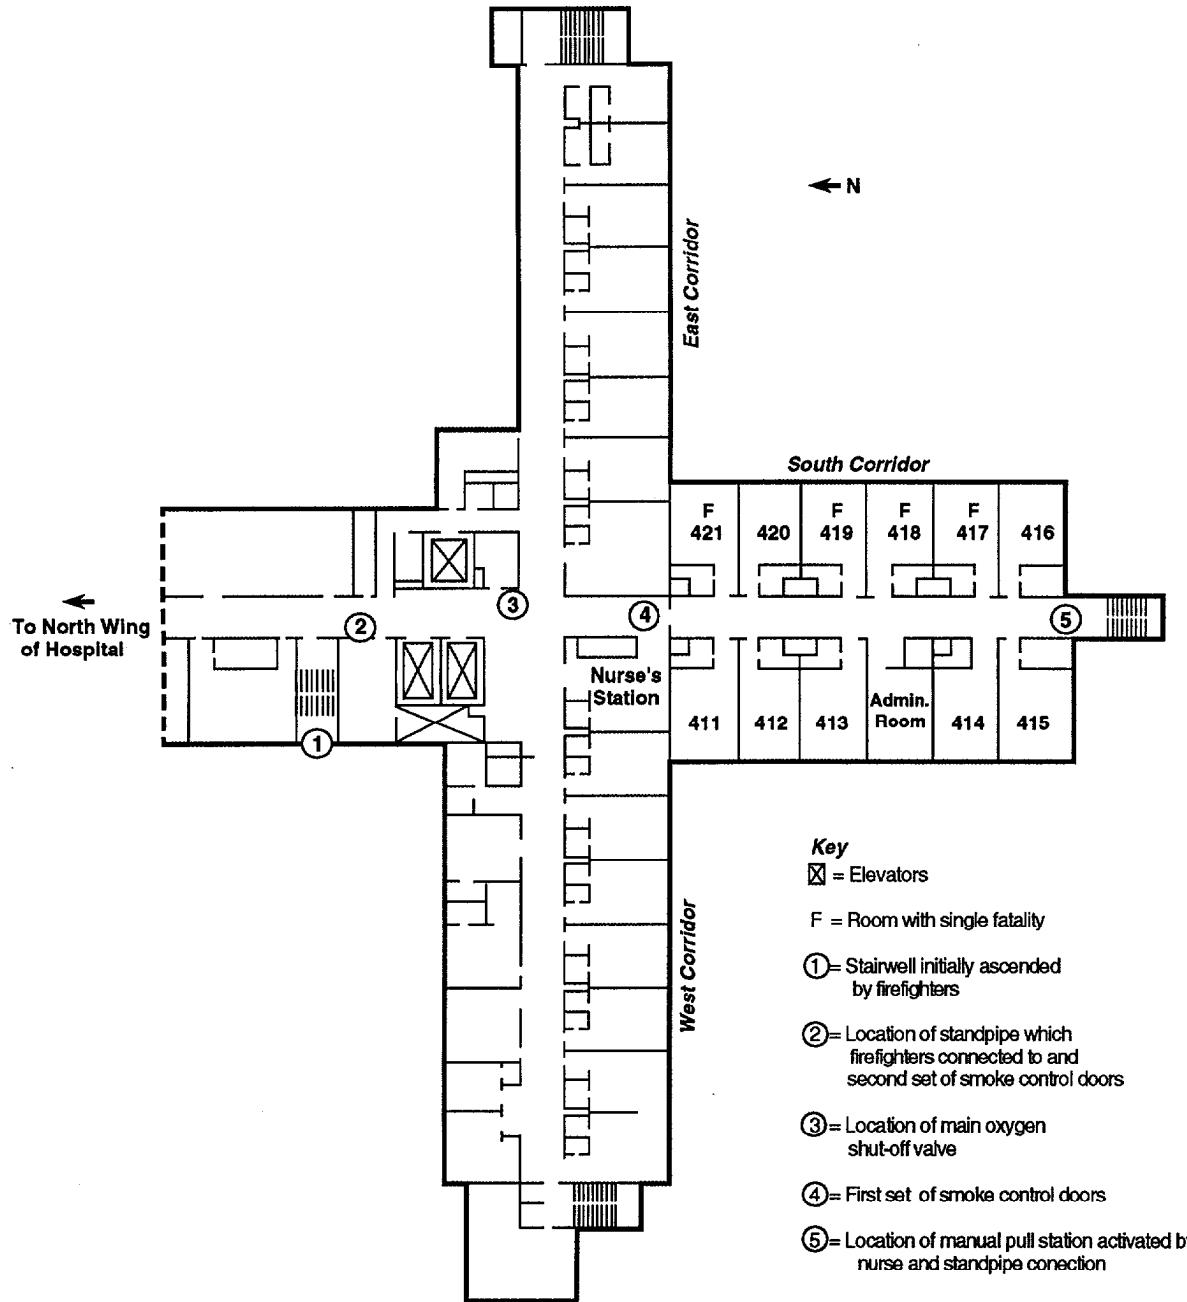
Four-South Floor Plan

The fire was contained to the room of origin with slight extension into the adjacent corridor. There was heavy smoke and heat damage to the corridor, and heavy smoke infiltrated adjacent patient rooms (see

Appendix A for floor diagram). Hospital staff and nurses rescued several patients before firefighters arrived. Three patients in rooms adjacent to the fire room died from smoke inhalation, and one patient in the fire room died from a combination of smoke inhalation and burns. Three firefighters were treated for minor smoke inhalation after their breathing apparatus ran out of air during rescue operations. Several nurses and patients also suffered minor injuries from smoke inhalation.
