# **Aerial Ladder Collapse Incidents (April 1996)**

**This is Report 081 of the Major Fires Investigation Project conducted by Varley-Campbell and Associates, Inc./TriData Corporation under contract EMW-94-C-4423 to the United States Fire Administration, Federal Emergency Management Agency.**

## **Aerial Ladder Collapse Incidents**

Failure Analysis of a  
100 ft Aerial Ladder

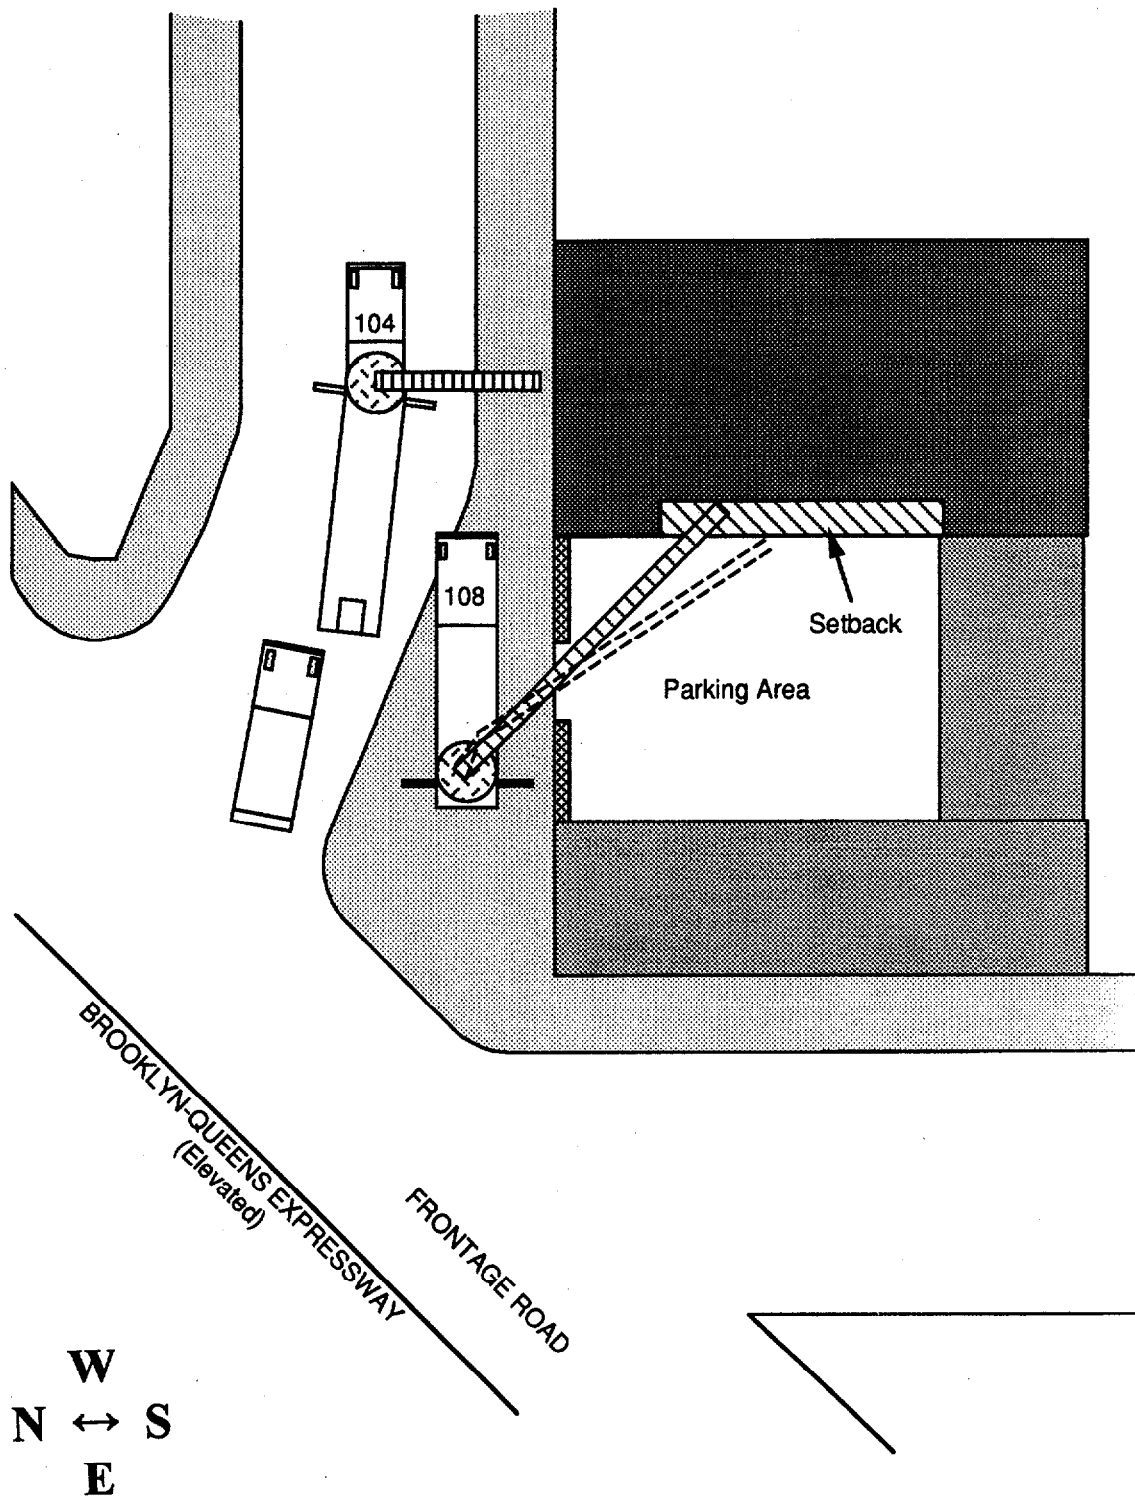
Figure 1. Apparatus Positions at New York City Ladder Collapse

The first arriving ladder company, Ladder 104, stopped in front of the building and raised their aerial ladder to the fifth floor, adjacent to the fire apartment (see Figure 1). In this situation the second due ladder company, Ladder 108, is expected to provide a ladder to the roof. Because Ladder 104 is a tractor trailer apparatus and several other vehicles were parked on the street in front of the fire building, Ladder 108 had limited access to position their apparatus within reach of the building.

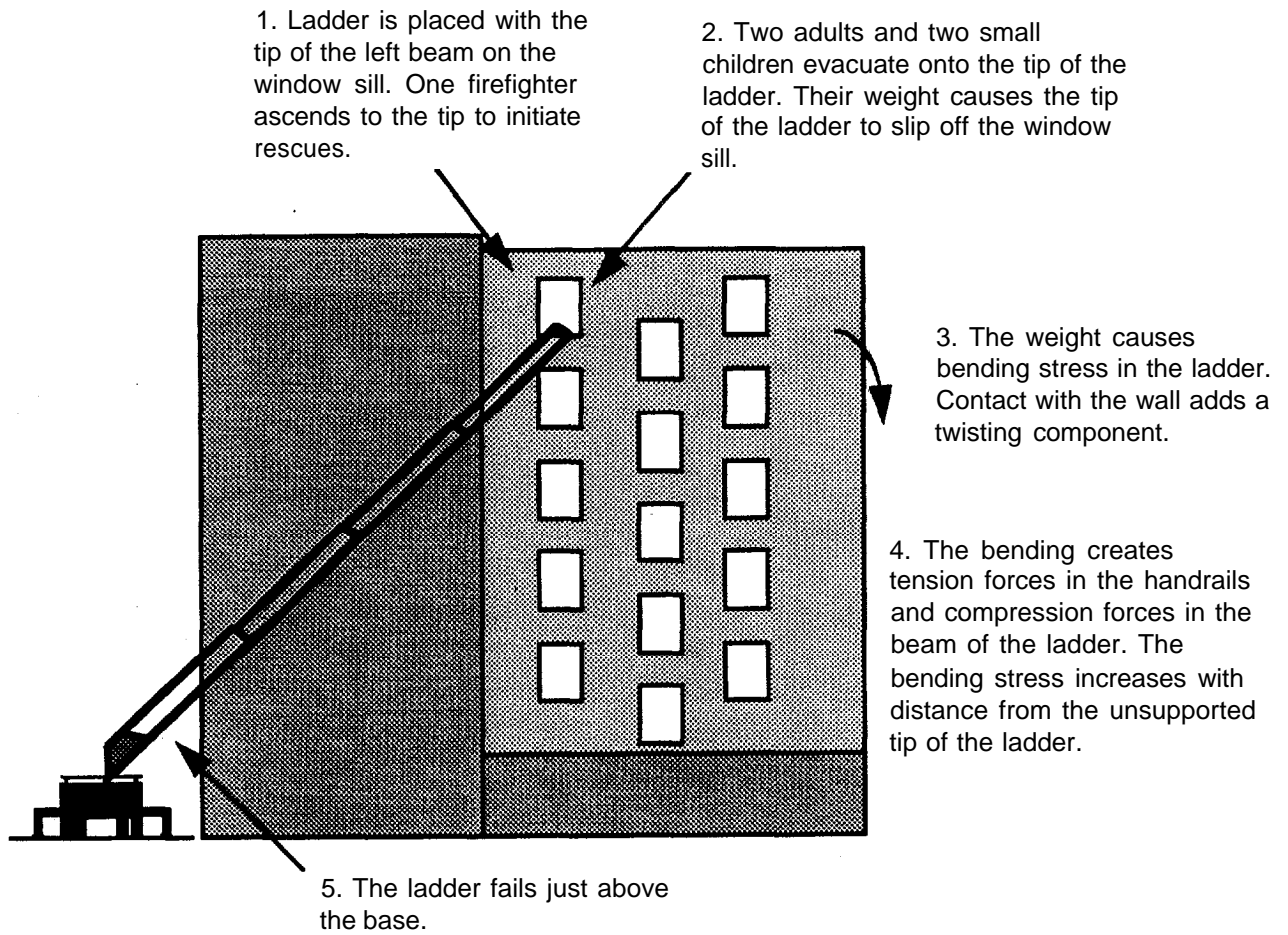
## Figure 2. Sequence of Events at New York City Ladder Collapse

The window is on the side of the building, approximately 30 feet back from the sidewalk, overlooking a fenced-in parking area (see Figure 2). When the building was originally constructed this window would have opened into a lightwell between two similar buildings; however, the adjacent building has been demolished, leaving the window exposed. The area directly below the window is a fenced-in setback.

The New York City collapse occurred when the capacity of the lower beam to support the compression forces was exceeded. The ladder was subjected to twisting forces caused by the contact between the building and the tip of the left beam (see Figures 2 and 5). In this situation the twisting increased the compressive load on the bed ladder at the location where the maximum bending stress is applied to the ladder, just above the area where the load is transferred to the vehicle. The inward buckling of the beam caused the right side of the ladder to fail first, which caused the ladder to twist to the right as it fell.

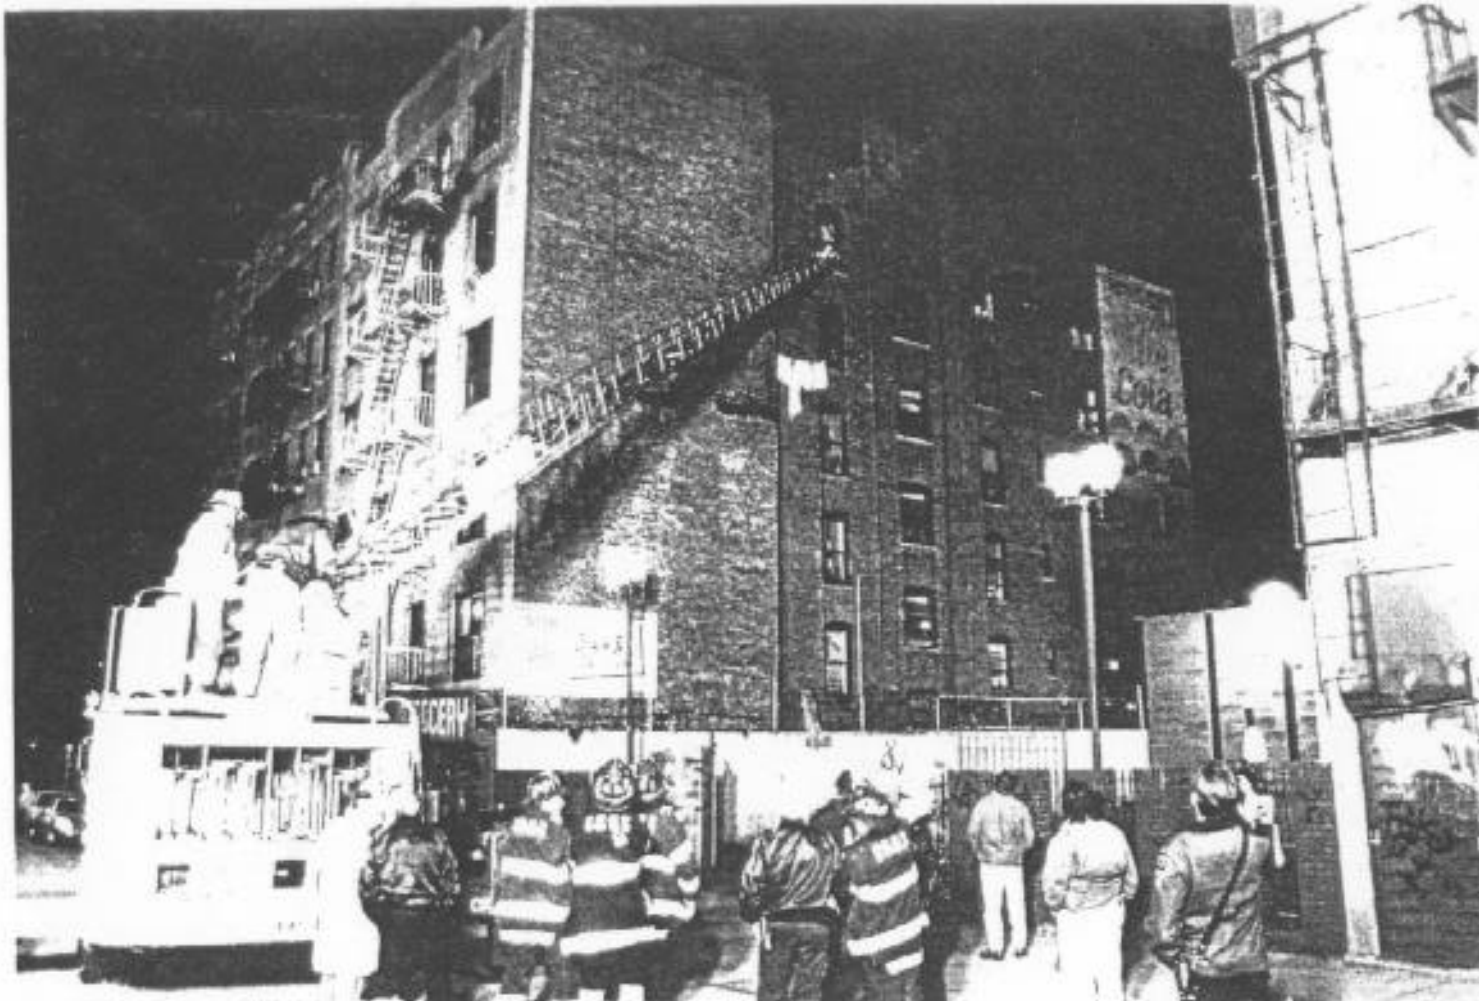
The ladder is made up of four sections, which are similar in construction. Each section consists of a pair of truss structures, one on each side, which provide primary ladder strength, and a hand rail (Figure 1.) These side truss sections are connected by rungs. Each section also includes equipment for extending the ladder and to ensure interlocking.

Figure 1. View of a 100 ft Aerial Ladder, Similar to the Failed Ladder, at the Site during Reconstruction of the Accident Conditions. This Figure also Shows the Truss Structure of the Ladder Sides.
