Broward Marine Fire Fort Lauderdale, Florida

BROWARD MARINE FIRE

FORT LAUDERDALE, FLORIDA

SEPTEMBER 5, 1996

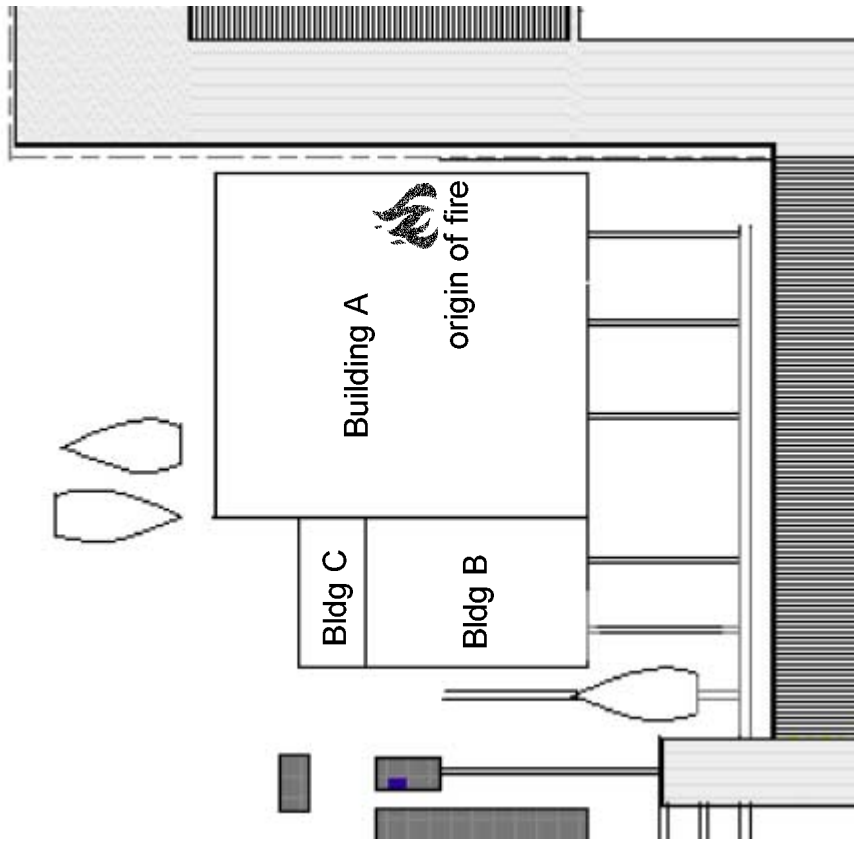
Site Plan
Figure 1

Situated on the New River, the Broward Marine facility housed boat production and storage buildings dating back to the 1930's and marina areas. The structures involved in the fire included a manufacturing building, a boat assembly building, and an office building. (See Figure 1) The facility had previously been cited by authorities for a number of code violations. Damage was estimated at 15 million dollars.

The largest building on the site was the manufacturing building (Building A), which abutted the canal directly to the west. Adjoining Building A were the one story assembly building (Building B) and the two story office building (Building C). A 30 foot tall dust collector was located directly to the east, in close proximity to the main electrical supply for the complex and a building housing restrooms and the electric winch for the boat launch. (See Figure 1) The one story, 90 by 140 ft woodworking shop and the 70 by 80 ft two story machine shop were situated to the east of the dust collector. The woodworking and machine shops incurred minimal damage as a result of the fire.
