Five Fatality Residential Motel Fire Thornton, Colorado

**Five Fatality Residential Motel Fire
Thornton, Colorado
January 27, 1997**

This is Report 104 of the Major Fires Investigation Project conducted by Varley-Campbell and Associates, Inc./TriData Corporation under contract EMW-94-4423 to the United States Fire Administration, Federal Emergency Management Agency.

**11 EAST 84TH AVENUE
THORNTON, COLORADO**

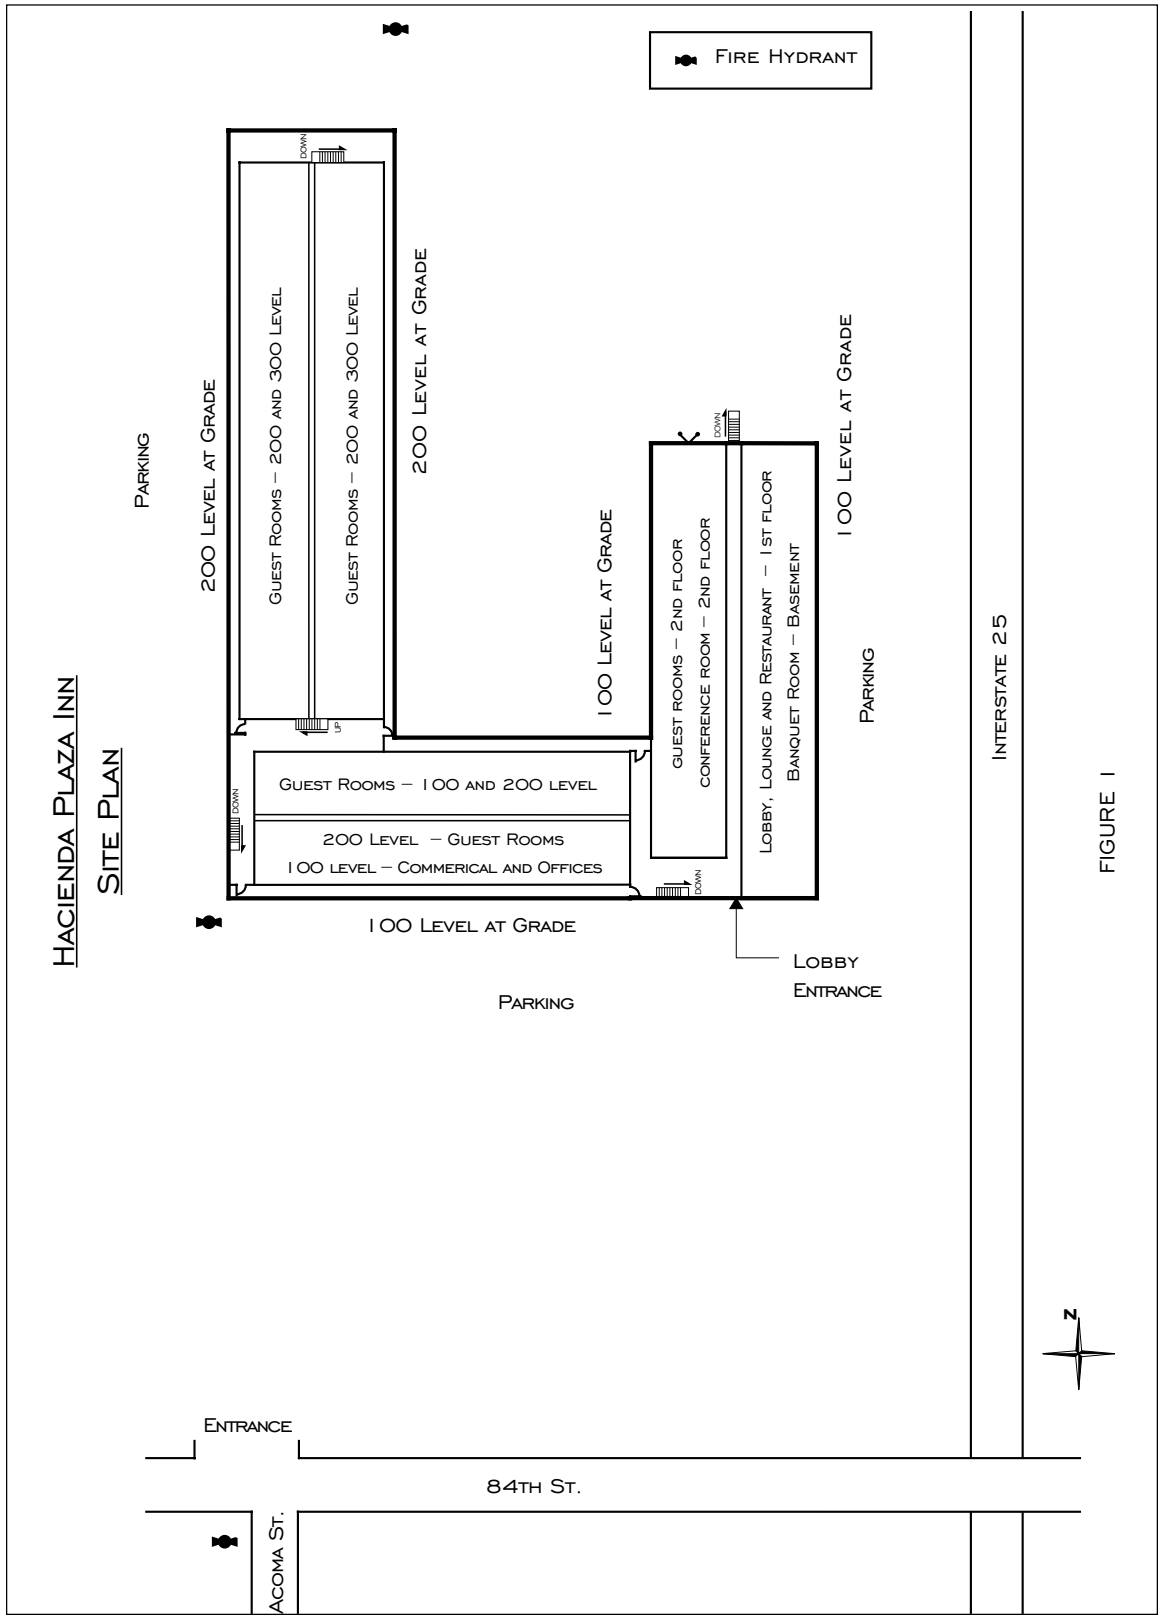
FIGURE 1

The Hacienda Plaza Inn was a partial “U” shaped structure consisting of three wings and was constructed in 1963. (See Figure 1 for diagram). The south or front wing and the west wing contained most of the guest rooms. The first floor of the front wing had several areas which were available for office and commercial use including one which was occupied by a quick print shop. The east wing contained the registration desk, offices, lounge, restaurant, banquet room, and on the second floor, efficiency style guest rooms with small kitchens.

Figure 1. Site Plan

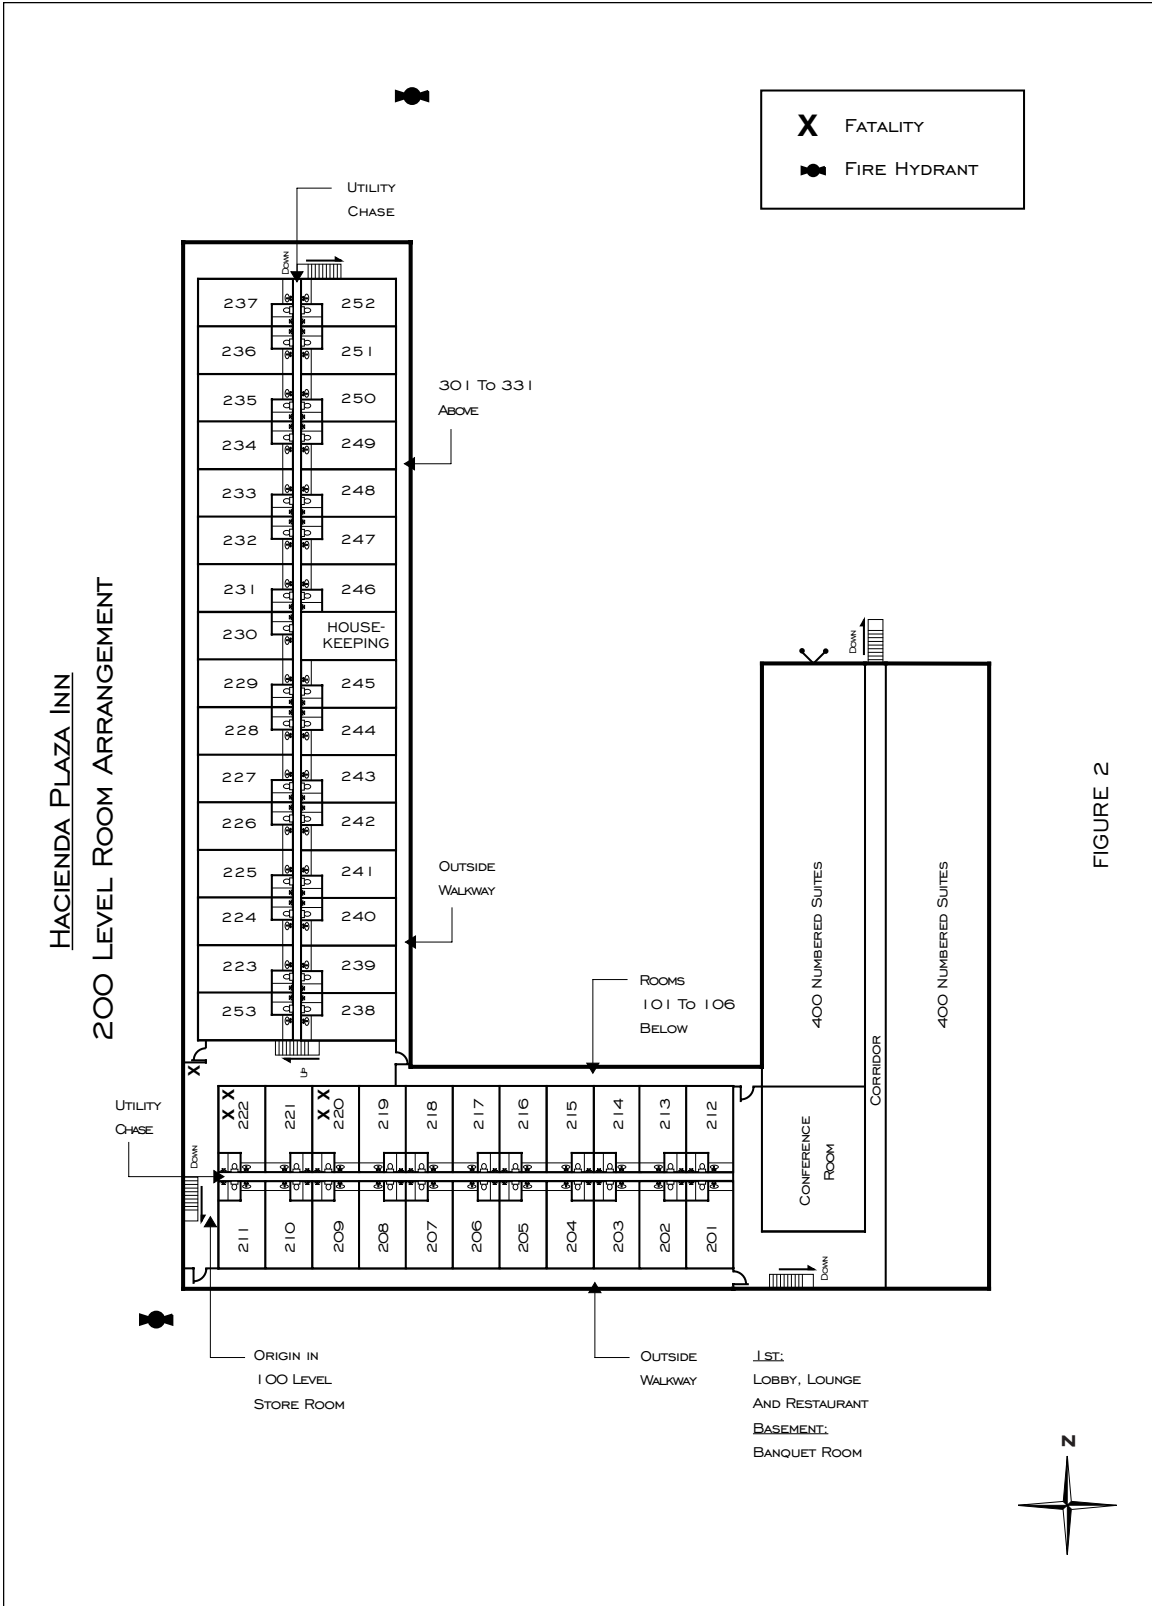
FIGURE 2

Figure 2. 200 Level Room Arrangement

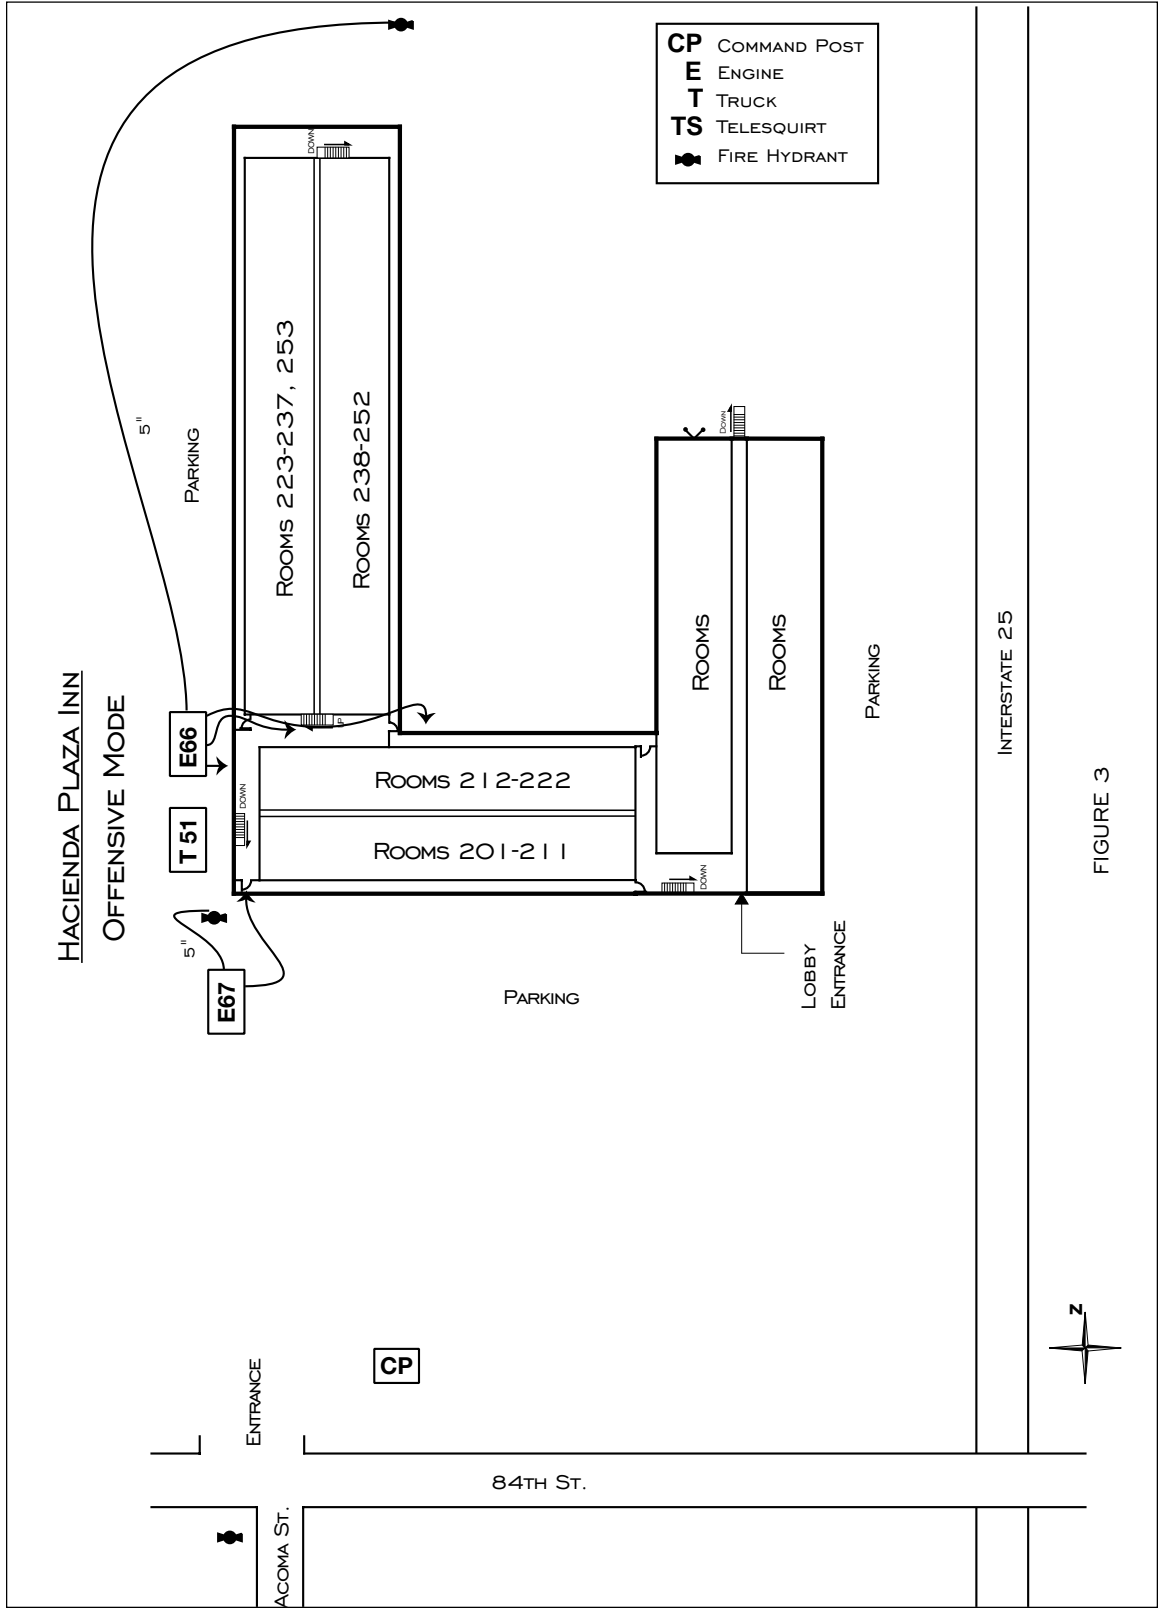
FIGURE 3

Engine 62 was the second engine on the scene just before 2:47 a.m. accompanied by Ambulance 62. The three member engine company assisted Engine 67 with rescue and advance of the hose line. The ambulance crew established a triage area in the front parking lot and requested additional resources from its headquarters. Eventually five AMR ambulances plus supervisory personnel responded to the fire scene. The search of Rooms 201 to 210 was completed by 2:52 a.m. and this area declared "all clear" by Engine 62. Attention now focused on extinguishing the fire at the base of the stairs at the west end of the front wing. (See Figure 3 for diagram)

Figure 3. Offensive Mode

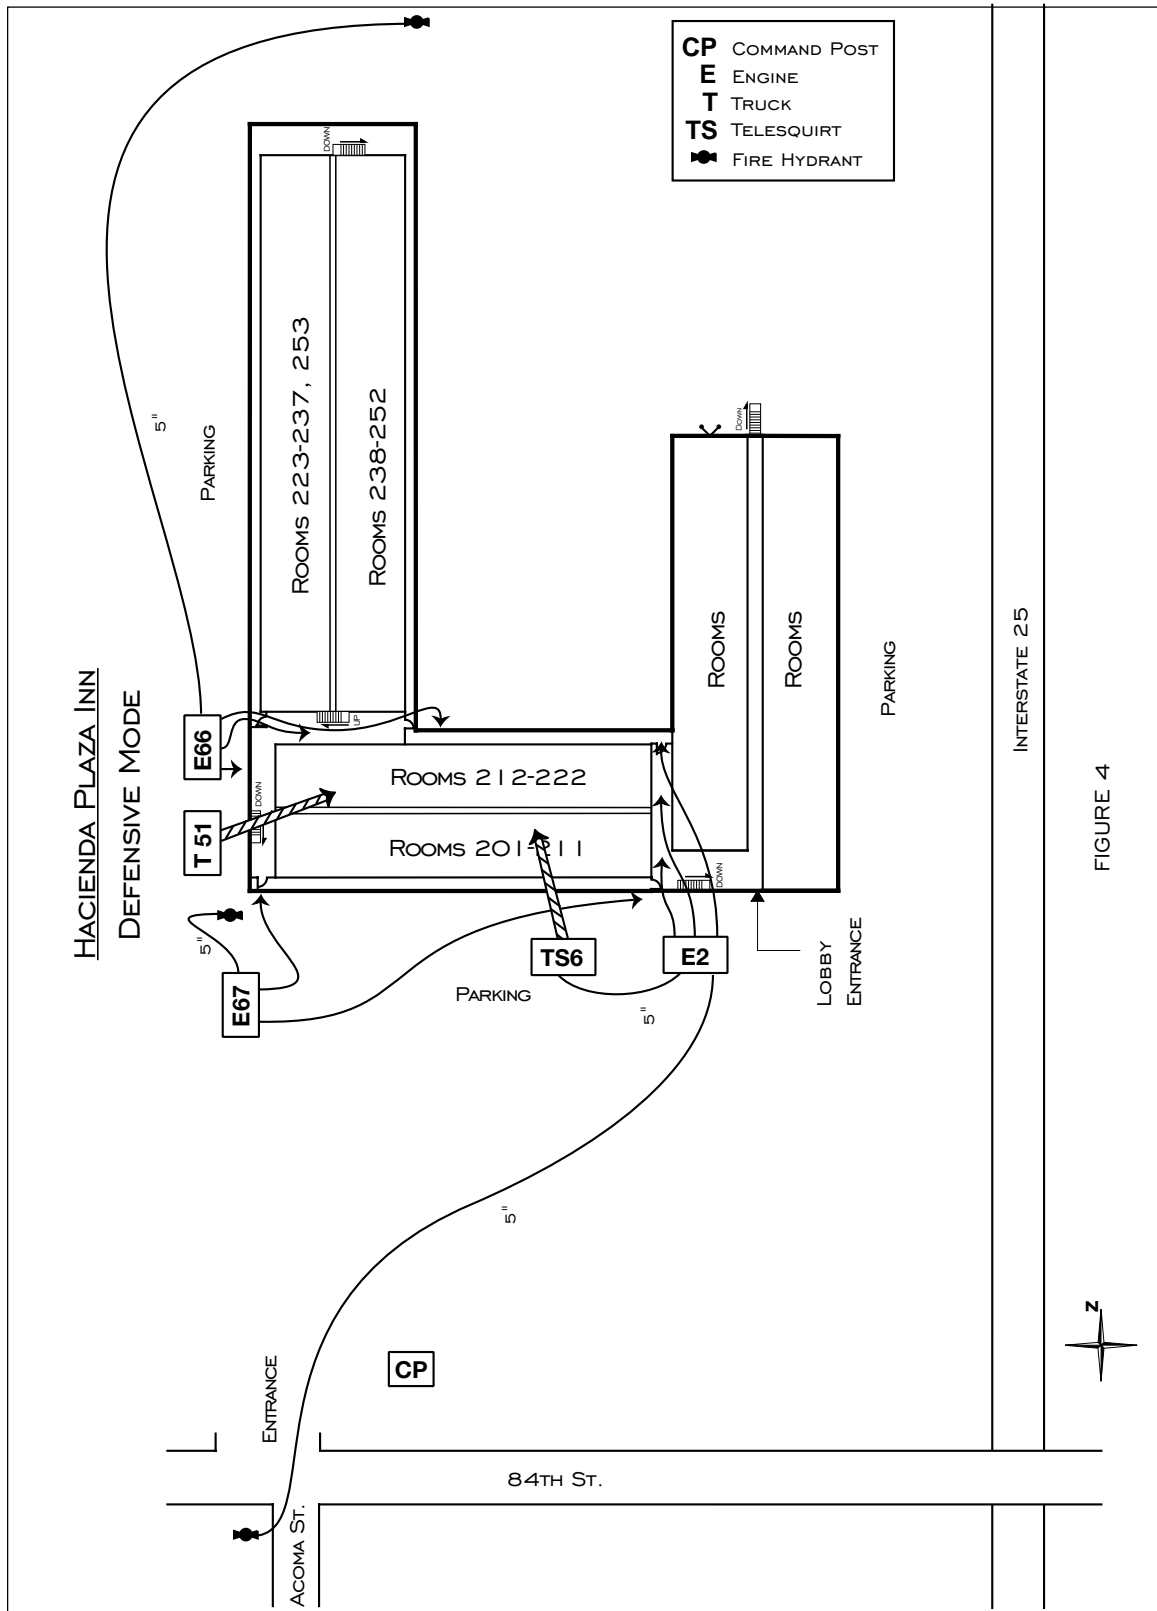
FIGURE 4

Tactical operations then changed from an offensive mode to a defensive one. About the same time the fire conditions were deteriorating, Incident Command was transferred to North Metro's deputy chief of operations. Command instructed Truck 51 to establish a ladder pipe operation at its position and two 2-1/2" lines were stretched from Engine 67. The "B" shift was recalled to their stations at 4:13 a.m. and two engines were requested from Southwest Adams County shortly after. (See Figure 4 for diagram)

Figure 4. Defensive Mode
