Old Buckingham Station Chesterfield, Virginia

Old Buckingham Station

58 Unit Apartment Building

May 19, 1995

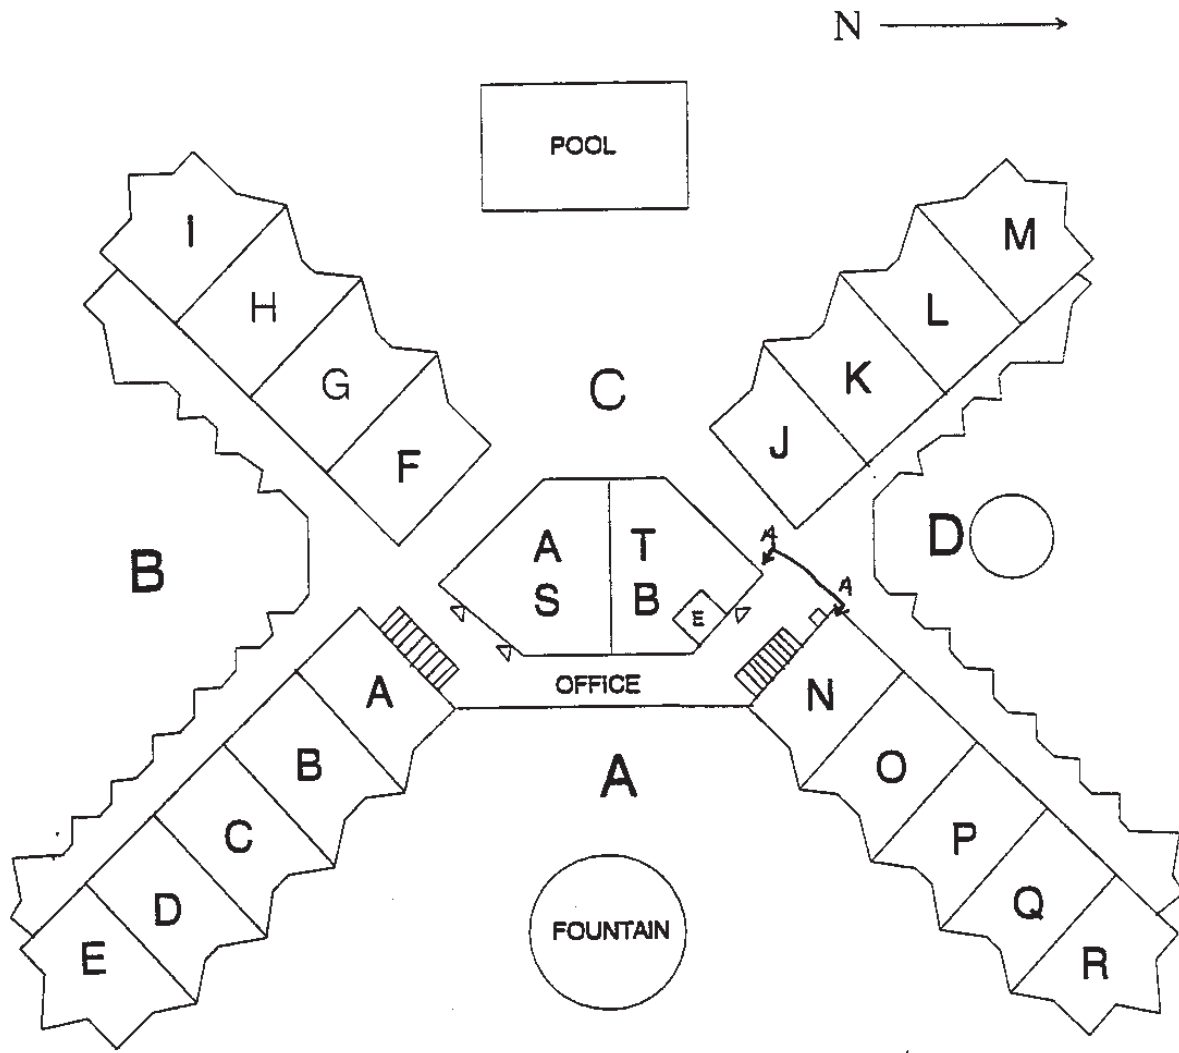
Fire investigators determined that the fire began on the second floor in a covered walkway between the northeast wing and the center core, just outside of apartment 2J. (See Appendix B for location) The cause was identified as an exterior light fixture that had been inverted from its usual operating position by one of the occupants and then wrapped with a flannel shirt to reduce the light intensity into their bedroom. The fixture's incandescent bulb was enclosed by a clear plastic globe. By inverting the fixture, the vent holes, which were intended to remove heat from the 60 watt bulb, were out of position and the plastic globe in combination with the flannel shirt held in the heat. This eventually resulted in the ignition of the shirt and the light fixture's plastic globe. The fire spread to the vinyl plastic siding and to the wooden stairway.

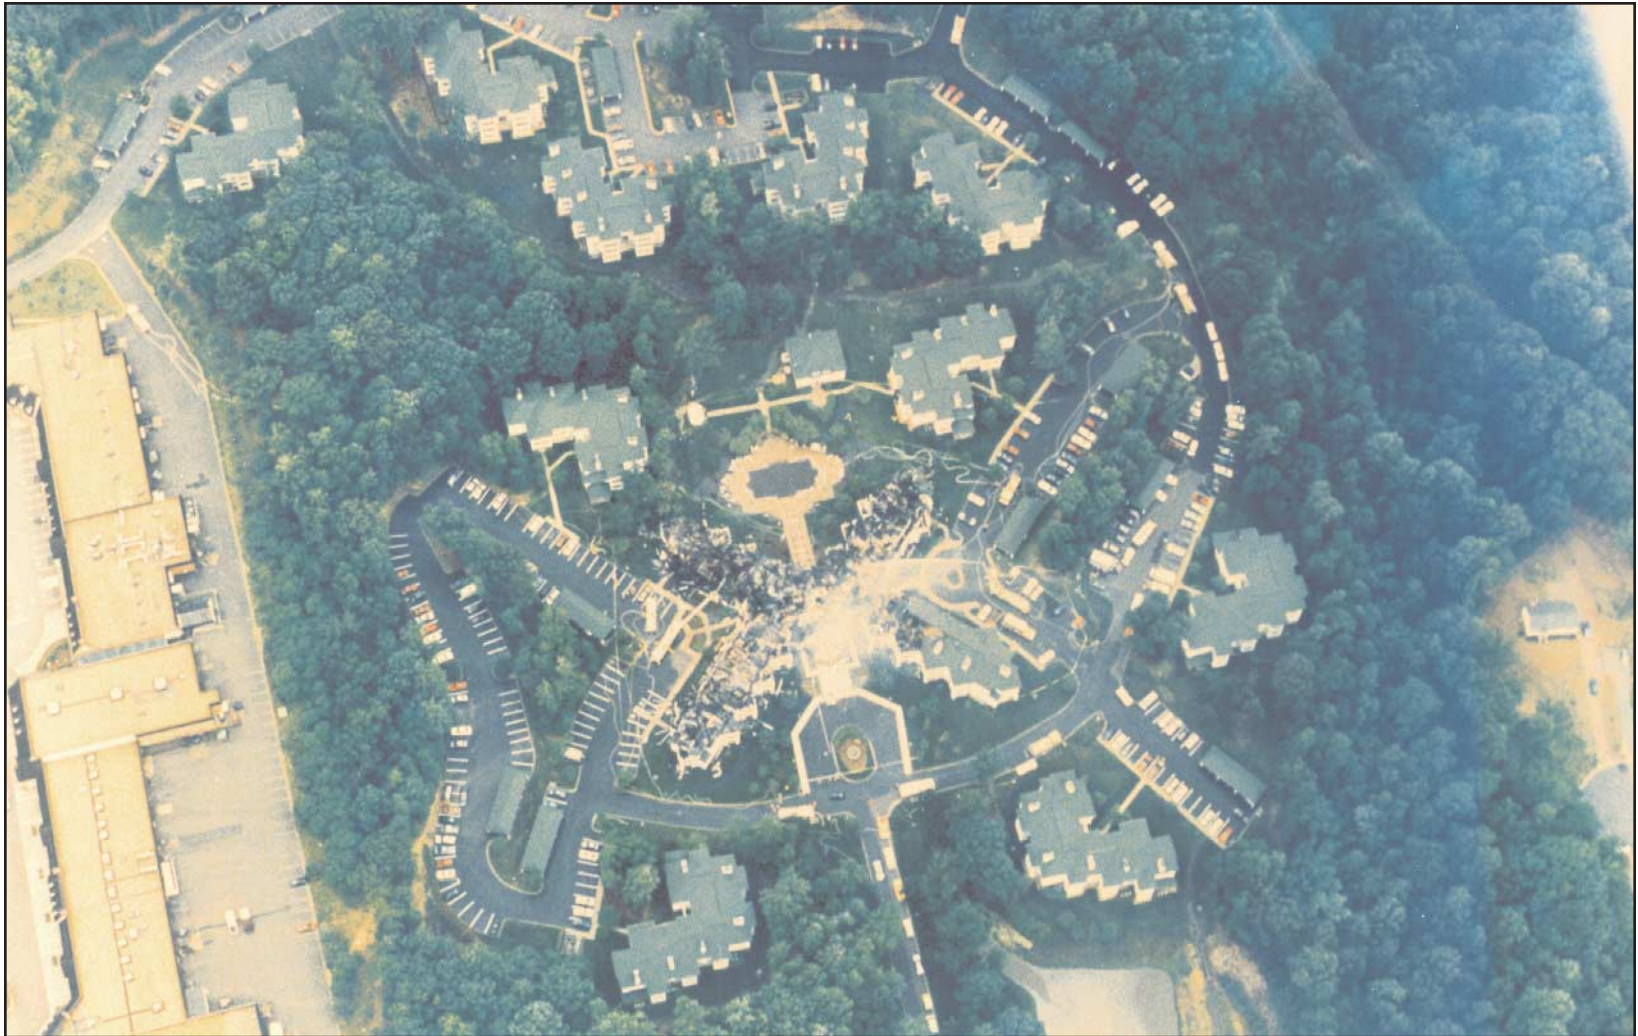
1. Site view of fire with north to the left. The shopping center and woods for the hand-stretched hose is on the left with Engine 73 still in position.

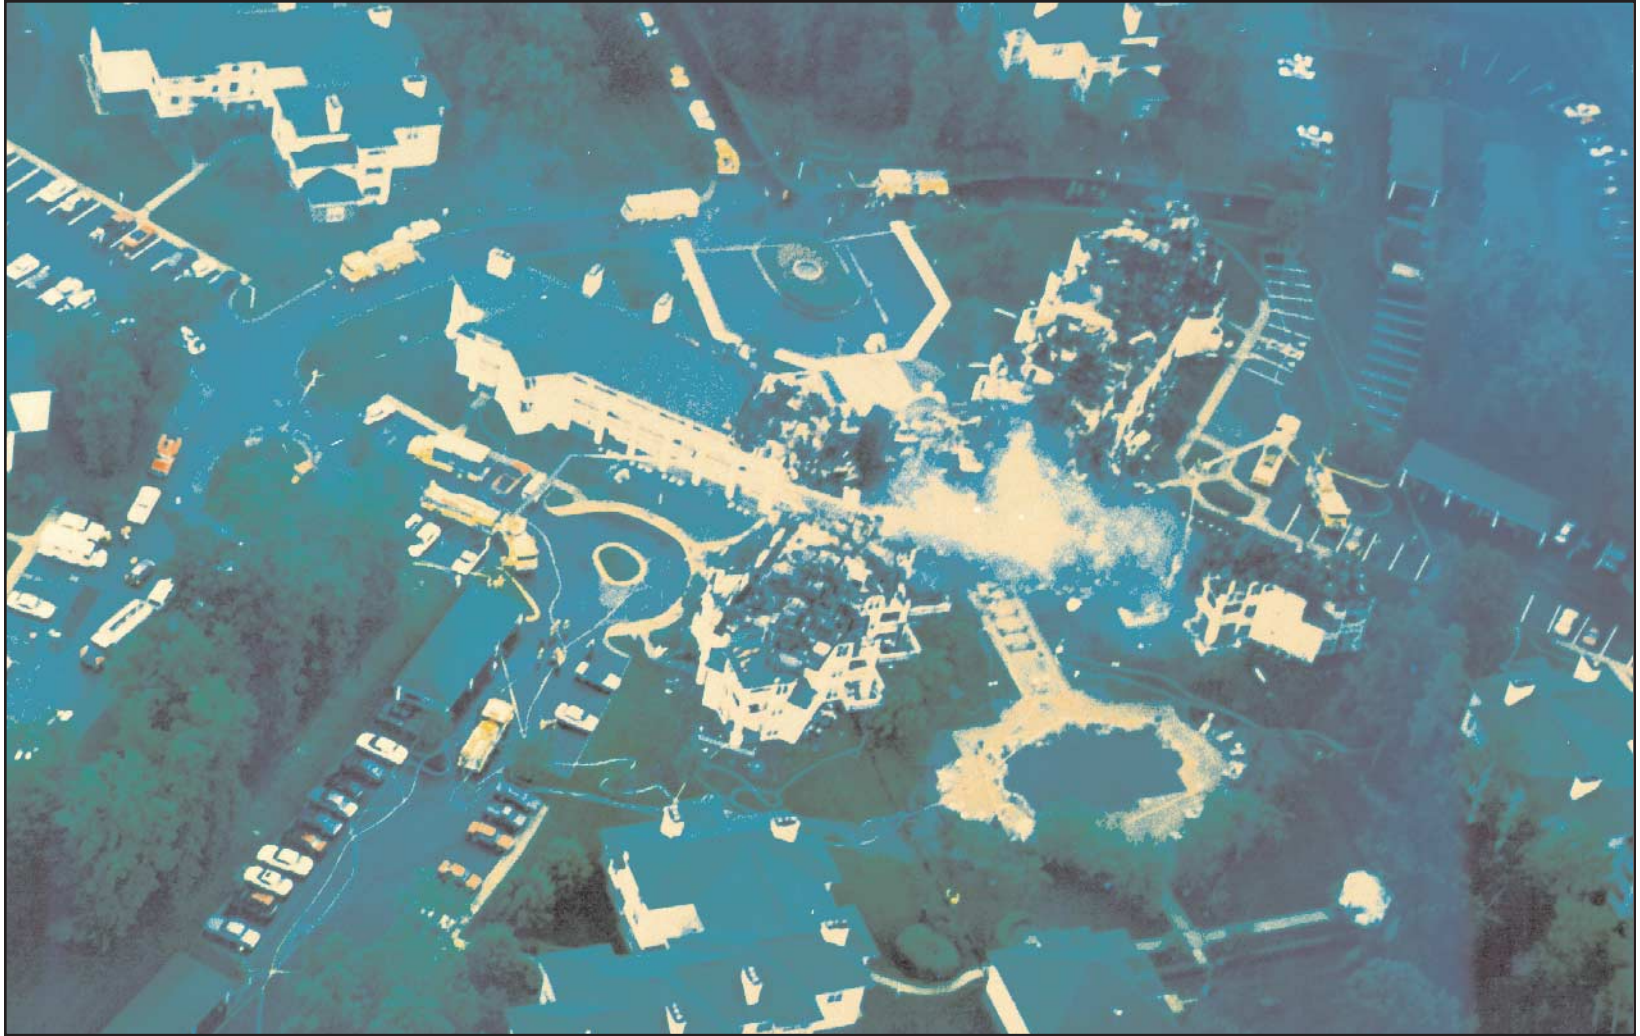
2. View of building with units still operating to complete extinguishment. North is to the left.

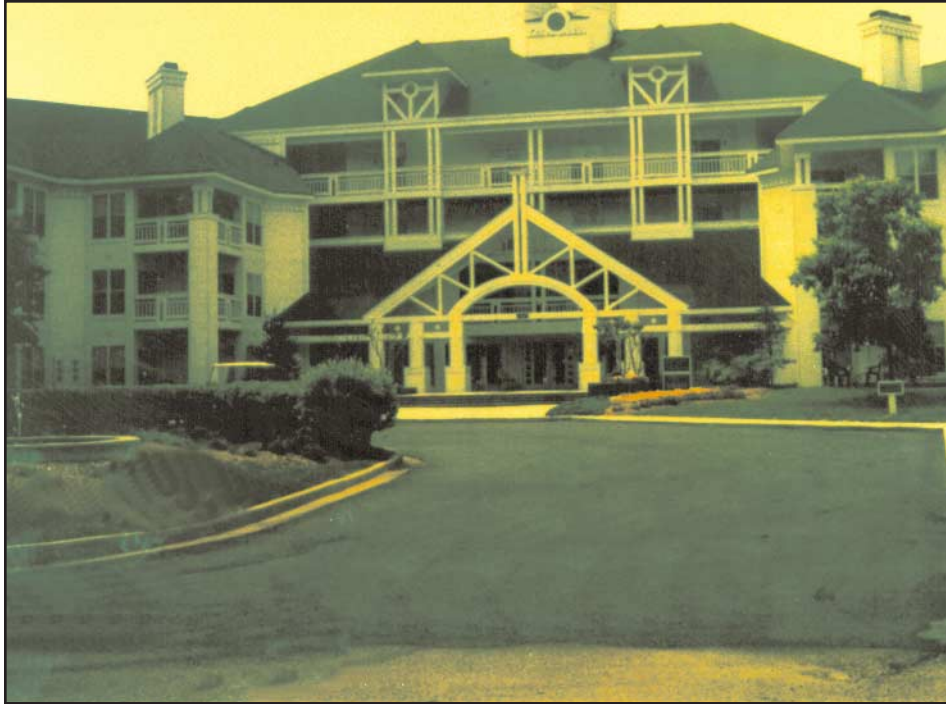
3. The main entrance to the building and the four story core building before the fire. North is to the right.

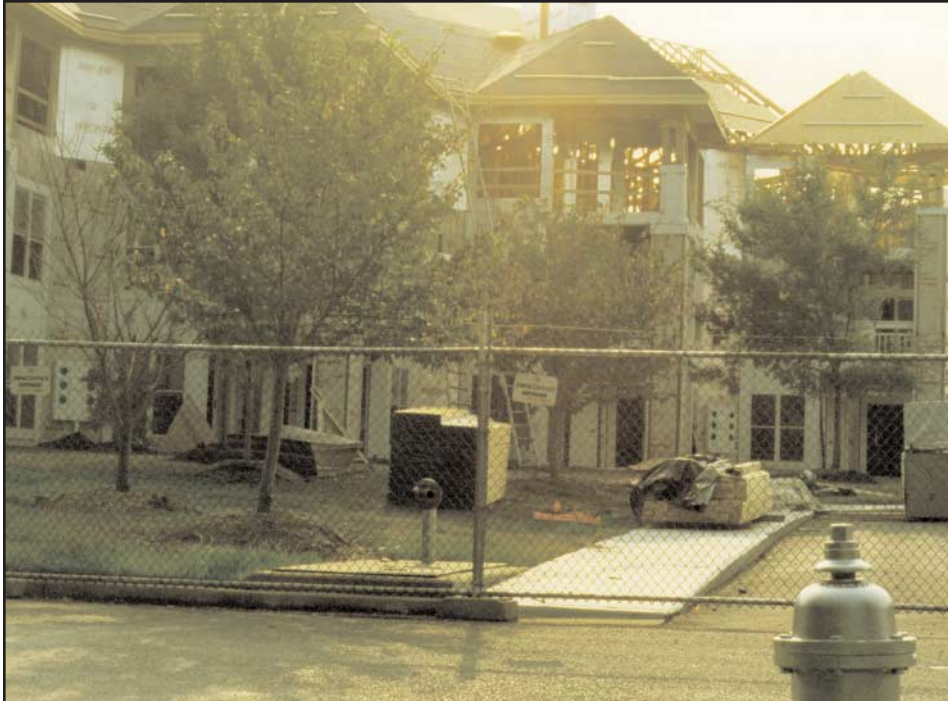
6. Fire hydrant and core siamese connection used by Engine 54 on arrival. Repairs and reconstruction are being made to the front wing; this side is the patio/balcony for each apartment.

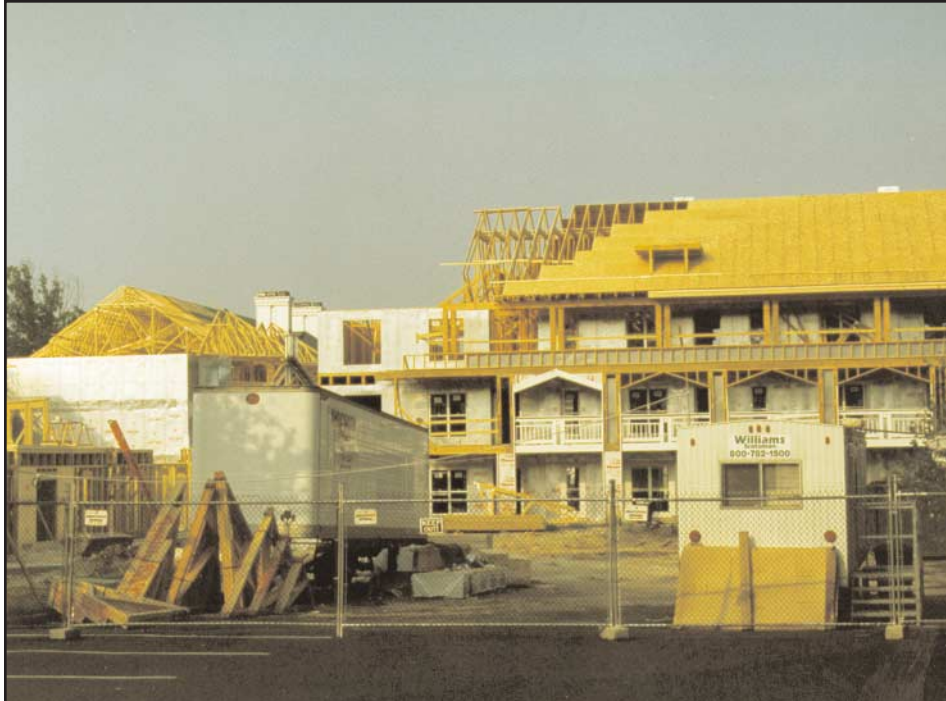
8. Reconstruction underway in Sector B, which is on the south side of the building. The exterior walkways were on this side of the wings.

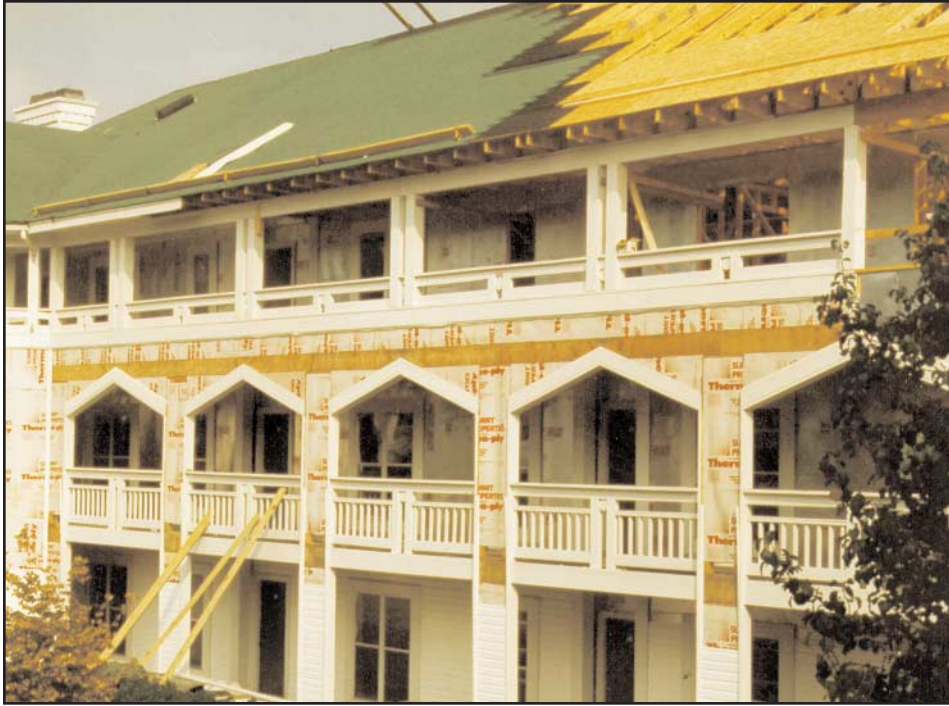
9. The exterior walkways in Sector D, with the stairway located at the left edge of the photograph. The core is out of the picture to the right.
