## **Sprinklered Records Storage Facility**

**Chicago, Illinois**

**Sprinklered Records Storage Facility  
Chicago, Illinois  
October 29, 1996**

This is Report 106 of the Major Fires Investigation Project conducted by Varley-Campbell and Associates, Inc./TriData Corporation under contract EMW-94-4423 to the United States Fire Administration, Federal Emergency Management Agency.

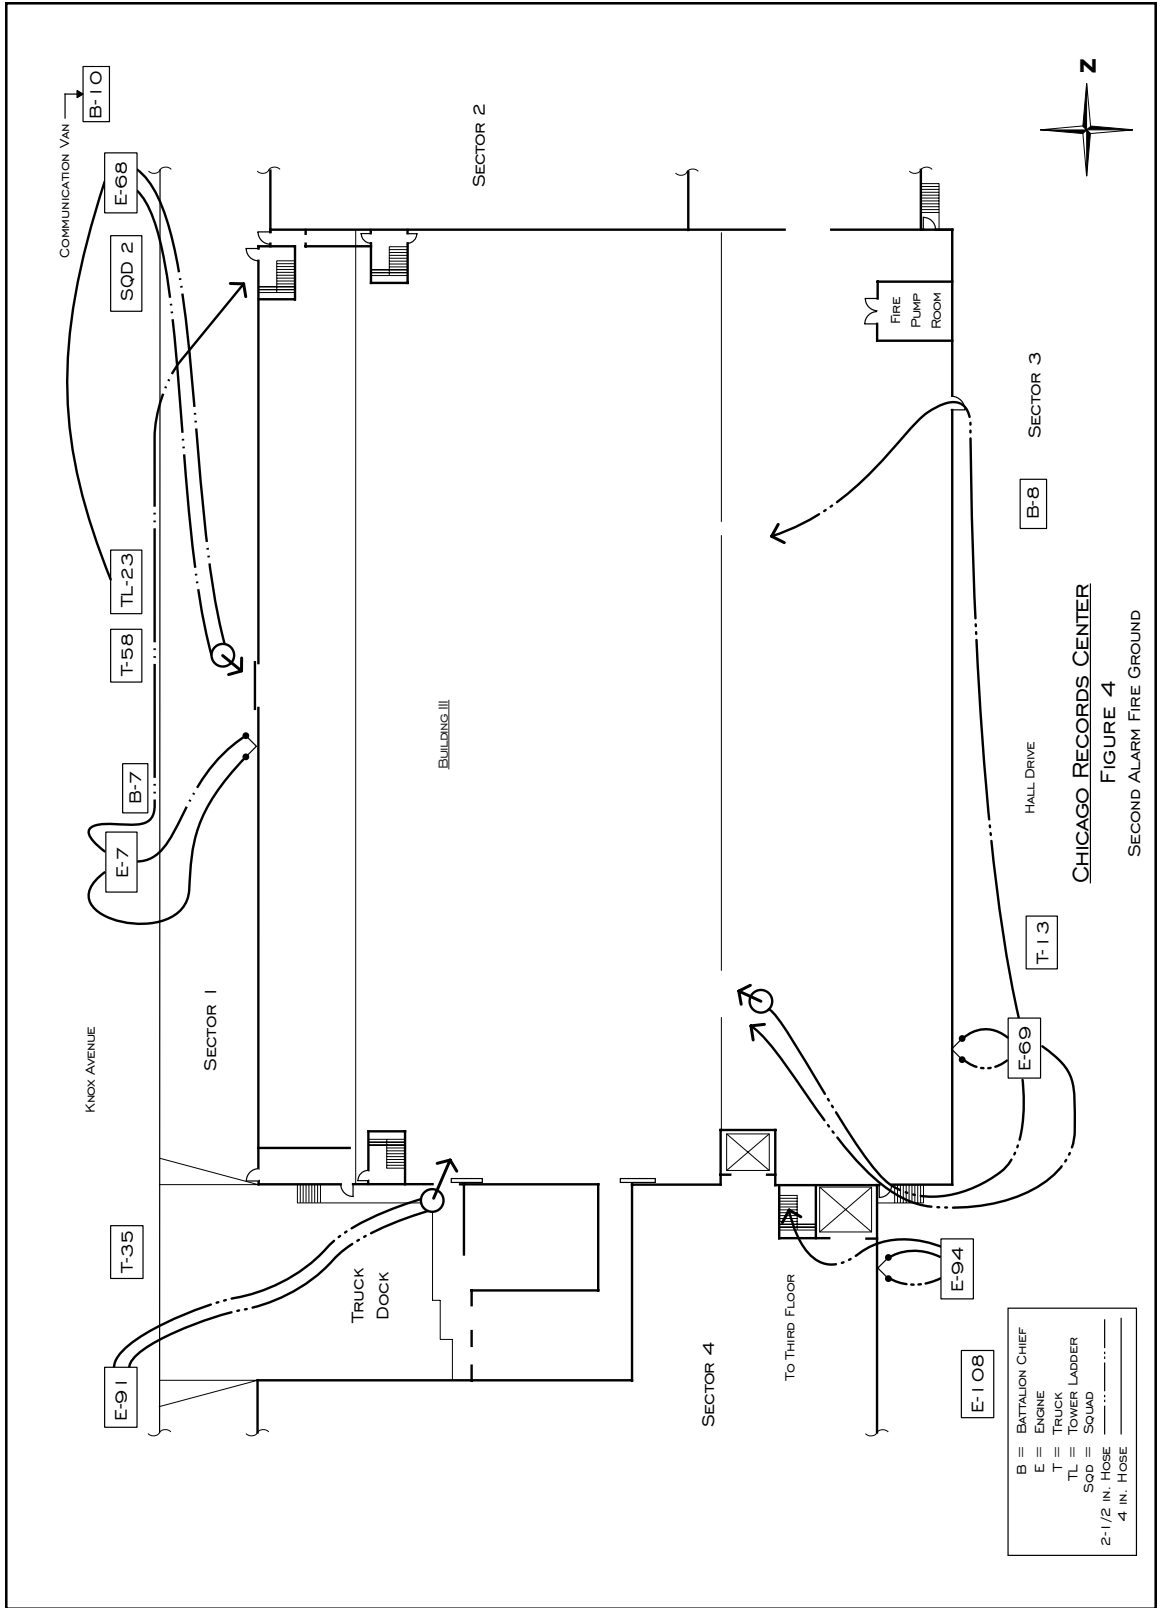
skylights in the roof of the rear sector and checked for fire extension. Engine 108 extended additional hose lines to deluge sets at the two unprotected door openings. Eventually, each opening had a 4" hose line and at least one 2-1/2" hose line. The members of both companies rotated the manning of the deluge sets and checking for fire extension through the masonry wall. (See Appendix A, Figure 4)

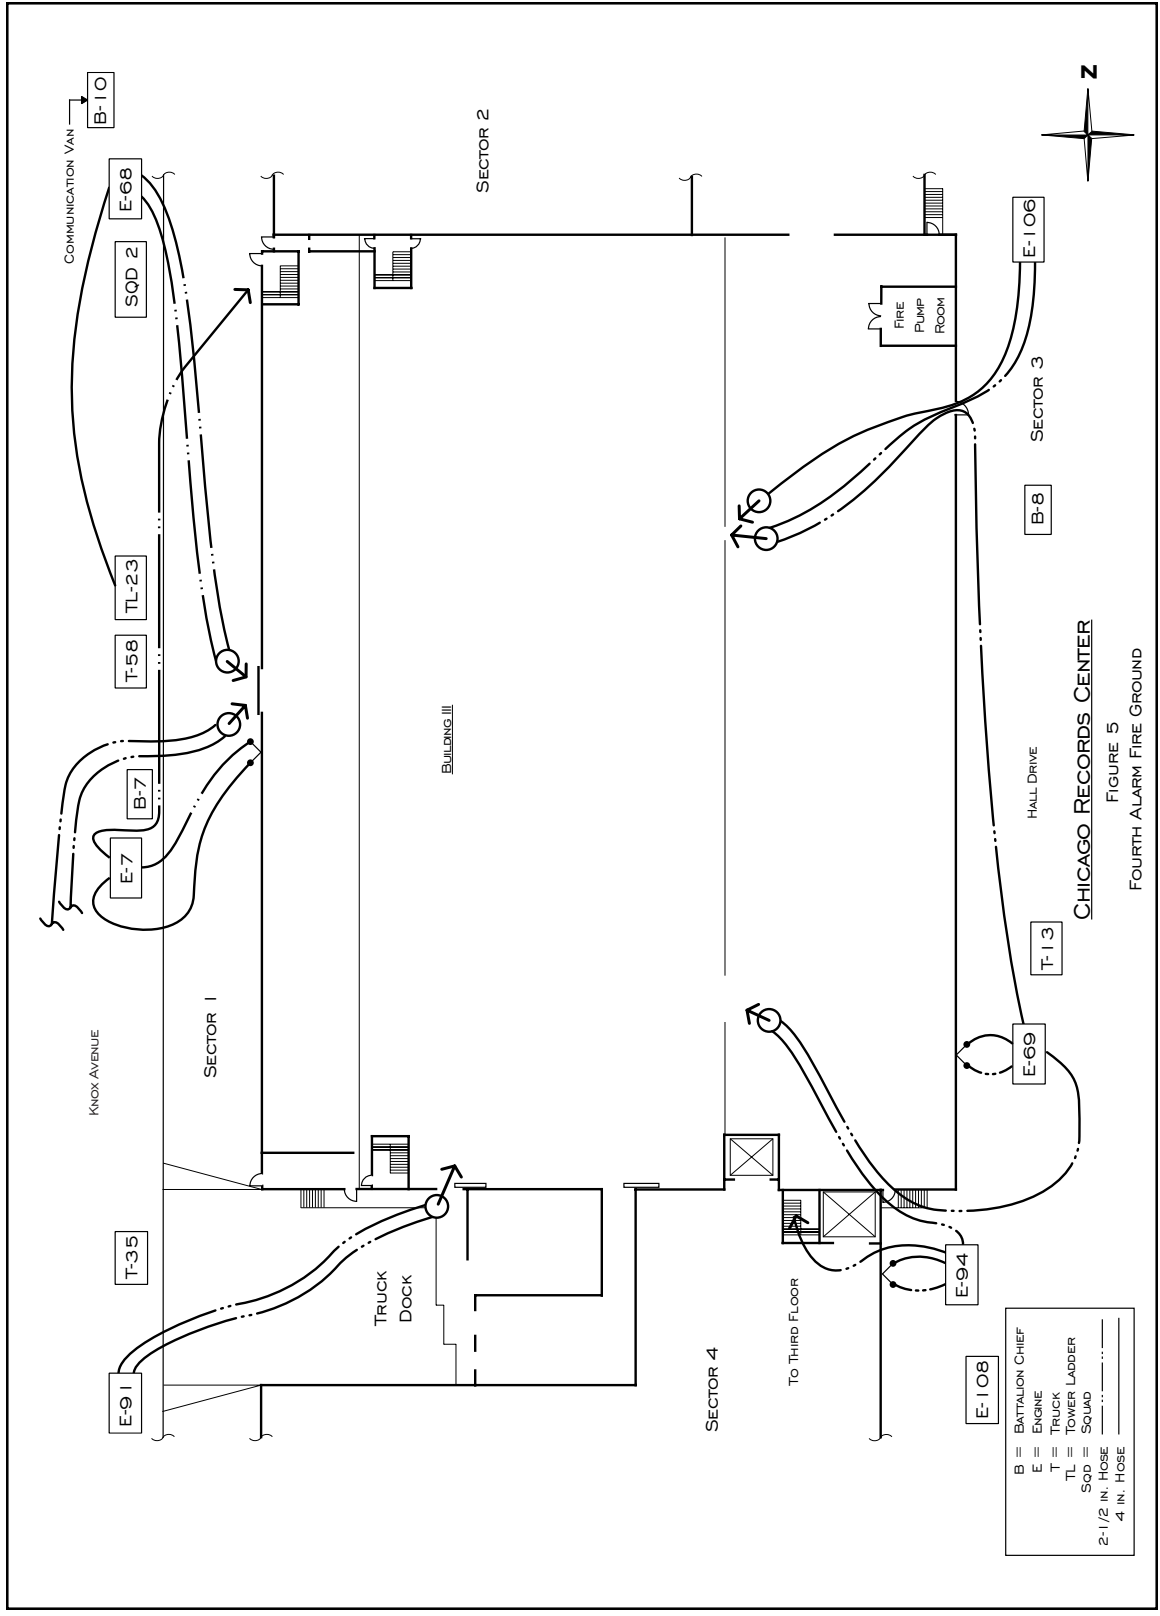
scene personnel who had been working for nearly two hours. Command personnel felt that the fire was contained to the fire separation area, barring any significant structural collapse. Such a collapse was not expected as the conditions at the masonry separations did not appear to be deteriorating. (See Appendix A, Figure 5)
