Nebraska Public Power District Minimizes Damage to Transmission System

Full Mitigation Best Practice Story

State-wide, Nebraska

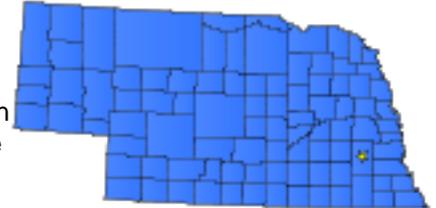
This project proved to be successful when extreme winds and tornadoes caused failure of five standard two-pole wood structures, setting up a cascading effect from the Columbus to Grand Island transmission line. The cascade ended at the dead-end structure funded through FEMA’s HMGP, demonstrating that these structures performed as designed.
