Wet Floodproofing Reduces Damage to Popular Beach Restaurant

Full Mitigation Best Practice Story

Monroe County, Florida

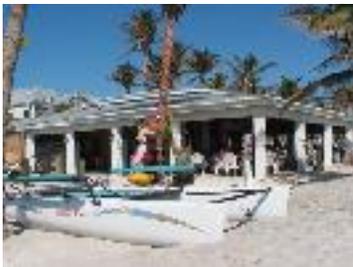
The wide-open design of the Duval Beach Club

The concept of wet floodproofing is simple: provide means to allow floodwaters to enter, flow through, and exit a building, thereby preventing more severe damage to the building as a whole. Non-absorbent materials and/or coatings are used to allow easier cleaning and sanitizing of interior surfaces after a flood event.

"Utilizing the old wall structure, we opened it up a little bit more, so we'd be able to get better penetration for water," Mr. Tillman said. "The center wall is a break away wall, so if we really have big water, it would just push out."
