Athens Resident Pleased With Retrofitted Home

Full Mitigation Best Practice Story

Athens County, Ohio

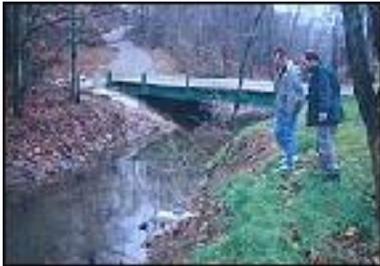
Stream caused homeowners to make adjustments

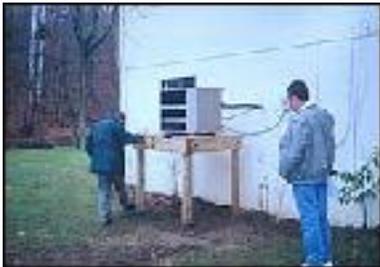
Elevation works to avoid flood damage

In 1998, with the help of a \$16,000 mitigation grant, Reese was able to retrofit her home by having her deck partially rebuilt, a waterproof rear door installed that would not allow high water to enter the house; a one-way check valve installed in her flood wall that would allow water to flow only away from the house; her heat pump condenser elevated on a masonry platform to above the peak flood level; and the electrical circuit box and meter moved from the rear to the front wall of her lower level and elevated to six feet above the floor.
