View From the Top: An Elevation Story

Full Mitigation Best Practice Story

Harrison County, Mississippi

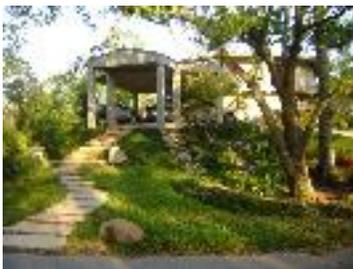
Front view of the Stecklers' elevated house.

Builders added stone work under the house to match the stone on the first floor of the dwelling to give it a more finished and uniform look. The Stecklers had the front yard “graded up” and built a raised, semi-circular driveway that includes a covered breezeway. The driveway serves as a dry place to park cars and lawn mowers during a flood event.

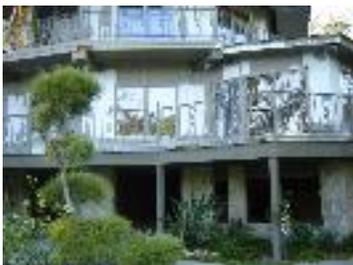
Backview of the elevated house.

Instead of the typical staircase in front and back of the house that usually accompanies an elevation project, the Stecklers decided to use personal funds to build a large wooden porch along the entire backside of the house that faces the river. “We were accustomed to having the outside and living areas inside as one component and we utilized it so much that having stairs in the front and rear would not have worked for us,” she explained. “We chose to spend our own money to supplement grant funds on the porch to make the house [meet our needs].”
