## Elevated House Attracts Local Attention

### Full Mitigation Best Practice Story

#### *Harrison County, Mississippi*

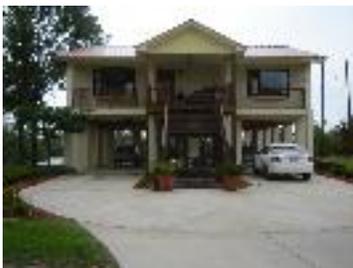
The Shoemakes' elevated house in Biloxi, Mississippi.

The couple's 2,100 square-foot home is elevated 11 feet 11 inches above the original slab-on-grade foundation and sits on an open concrete column system with embedded anchor plates for added structural support. The open space beneath the house is utilized for parking. Harry Shoemake noted that the elevation includes an additional three feet (freeboard) that is higher than Harrison County's minimum code requirement. "I wanted to be on the safe side, elevate higher, and never have to worry about it again," Harry Shoemake explained.

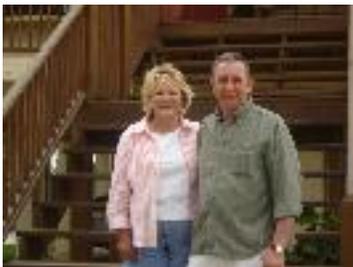
The Shoemakes at the front entrance to their elevated home.
