## A Dream Comes True: Mitigated Haven in Mississippi

### Full Mitigation Best Practice Story

#### *Jackson County, Mississippi*

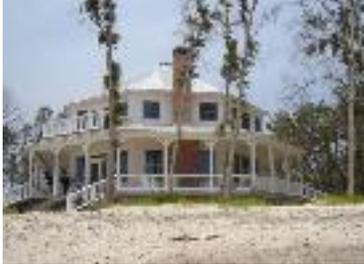
Beachside view of Charlotte Lamar's House in Ocean Springs, MS.

Eight pressure-treated wood pilings were positioned at the corners of the octagonal structure, embedded 15 feet in the ground, and connected to the roof. The design of the roof aids in its wind resistance; its pitch equalizes downward pressure from high winds. The entire house is tied together with metal brackets and hurricane straps that help distribute wind loads by providing a continuous load path from the roof to the foundation. The home, built of cedar, stands approximately 22 feet above sea level and is located in Zone C where there is no regulation to elevate above the Base Flood Elevation. Therefore, Ms. Lamar elevated her house by choice, basing her decision on historical events, such as Hurricane Camille. Following fourteen months of construction, she gazed toward the Gulf from the second floor deck of her new home.

The tidal surge rose two feet on Ms. Lamar’s property, but missed her house by three feet because of the additional elevation incorporated into her home’s construction. The force of the tidal surge destroyed the air conditioning and heating ductwork beneath the house; saltwater invaded the floor vents and left mud on the floors of the house; and the 102 mile-per-hour winds and rain damaged a window, allowing water into the house. However, compared to other beachfront homes, Ms. Lamar’s house sustained minimal damage.

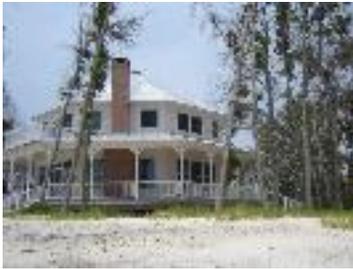
Beachside view of Charlotte Lamar's House in Ocean Springs, MS.
