## Couple Fully Braced for Tornado

### Full Mitigation Best Practice Story

#### *Volusia County, Florida*

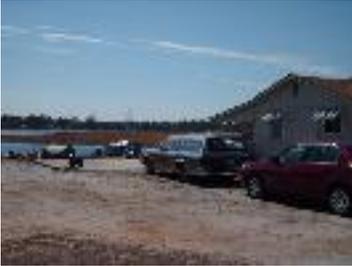
What is left of the garage

Louedna Huber, 81, and her husband, Vern, 87, of DeLand lived to see destruction all around their home and throughout the community. Fortunately, the couple was not harmed and their house had minimal damage in the wake of the storm. Tornado winds uplifted their garage, a detached building next to their house, slamming it into neighboring Bear Lake almost 200 feet away. The open porch suffered little damage as strong winds slightly shifted the support beams. The powerful winds of the rapid moving tornadoes partly sucked out one set of windows in front of the house and flying debris shattered one at the back of the house; all other windows held.
