Repair, Improvement of Flood Damaged Road in Stratford

Full Mitigation Best Practice Story

Fulton County, New York

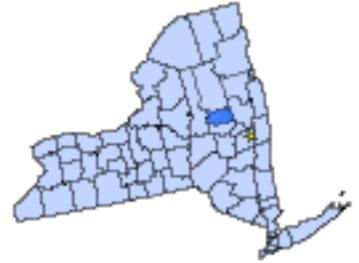
June’s torrential rains destroyed twin, 42-inch by 42-foot culverts running under the road. This forced flood waters over the road and washed out pavement 20 feet wide, 50 feet long, and four inches deep.

SEMO and FEMA have approved about \$63,400 in road-repair costs. They also approved an additional \$61,600 to replace the destroyed culverts with a 154-inch-wide by 40-feet-long box culvert with a rise of 100 inches. The bigger culvert will reduce the chance that debris will clog the culvert should another flood occur. The total project costs approximately \$125,000, of which the federal share is approximately \$94,000.
