County Residents Partner with FEMA to Secure Waterway

Full Mitigation Best Practice Story

Oakland County, Michigan

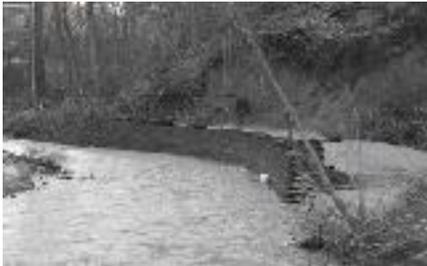
Bloomfield Area During Construction.

As a community committed to the protection of its natural features, this project focused on the use of innovative engineering alternatives that included brush mattresses, live staking, fascines, pools and riffles, and vegetated geocell retaining walls. The 100-year floodplain elevation was not increased at any of the project sites. In addition, this project included an extensive reforestation phase. Among all four sites, a total of 911 new trees were planted which included American Sycamore, Silver Maple, Red Maple, Sugar Maple, River Birch, and White Pine.

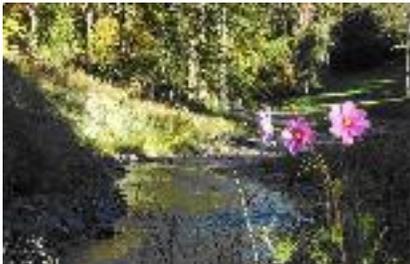
Bloomfield Area Post Project

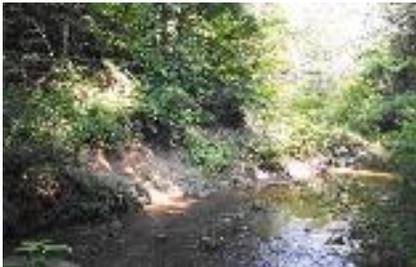
Bloomfield Area Pre Project

The Franklin Stream Bank Stabilization Project focused on four areas of stream bank erosion along a one-mile stretch of the Branch. Each site was ranked a priority based on the threat to infrastructure, such as sewers, homes, and roadways. In the past, the standard engineering solution for rectifying stream bank erosion problems was to install hard armoring like riprap, concrete lining, or sheet piling.
