## Winchester Culvert Upgrades Prevent Flooding

### Full Mitigation Best Practice Story

#### *Middlesex County, Massachusetts*

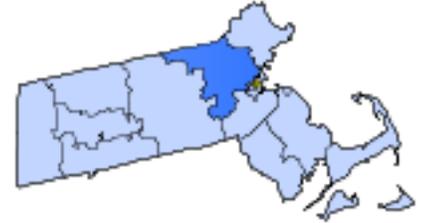
When the water reached the Sylvester Avenue culvert, the force cracked the sidewalls, washed out the area embankments, and damaged the surrounding pavement. The Canal Street culvert was also negatively affected in similar ways. In addition, the flooding significantly impacted 14 neighborhood homes. A nearby elementary school suffered water damage to carpeting and furniture located in basement classrooms.

The proposed fix was to enlarge the culvert capacity by 20 percent. The original culverts were 12 by 10 foot. The new culverts were to be upgraded with pre-cast reinforced concrete, 15 by 12 foot culverts. New headwalls were also to be installed at the entrances and exits of the culverts to prevent erosion and scour. Construction would involve demolition of existing structures, casting new footings and then the installation of new culvert boxes.

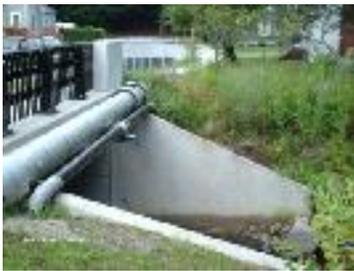
Canal Street after Repair

With funding from FEMA's Hazard Mitigation Grant Program (HMGP), a \$230,018 grant was awarded. Construction occurred in the summer months and required the bypass pumping of Horn Pond Brook to facilitate installation of the culverts and headwalls. This hazard mitigation project for the Town of Winchester was completed in 2005.

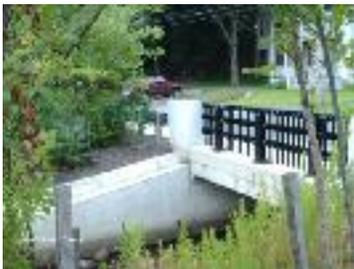
Canal Street after Repair
