## Built to Protect Against Floods, Windstorms, and Earthquakes

### Full Mitigation Best Practice Story

#### *Columbia County, Oregon*

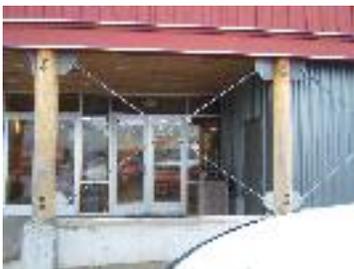
Exterior load-bearing construction

Now, the building is anchored on pilings set 60 feet into the bedrock. The all-steel exterior is reinforced from the roof down to the floor and then secured to the pilings, and the roof sections were machined together so that there are no seams to catch the wind.

- The all-steel exterior is reinforced from the roof down to the floor and then secured to the pilings.
- The roof sections were machined together so that there are no seams to catch the wind.

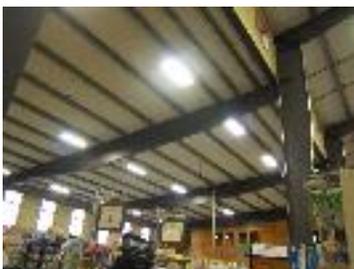
Interior load-bearing construction

Stemper hired engineers to design a building that would protect his investment from damages and his employees from injuries resulting from floods, windstorms, and earthquakes. The storm drainage system was re-engineered, and the entire structure incorporates the best features of continuous load-bearing construction.
