Higher and Drier in Wisconsin Full Mitigation Best Practice Story

Crawford County, Wisconsin

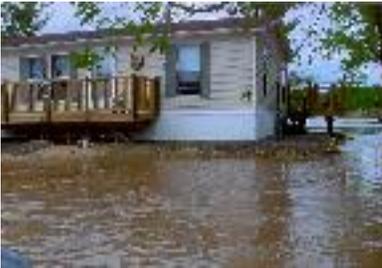
Evans house above water 2007: water came to within inches of the bottom of their new foundation

After receiving the approval of local officials and floodplain managers, 38 tandem truckloads of fill were off-loaded, and each truckload was tamped down tightly on the new lot. A large, flatbed truck off-loaded his new manufactured home onto the footings of the newly raised lot. Once all the utilities were connected, the Evans' were safe and secure in their new home.

Now that he's three feet above BFE, Evans believes he and Diane could ride out still another flood with very few problems. All he needs now at the foot of his property is a hitching post to tie up the boat he'll need to make his getaway when the Kickapoo River jumps its banks again.

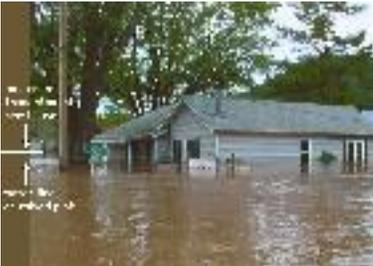
Photo shows water line and bottom of new house's foundation line

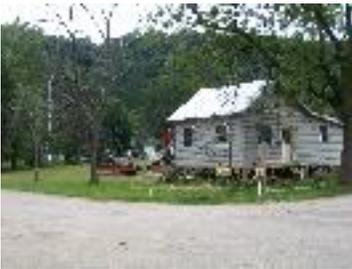
A neighbor's house sits on a temporary raised foundation awaiting the new masonry foundation
