South Padre Island: Living with Mother Nature's Wrath

Full Mitigation Best Practice Story

Cameron County, Texas

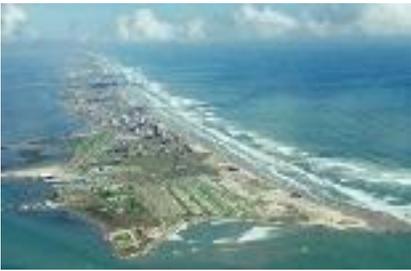
City Hall, South Padre Island

A case in point is City Hall, completed just before Hurricane Dolly. It fared very well with just minor water damage from rain that came through and under a door.

City Hall is a shiny new building, colorful and very pleasant, with generous impact-resistant windows that fill the rooms with sun and light. But on closer inspection, it is also a vault. It has a concrete, monolithic-pour roof deck, and its floors and ceilings are poured concrete with concrete blocks filled between the massive columns.

"This building is equipped with an on-site generator and was built to weather a moderate storm, the kind we just had with Dolly," Mitchim said. "The entire two-story City Hall is built 10 feet above sea level. That's two feet higher than the code requirement. Why? To build in an extra measure of safety for this critical public building near the sea."
