Mitigation Project Reunites a Town Divided

Full Mitigation Best Practice Story

Columbia County, Wisconsin

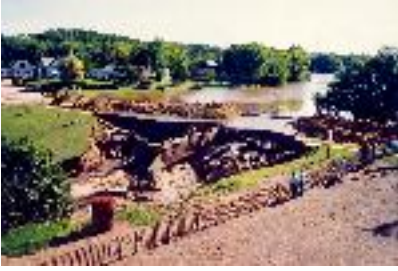
The day after a flood washed out the road over the dam

By three in the afternoon of the same day, sections of roadway began to fall away. At 8 pm, the Cambria dam failed and water from Lake Tarrant roared across Route 146, creating a gully more than 70 feet across. Fortunately no homes downstream were damaged, but the disaster had effectively cut the town in two. Now, residents in half the town had to travel five miles further to reach the main street, schools, and businesses.

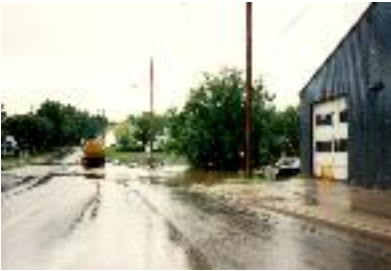
Tarrant Lake (to the right of the road) begins to overflow its dam during heavy, persistent rains in late May 1993.

In 1993, the Cambria Dam suffered a major washout. Damage to the old earthen constructed roadway was extensive. Repairs included the installation of two new five-foot culverts under the road and flood gates to control the release of water from the lake to prevent water from overtopping the dam and roadway.

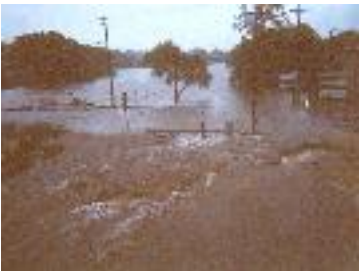
Water coming over dam

By daybreak on June 12, Tietz and his crew could only stand and watch the water's terrible power as it swept over the road. They all knew that there was even more damaging action they couldn't see -- the relentless tearing away of gravel, rock, and earth below the surface of the water on the lake side of the roadway.

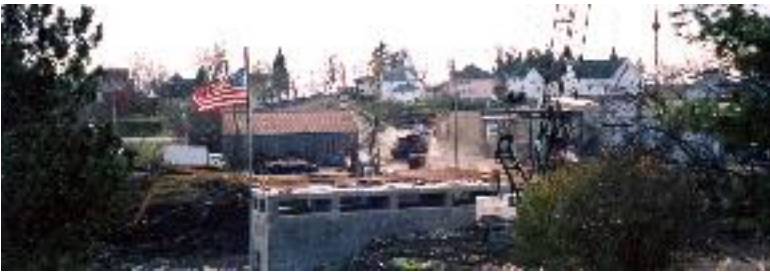
New dam in construction

Construction on the project began on September 29, 2005. The result of the project was one main structure with integrated overflow discharge capabilities. The structure was almost entirely concrete with a lower mechanical gate and a perimeter weir overflow system. This system was integrated into the roadway, with discharge water flowing under the road through a dual box culvert.

Massive amounts of rock and gravel were used to fill the washout. A pile driver worked for several weeks pounding wide slabs of lapped steel into the earth on the lake side of the roadway. Tons of muck and debris were scooped out and trucked away to prepare a foundation bed for the new dam. Forms for concrete were put in place and concrete was trucked in and poured. Finally, the new sliding gate was set into place, while massive amounts of concrete were poured on the opposite side of the road to harden that area.

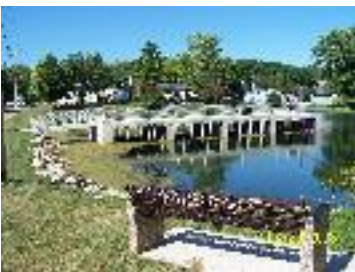
Perimeter weir overflow system type

In addition to human intervention during the storm of 2008, the design of the new dam helped to prevent a repeat of the 2004 washout. A weir dam, also called a perimeter weir overflow system, is composed of a large concrete box (weir) constructed perpendicular to the old dam with openings on all sides for the water to flow from the lake under the road through the dual box culvert. The openings are covered with debris guards. This design reduces water pressure on the earthen berm dam.

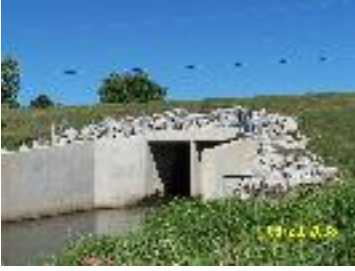
A dual box culvert
