Fire, Police, and EMS Coordination at Apartment Building Explosion Harlem, New York City

**Fire, Police, and EMS Coordination
at Apartment Building Explosion
Harlem, New York City
(November 2, 1992)**

**This is Report 068 of the Major Fires Investigation Project conducted
by TriData Corporation under contract EMW-90-C-3338 to the United
States Fire Administration, Federal Emergency Management Agency.**

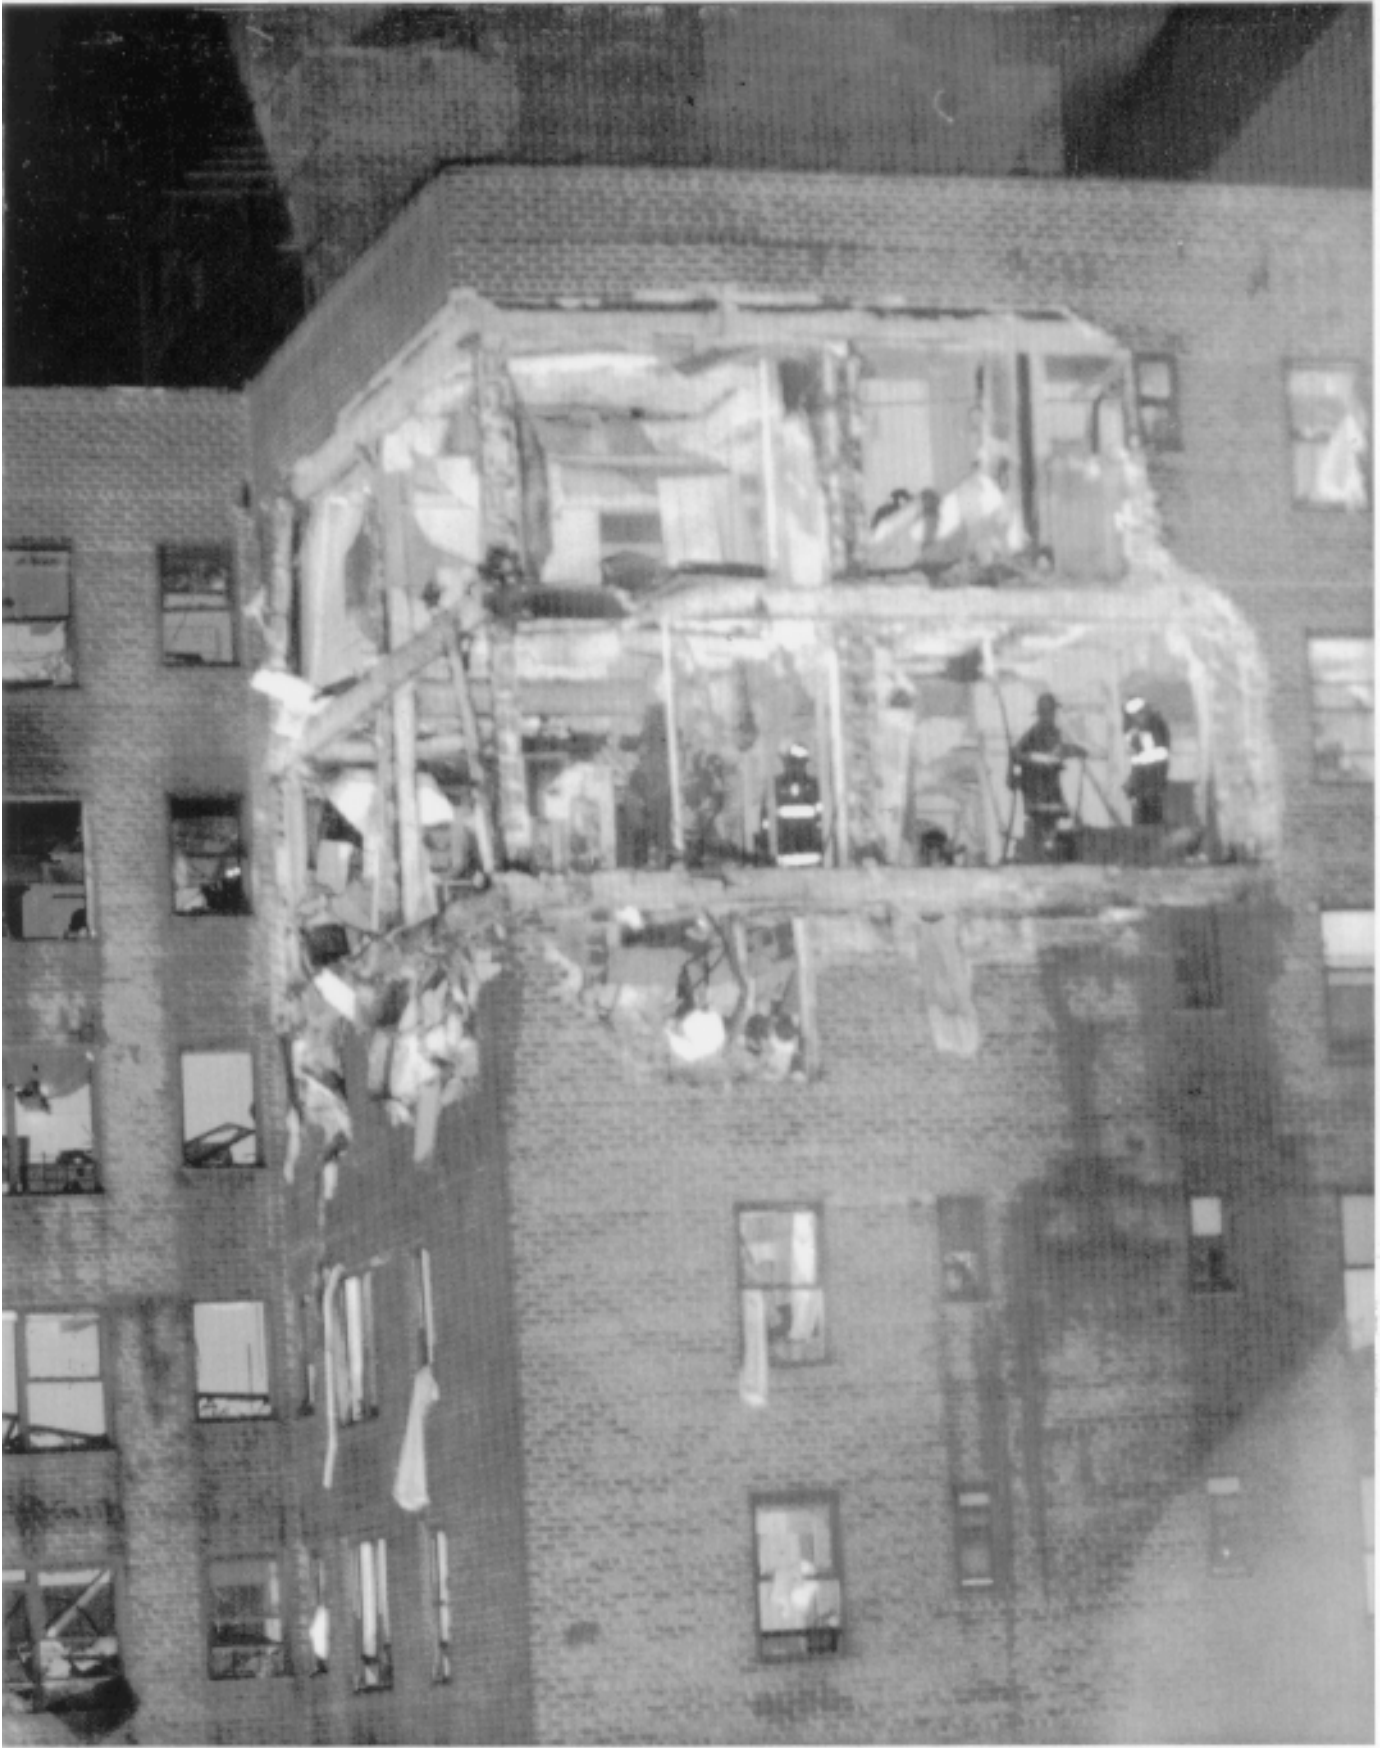
Appendix A
Photograph

Exterior view of explosion damage on upper floors of 12-story apartment building at 45 East 135th Street, New York City.

The force of the explosion blew out the exterior brick walls on the ninth through the twelfth floors on the south and west sides of the building, and shattered windows in surrounding buildings in the neighborhood. In the area of the explosion, sections of floors crumbled, leaving the steel skeleton of the structure exposed. Building debris, bricks, broken glass, and apartment contents were blown out and down to the streets below. Flames were visible on the eleventh and twelfth floors. The noise and vibration of the explosion was felt by some fire department units that were 12 blocks away.
