# NATIONAL TRANSPORTATION SAFETY BOARD

## Study of Autopilot, Navigation Equipment, and Fuel Consumption Activity Based on United Airlines Flight 93 and American Airlines Flight 77 Digital Flight Data Recorder Information

Location: Arlington, VA  
Date: September 11, 2001  
Time: 09:38 AM Eastern Daylight Time  
Flight: American Airlines Flight 77  
Aircraft: Boeing 757-200, registration: N644AA  
NTSB#: DCA01MA064

Location: Shanksville, PA  
Date: September 11, 2001  
Time: 10:03 AM Eastern Daylight Time  
Flight: United Airlines Flight 93  
Aircraft: Boeing 757-200, registration: N591UA  
NTSB#: DCA01MA065

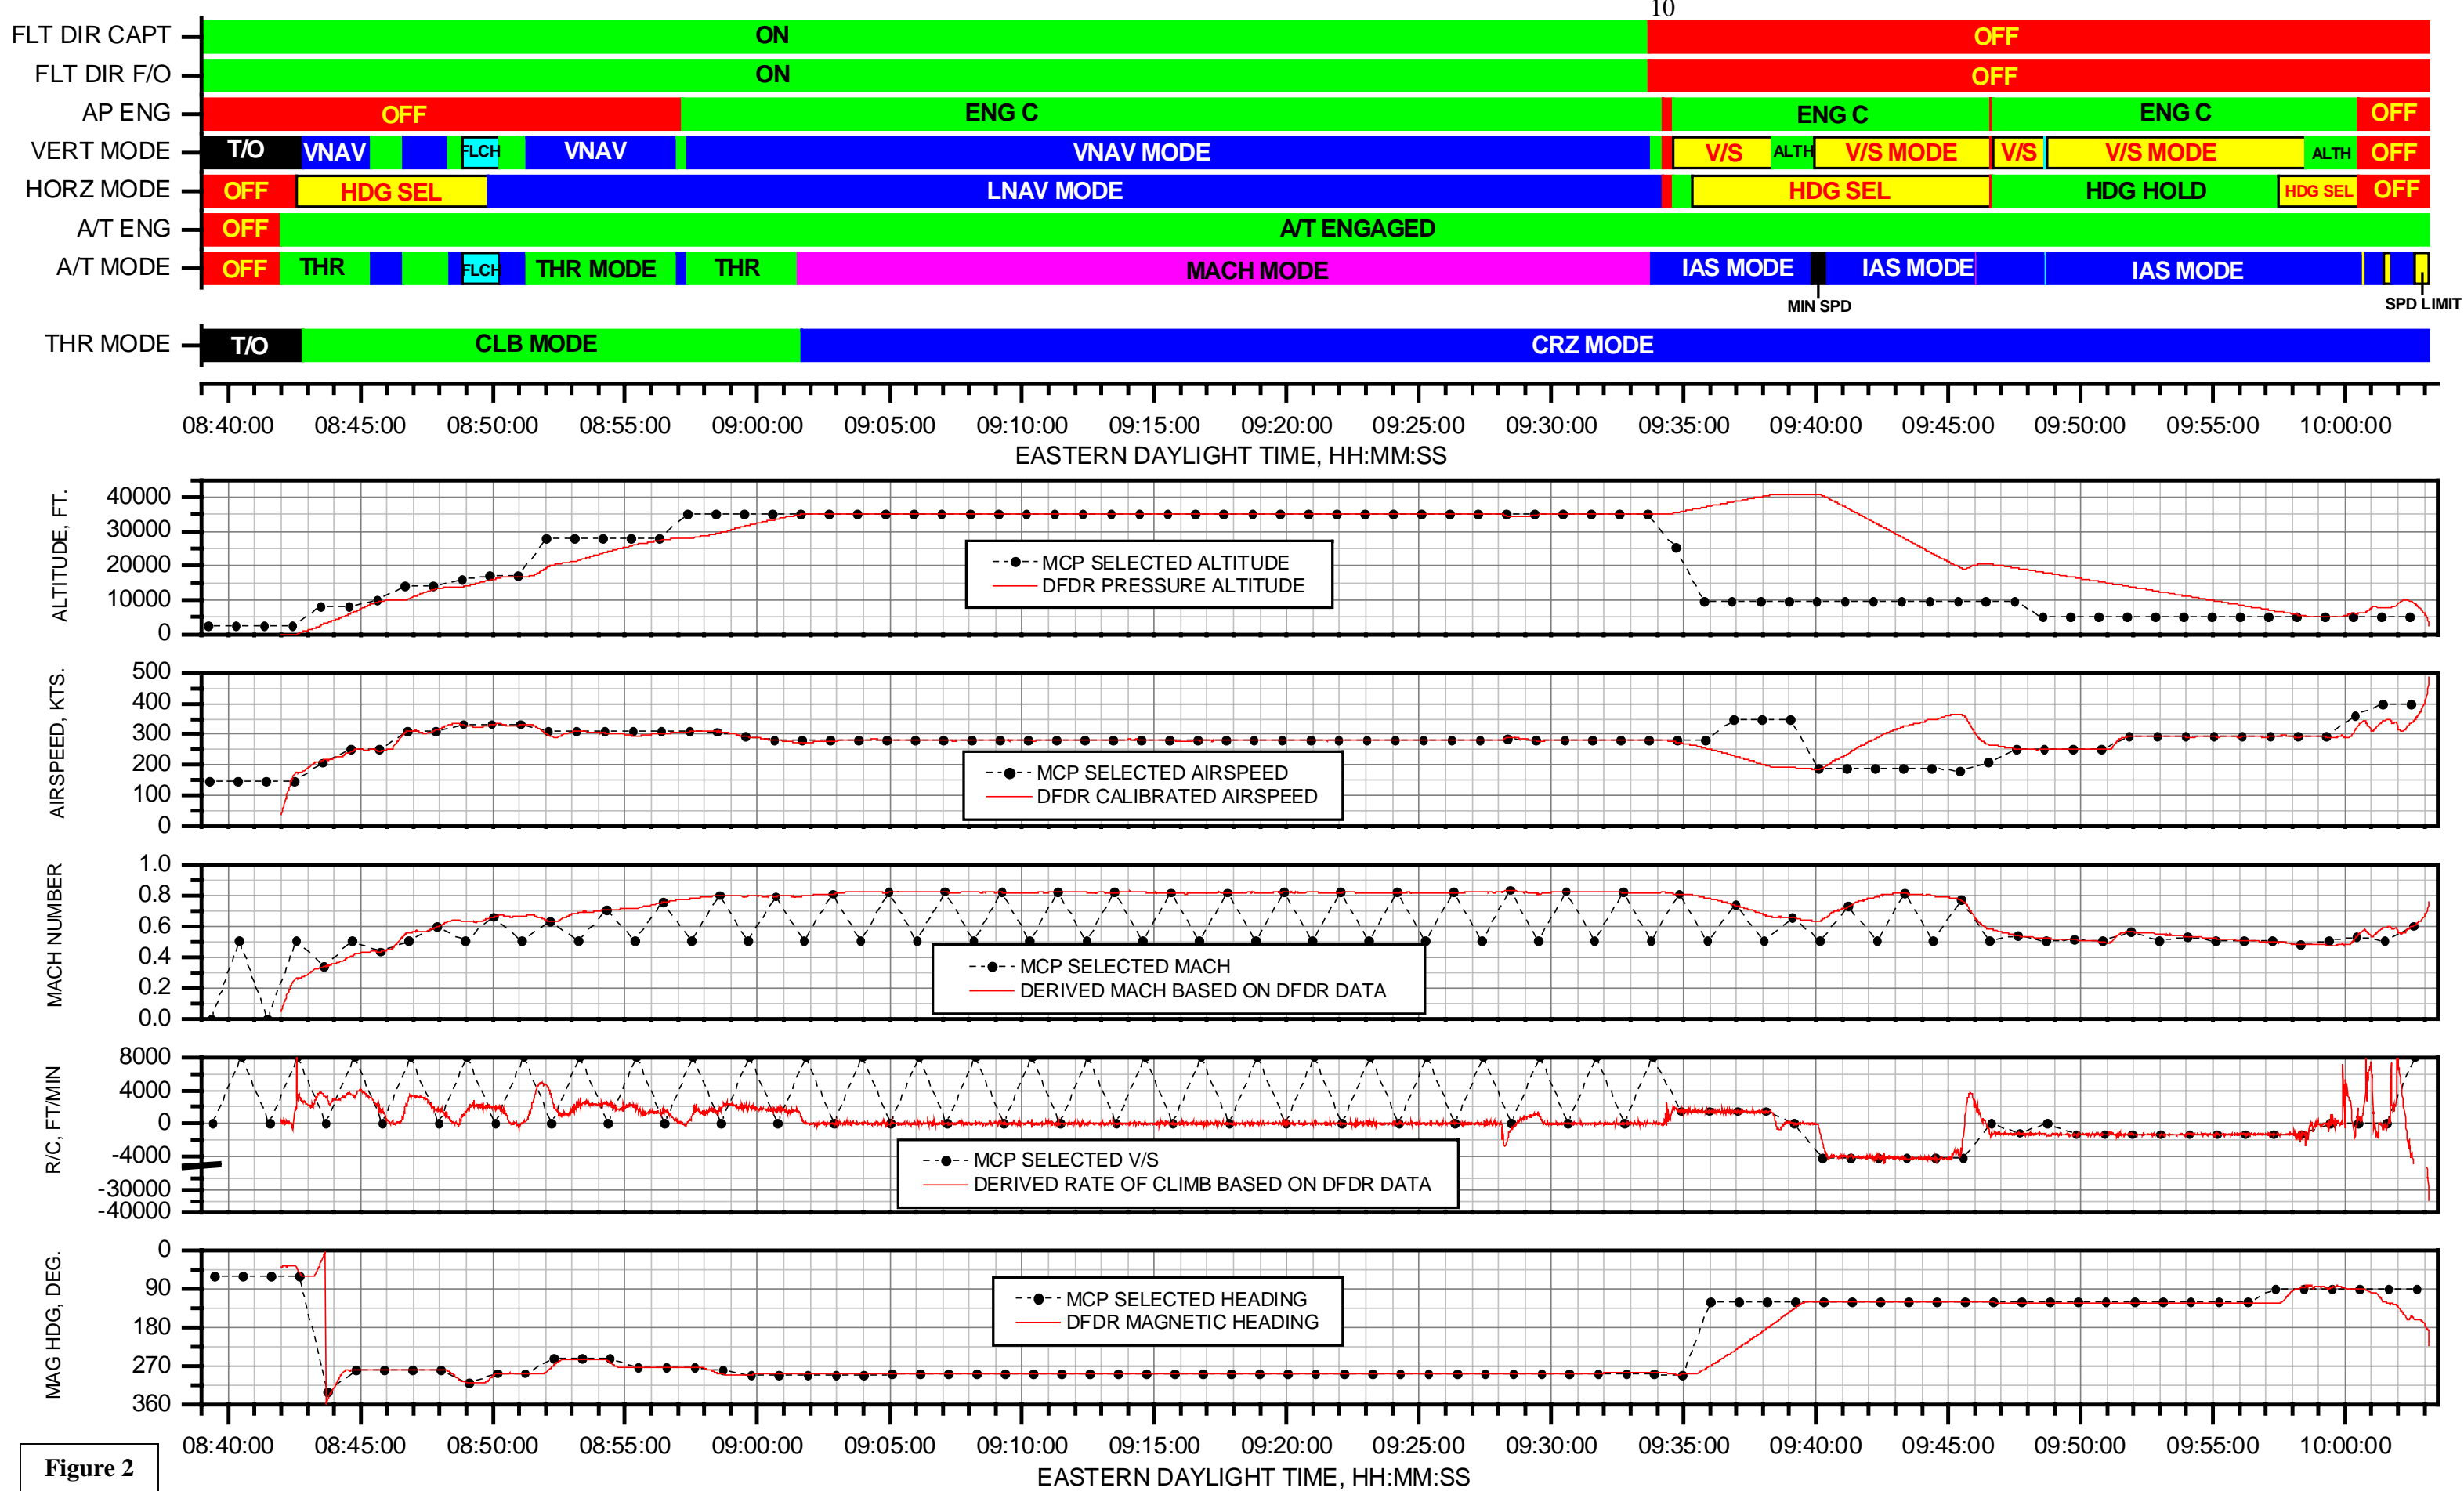
Figure 2 shows a time history of the various autopilot and autothrottle modes engaged on Flight 93, from takeoff from Newark to the end of the DFDR data at impact. Also shown in the Figure are the values of speeds, altitudes, headings, and climb/descent rates set in the MCP, along with the values of those parameters that the airplane actually flew.

# UNITED AIRLINES FLIGHT 93: AUTOPILOT & AUTO THROTTLE MODES & AIRCRAFT RESPONSE

For most of the flight, until shortly after the hijackers took control of the cockpit (at approximately 09:30), both the Captain's and First Officer's Flight Directors were on. During the takeoff, the autopilot was off, and the Flight Director was issuing roll commands based on inputs made in the MCP, and pitch commands based on inputs coming alternatively from the FMC (when in VNAV mode) or from the MCP (when in Altitude Hold or Flight Change modes). Once the flight was cleared to its 35,000 ft. cruising altitude, the autopilot was engaged in LNAV and VNAV modes, which use inputs from the FMC to guide the airplane along the desired horizontal and vertical flight path.

The autothrottle was engaged throughout the flight. During the climb the autothrottle mode varied between climb thrust mode, airspeed hold mode, and flight level change mode. Upon reaching the 35,000 cruise altitude, the autothrottle switched to a Mach number hold cruise mode, applying thrust to achieve a Mach number of 0.82.

At about 09:33, the autoflight modes started to change. Both the Captain and First Officer's flight directors were turned off, and at about 09:34 the autopilot was turned off briefly. After the autopilot was reengaged (less than a minute later), up until the last three minutes of the flight it operated in modes that receive inputs from the MCP (i.e., target values of altitude, speed, heading, and descent rate set directly by the operators of the aircraft) rather than from the FMC. The autopilot was off for the last three minutes of the flight.

The autothrottle switched from a Mach hold mode to an airspeed hold mode at about 9:33:30, and remained in this mode for the remainder of the flight, except for brief periods where the airspeed was either below or above pre-set limits and the autothrottle adjusted thrust in an attempt to correct the situation (these are the MIN SPD and SPD LIMIT modes).

From 09:33 to the time the autopilot was turned off (about 10:00), the airplane was maneuvered horizontally via the heading select and heading hold modes, with the desired heading set on the MCP. The bottom graph in Figure 2 shows the magnetic heading selected in the MCP was 120 degrees, and also shows the airplane turning towards that heading. From the airplane's position at this point, a magnetic heading of 120 degrees

would put the airplane on course for Washington, D.C.. At 09:57, the heading selected in the MCP is changed to 90 degrees. About half a minute later, the autopilot switches from heading hold to heading select modes, and the airplane turns to the 90 degree heading selected in the MCP.

From 09:33 to the time the autopilot was turned off, the airplane was maneuvered vertically using the vertical speed and altitude hold modes. In the vertical speed mode, the desired rate of climb or descent is set in the MCP. In altitude hold mode, the airplane maintains the altitude at which the altitude hold mode button on the MCP is pressed. As shown in Figure 2, initially the vertical speed selected was about +1,500 ft/min, and the airplane climbed accordingly. Interestingly, at the same time, the altitude selected in the MCP was 9,600 feet (lower than the current airplane altitude). At about 09:38 the autopilot entered altitude hold mode at 40,700 feet. A couple of minutes later, the autopilot re-entered vertical speed mode, with a descent rate of -4,200 feet/minute selected in the MCP, and the airplane started to descend. At about 09:47, this descent rate in the MCP was adjusted to about -1,300 feet/minute. At around the same time, the altitude set in the MCP was adjusted to about 5,000 feet. This suggests that the intent of the operators may have been to descend to 5,000 feet.

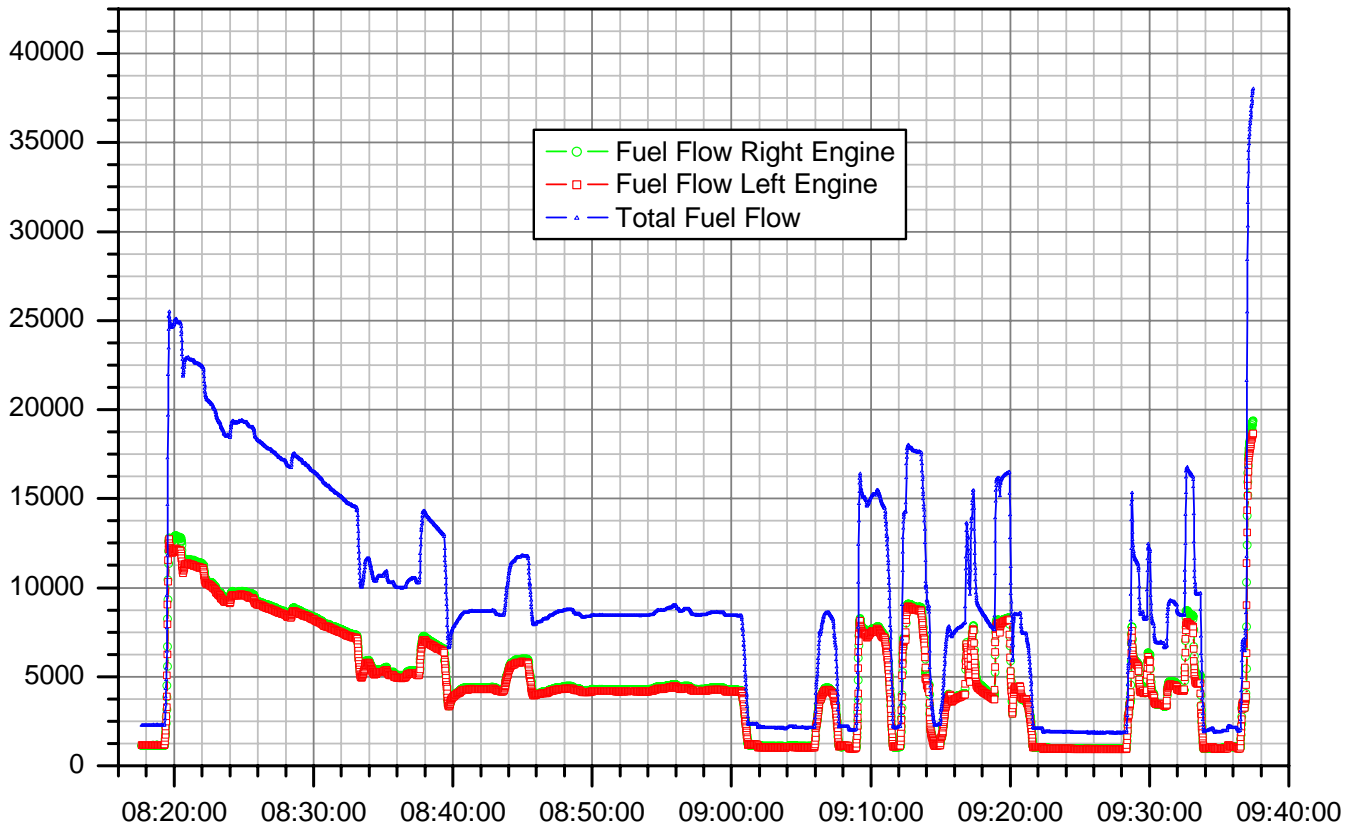
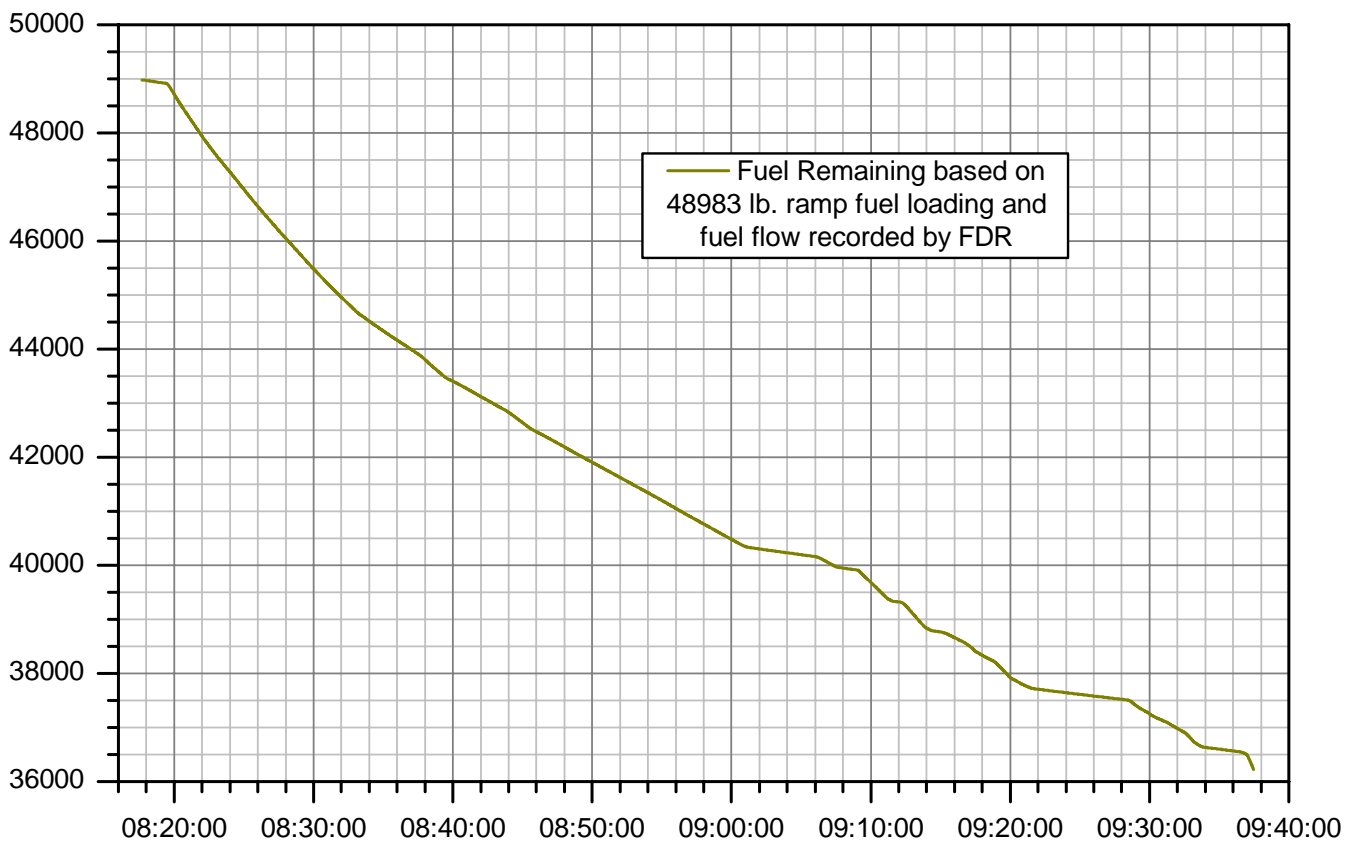
Figure 6 shows AAL flight 77's fuel flow to each engine as recorded by the DFDR, and the sum of these, equal to the total fuel flow. By integrating the total fuel flow with time, the amount of fuel consumed throughout the flight can be calculated. Subtracting the fuel consumed from the initial fuel load then gives the amount of fuel remaining, as shown in the bottom plot of Figure 6.

### AAL 77 Fuel Consumption and Quantity Remaining

Based on ACARS transmissions to the airplane, the fuel load on the airplane when on the ramp was 48983 lbs. This results in about 36,200 lb. of fuel remaining upon impact with the Pentagon (the end of the DFDR data).

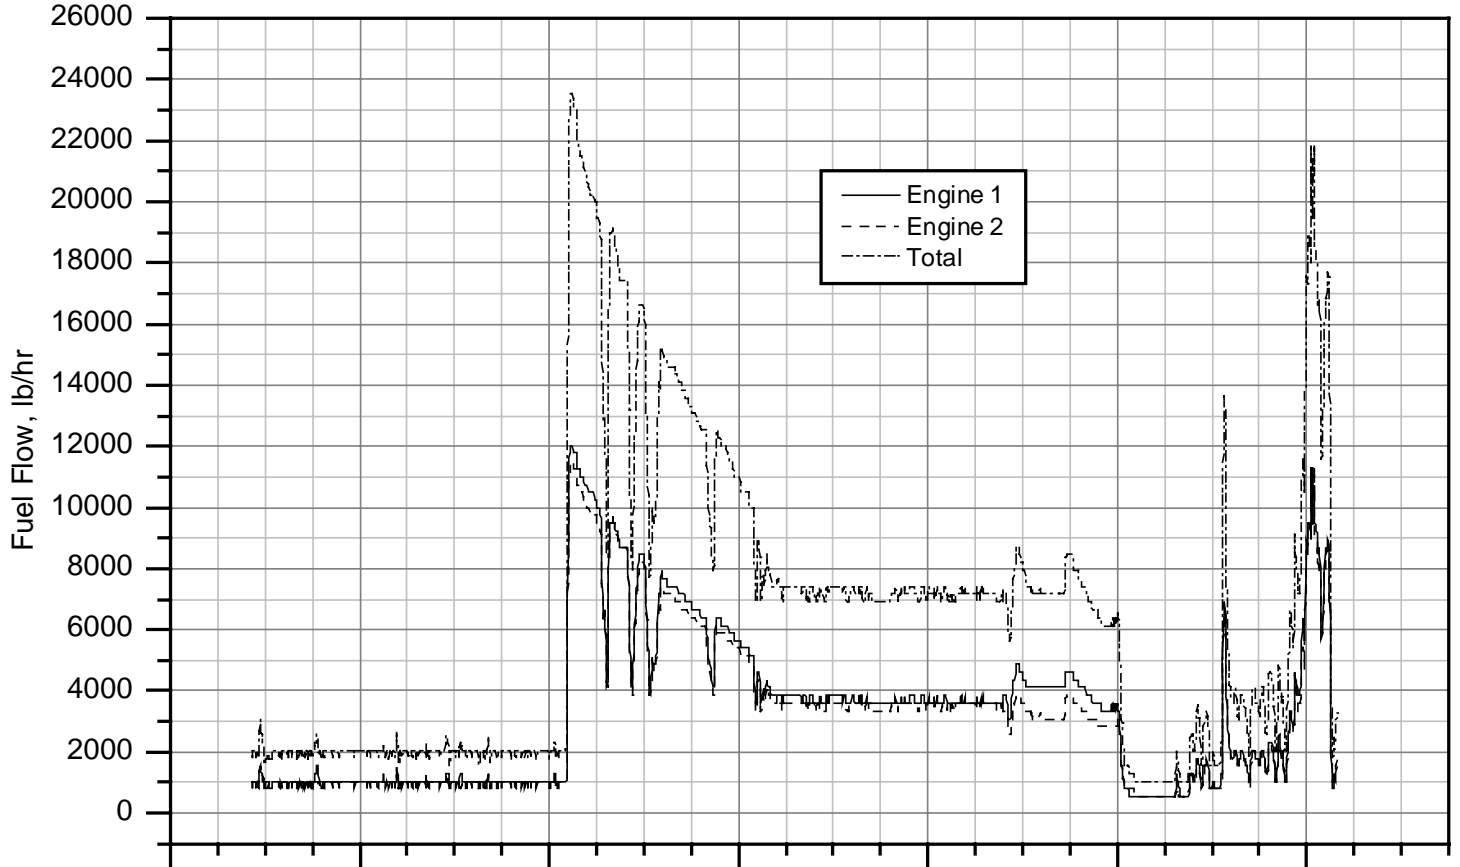
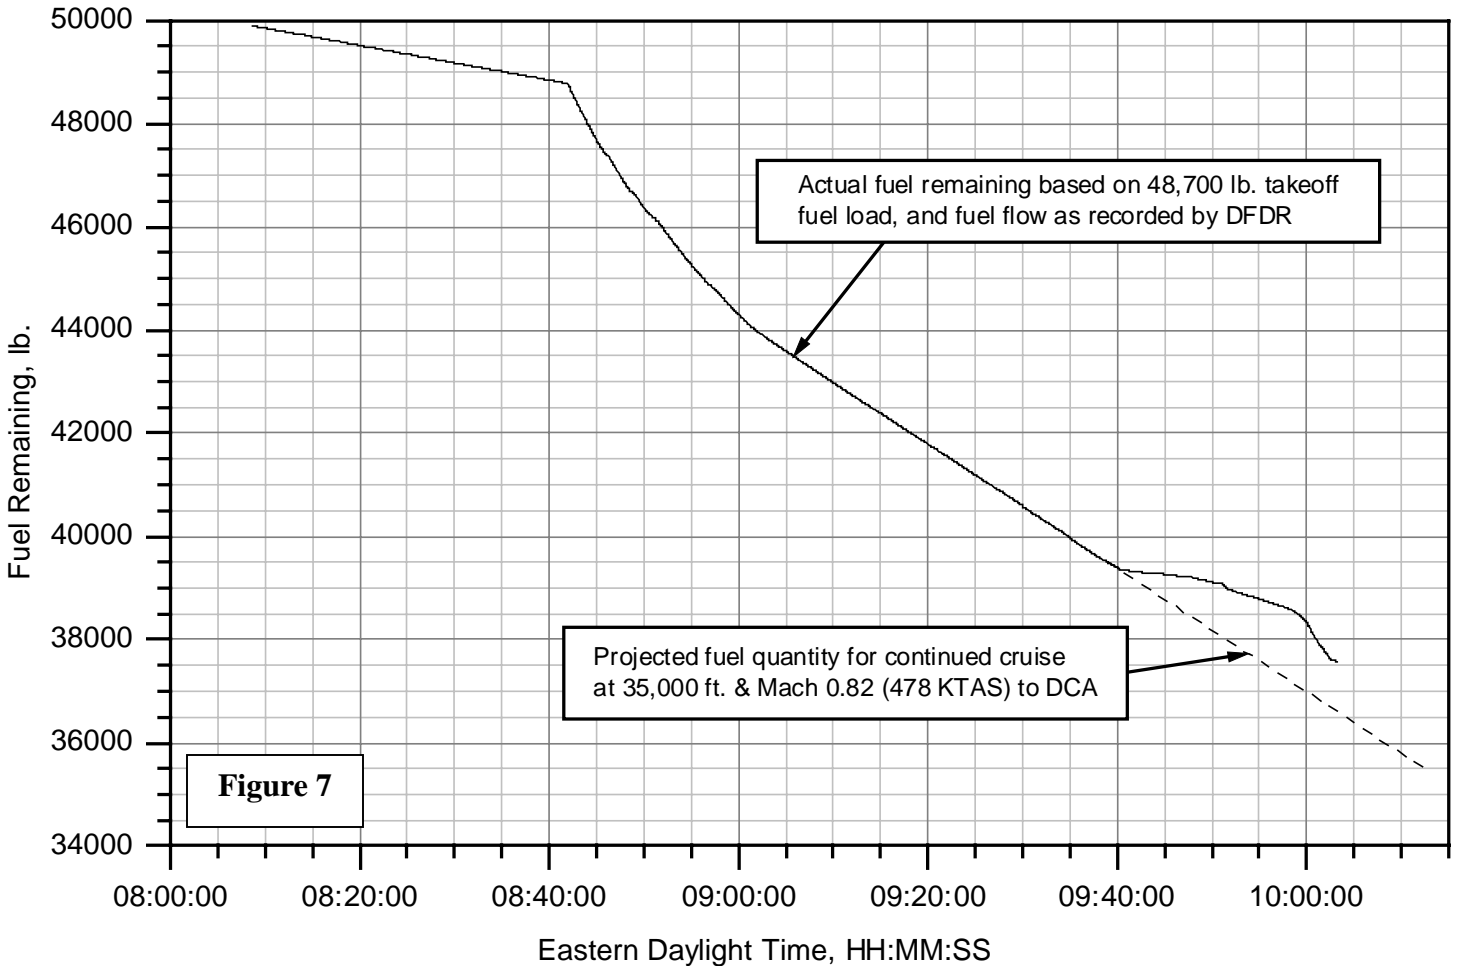
Figure 7 shows fuel flow and fuel remaining for UAL Flight 93, calculated in the same way as just described for AAL Flight 77.

# UAL93 Fuel Consumption and Quantity Remaining

Based on ACARS transmissions to the airplane, the fuel load on takeoff was 48,700 lb. This results in about 37,500 lb. of fuel remaining upon impact (the end of the DFDR data). If instead of descending to about 5,000 feet over Pennsylvania, Flight 93 had continued cruising at 35,000 feet to Washington, it would have arrived over Washington with about 35,500 lb. of fuel on board.
