## Inspection Techniques: What's wrong with this picture?

No. FP-2009-22 June 3, 2009

**Learning Objective:** The student shall be able to identify conditions affecting the location of fire department connections.

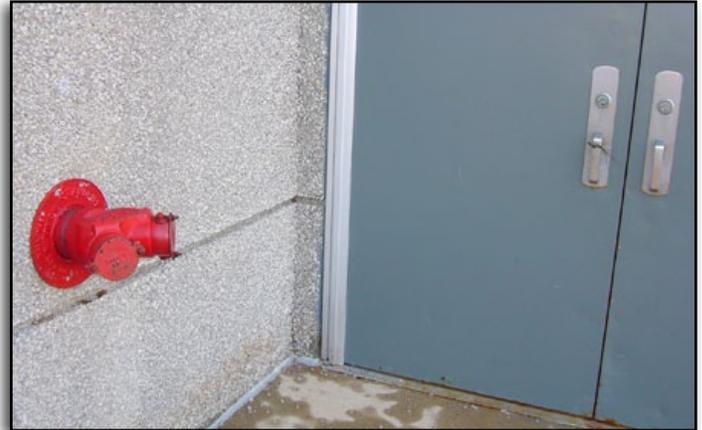
Hoses connected to this fire department connection could block traffic through this pair of doors.

Fire department connections (FDC) should be visible and accessible at all times. This installation is adjacent to a fire apparatus access road so it is convenient to the engine and nearby fire hydrants. One of the model fire codes requires that FDC be located "on the street side of buildings, fully visible and recognizable from the street or nearest point of fire department vehicle access or as otherwise approved by the fire code official."

NFPA<sup>®</sup> 13, *Standard for the Installation of Sprinkler Systems*, says connections shall be "on the street side of buildings and shall be located and arranged so that hose lines can be readily and conveniently attached to the inlets without interference from any nearby objects, including buildings, fences, posts, or other fire department connections. The location shall be based on the requirements of the fire department."

This FDC also has been color-coded using this community's marking scheme that colors fire department connections to standpipe systems in yellow, sprinkler systems in green, and combined sprinkler/standpipe systems in red. This color-coding gives the Incident Commander (IC) or Company Officer (CO) a quick reference to select the correct FDC when more than one exists.

So what might be "wrong" with this picture? Look closely at the FDC position in relation to the doors to the right. Charged fire hoses 2- 1/2-inch (63.5 mm) or larger connected to the right-hand side of this FDC would block the doors, making them unusable for emergency egress or even access in to the building firefighting operations. While technically not a violation of the codes or standards, this installation might affect safety and tactics. Code officials should pay close attention to these potential conflicts when approving the location of FDC.
