U.S. Fire Administration / National Fire Academy

Coffee Break Training

Topic: Sprinklers in Corrosive Environments

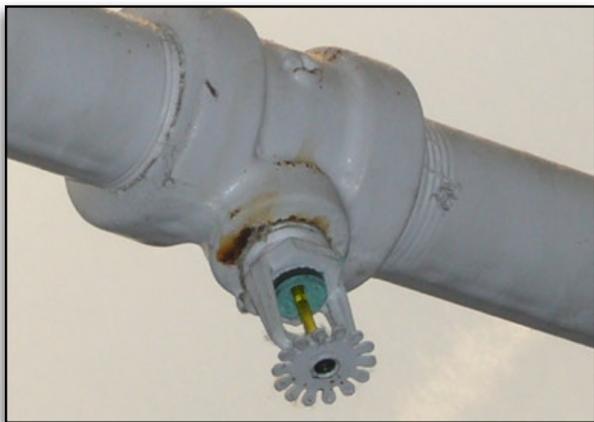
This sprinkler above a public swimming pool shows signs of corrosion.

Typical locations where corrosive conditions can exist include bleaching operations, dye houses, metal plating processes, animal pens, chemical plants, and salt air environments such as beneath piers and wharves. A not-so-obvious location is this indoor swimming pool where airborne vapors from water treatment chemicals may have a corrosive effect on the Belleville seal that holds back the water as well as the pipe where the sprinkler is connected.
