**Missouri River Flood 2011  
Vulnerabilities Assessment Report  
Volume I: Summary**

**Northwestern Division  
US Army Corps of Engineers**

**October 2012**

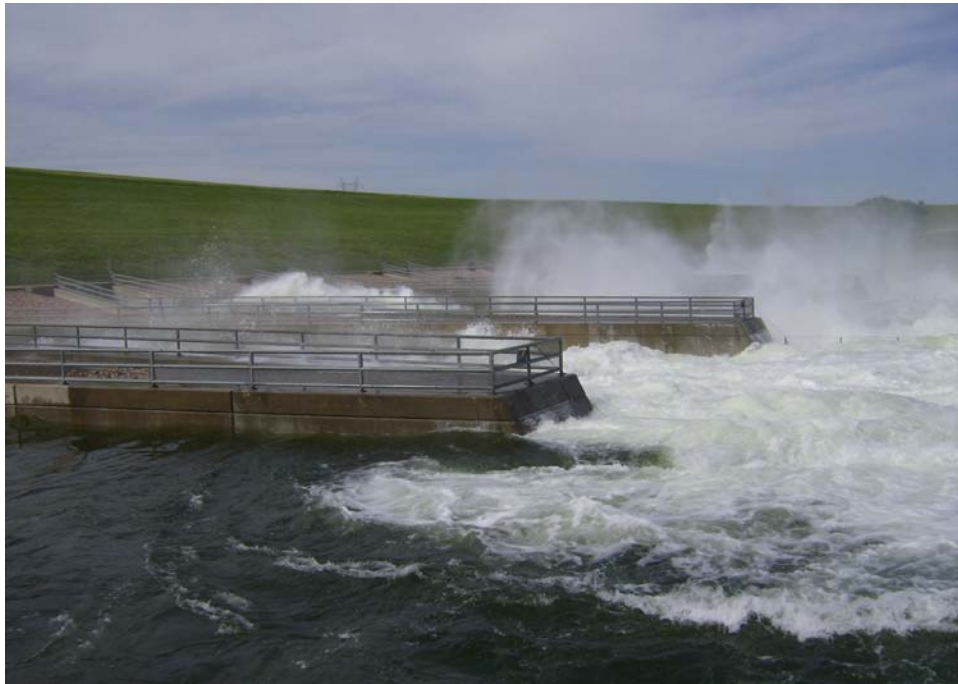
**Figure 4. In 2011, the flood tunnels at Oahe Dam released a record volume of water. The earthen-channel spillway (not shown) was not used to avoid damages and the need for costly repairs. (Photo taken June 2011.)**

At Oahe Dam, discharges have never been allowed to pass through the emergency spillway due to fears of backward erosion of the unlined, earthen channel and the potential for a catastrophic uncontrolled release of the reservoir. At critical times during the 2011 flood, system releases

were within 5,000 to 7,000 cfs of the maximum capacity of all available discharge features and pool elevations were within a few inches from the top of the spillway gates. If a single outlet tunnel or hydropower unit had been unavailable during these times or if inflow spikes had driven the pool higher, it would have been necessary to release through the spillway and possibly incur substantial erosion damage, raising significant dam safety concerns. The Oahe reservoir has been in the exclusive flood control zone (above elevation 1,617 feet) nine times since the system was filled in 1967, or about one of every five years. At such times, there is precious little available storage in the reservoir and inflows must be cautiously managed to prevent overtopping of the spillway gates. During the 2011 flood event, the system was operated to minimize the possibility of using the spillway at Oahe. However, risk was transferred to the upper two projects by going higher into the surcharge pools at Fort Peck and Garrison and possibly having to release larger volumes of water than if we could have used surcharge storage in Oahe. Restoration of the Oahe spillway to the intended design criteria is imperative to ensure operational flexibility during future large flood events.

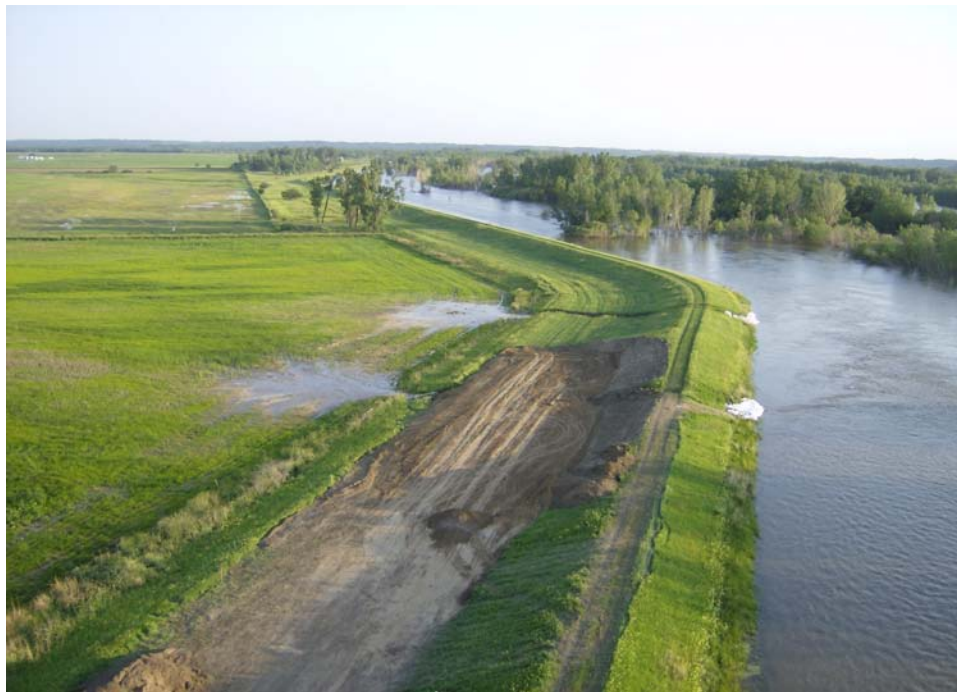
Levees are typically designed and constructed to withstand water loading for a few days or weeks during a year. The 2011 flood subjected the Missouri River levees to months of loading, well beyond the envisioned flood duration. All told, the event caused moderate to extensive damage to roughly 75 federal levees (and many more non-federal levees) within the basin due to overtopping, erosion, and underseepage. (Figure 5) Significant efforts to assess and repair are on-going under the authorities of the Public Law (PL) 84-99 program<sup>1</sup>.

Although levees protect property within the floodplain, they also reduce the flow area available for the passage of flood waters, resulting in higher and faster water flow during high water events. In 2011, the flood waters carried excess energy which acted on the river corridor. The extreme high flood flows tended to travel across bends in the most energy efficient manner, severely degrading channel training structures such as dikes and revetments. Sediment traveled with the flood flows, causing both scour and deposition at different locations. Recreation facilities, plant and wildlife habitat, and historic tribal sites<sup>2</sup> along the river channel were also impacted by the force of the flood waters and will require assessment and possibly rehabilitation.

**Figure 5. The levees along the Missouri River were subjected to prolonged water loading. Consequently, many suffered from erosion and underseepage, necessitating extensive repairs. (Photo taken June 2011 of levee L575 near Hamburg, Iowa.)**

The 2011 flooding caused moderate-to-extensive damage to levees that are within the basin and currently eligible to participate in the PL 84-99 Levee Rehabilitation and Inspection program. Only those levee systems that have been maintained to an “acceptable” or “minimally acceptable” rating qualify for federal rehabilitation funds. Levee repairs are being completed under the Flood Control and Coastal Emergencies (FCCE) funds provided within the DRAA. We have investigated levee damages, requested funding, and initiated repairs at most damage sites. We expect to have all qualifying levee repair contracts awarded in fiscal year (FY) 12 or early FY13, and all sites completed prior to the 2013 runoff season. For levee sections not repaired to pre-flood condition prior to the 2012 runoff season, the Corps is continuing to use the enhanced regional coordination activities that were developed and refined during the 2011 flood event and have pre-positioned federal and non-federal flood-fighting resources.
