# Coffee Break Training - Fire Protection Series

## Building Construction: Concrete Spalling

No. FP-2014-18 May 6, 2014

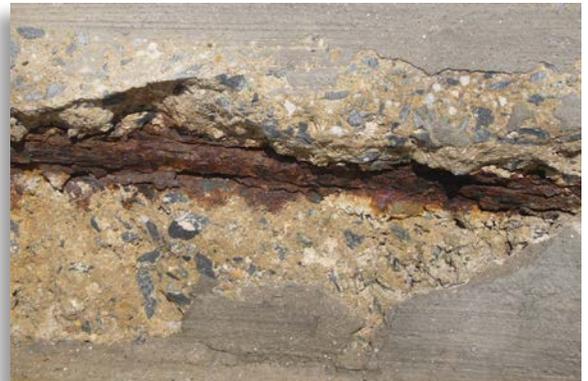
The concrete that once protected this steel reinforcing bar has spalled, exposing the reinforcement to the elements, including the heat from a fire.

In addition to affecting the building's structural integrity, the consequences of spalling that exposes steel reinforcement materials have a potential fire safety consideration as well. The exposed steel is highly susceptible to damage from increased heating, further weakening the structure and increasing the risk of catastrophic failure. (Please see Coffee Break Training FP-2012-50 for a discussion of heat influences on steel construction.)
