Coffee Break Training - Fire Protection Series

Automatic Sprinklers: In-Service Recalled Fire Sprinklers

No. FP-2014-40 October 7, 2014

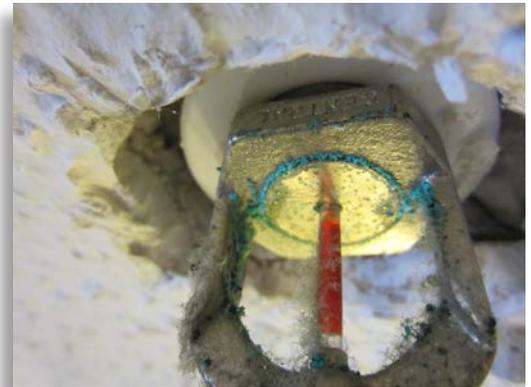
The corrosion around the cap of this recalled Central ELO-LH wet sprinkler increases the likelihood that it will not operate when needed. (Photo/Byron Blake)

As seen in this photograph, the recall program did not reach all of its intended customers, and many of the recalled sprinklers remain in their original installations. Meanwhile, the voluntary recall and replacement program has ended, and lives and property continue to be at risk where these sprinklers are installed.

The sprinkler in this photograph is in a hotel room, less than 10 feet (3 meters) from the floor, where it is highly visible. An inspector who is fulfilling the NFPA 25 requirements should have no problem identifying the corrosion. The key issue is for the code official to ensure that the inspections are being done.

NFPA 25 also requires that sprinklers show neither signs of leakage nor corrosion, foreign materials, paint or physical damage. Sprinklers must also be installed in the correct orientation (e.g., upright, pendent or sidewall). Any sprinkler that shows signs of those conditions, or loss of fluid in the glass bulb heat-responsive element, should be replaced.
