22 July 2010
HETA 2010-0115

Health Hazard Evaluation of Deepwater Horizon Response Workers
HETA 2010-0115

Interim Report #3A
Evaluation of June 14-16, 2010 M/V Queen Bee Mission

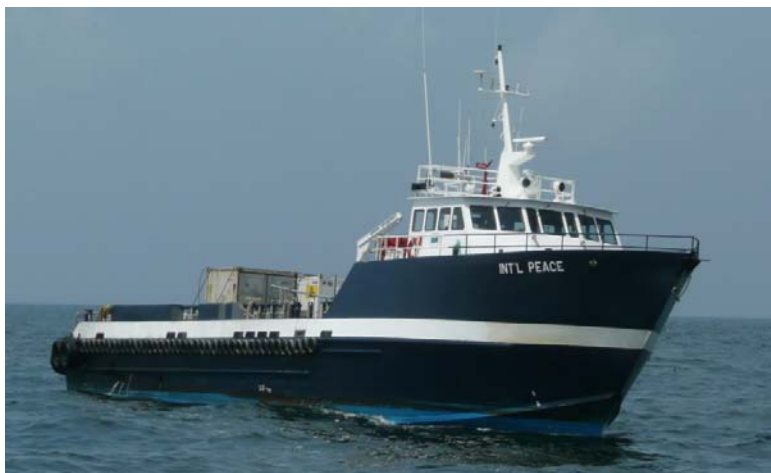
Figure 1. M/V International Peace

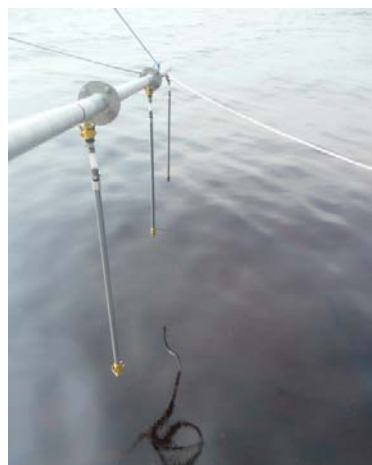
As part of these monitoring efforts, the IP was outfitted with six dispersant-holding tanks (each with an approximate volume of 1 cubic meter [m³]) on its deck and two dispersant spray arms, each of which extended from either side of the IP (see Figure 2). Each spray arm had three tubes descending from the main arm through which dispersant was pumped from one of the tanks. The tubes extended to within several feet of the surface of the water and allowed dispersant to be applied as a mist. At the time of the June 21-22, 2010, NIOSH evaluation, the dispersant being used and evaluated by the SMART Team was Corexit® EC9500A (Nalco, Naperville, Illinois). The tanks on the IP had previously held Corexit® EC9527A, a dispersant that was discontinued in early May.

Figure 2. Dispersant spray arm

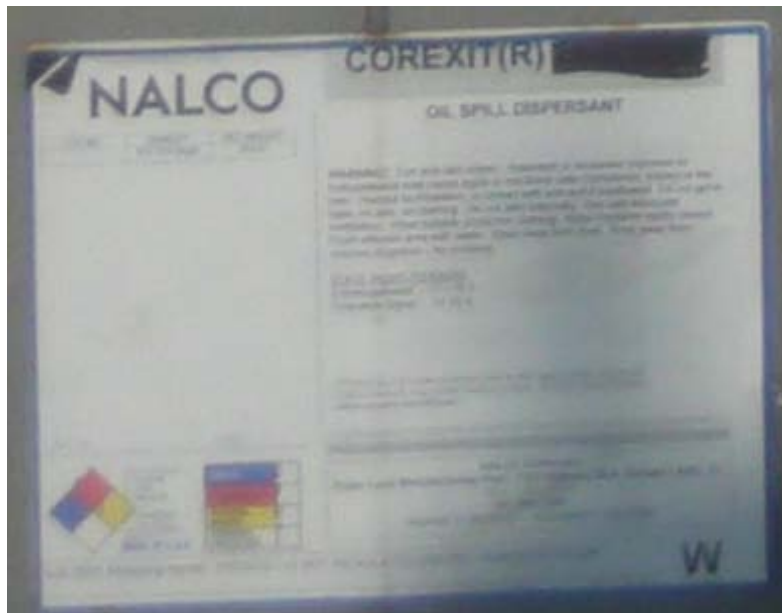
The Corexit® EC9500A material safety data sheet (MSDS) does not list 2-butoxyethanol as a component of the 9500 dispersant [Nalco, 2008a]. It is possible that the compound is present as a contaminant in one of the reagents used in the formulation of the dispersant. It is also possible that the higher presence of 2-butoxyethanol in the sample collected on the IP may be a result of contamination from the re-use of dispersant-holding tanks that previously held Corexit® EC9527A (which was published as containing 30–60% 2-butoxyethanol) [Nalco, 2008b]. The tanks on the IP had originally been identified with labeling for the 9527 dispersant. The original labeling on these tanks identifying the contents as Corexit® EC9527A had been marked or covered over when the change to the 9500 dispersant was made (see Figure 3). However, new labeling specifically for the Corexit® EC9500A dispersant had not been applied to the tanks at that time. Additionally, labels of '2-butoxyethanol' (a dispersant component identified on the MSDS of the Corexit® EC9527A but not for the 9500A) had not been removed from the tanks (see Figure 4). It is not known whether the tote from which the BP contractor collected their samples had previously contained other products such as Corexit® EC9527A.

Figure 3. Labeling on dispersant-holding tank

Further evaluation is needed regarding the identification of trace quantities of 2-butoxyethanol in the bulk dispersant samples. NIOSH has contacted the manufacturer to obtain additional information and may conduct additional testing on a neat sample obtained directly from the manufacturer. To prevent cross-contamination, it is recommended that new totes be used if a chemical product such as the dispersant is changed rather than refilling totes previously used. If totes or tanks such as those on the deck of the IP are reused, it is recommended that they be cleaned before they are used with a new product and new identifying labels be added. Labels associated with the previous chemical should be removed to ensure proper identification of the tanks' current contents.

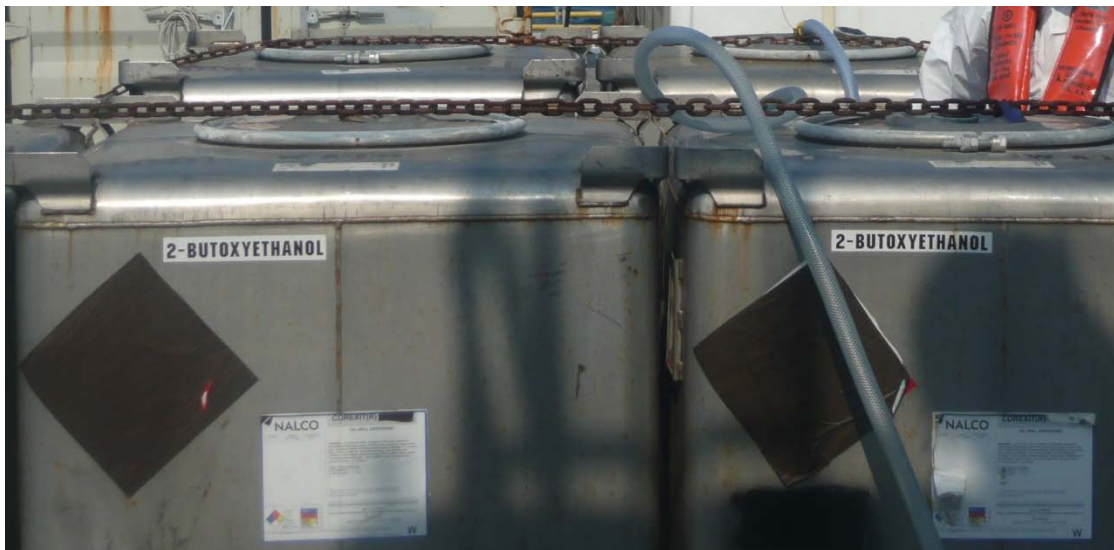
Figure 4. Dispersant-holding tanks on the deck of the International Peace
