### Elevated Home along Arkansas River Survives Christmas, 2015 Flood

**Jefferson CO, AR:** The Christmas weekend of 2015 is one that many residents in Arkansas will never forget. The holiday began with up to 10 inches of rain on December 24 and Christmas Day was drenched. The downpour finally came to an end on December 26, but not before causing widespread destruction.

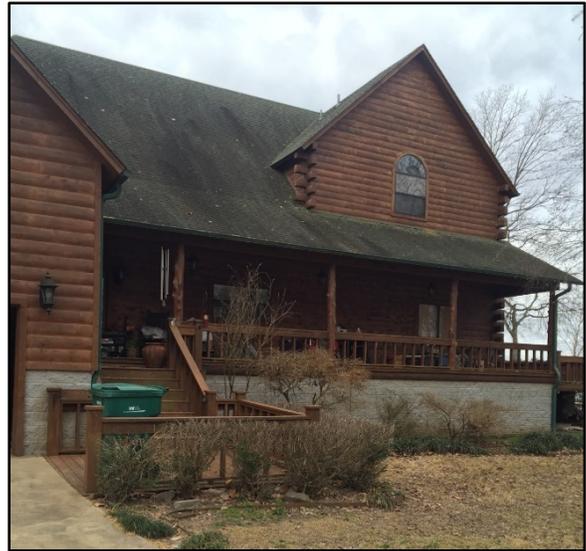
Back view of the elevated house on cinderblocks photo: Wayne Berggren/FEMA

The 5,000-square-foot cedar log home is located approximately 50 feet from the Arkansas River. The house is elevated on a continuous wall using 8”x16” inch cinderblocks. The Erwins finished construction in 2000. “It took me three years to complete the work,” he said.

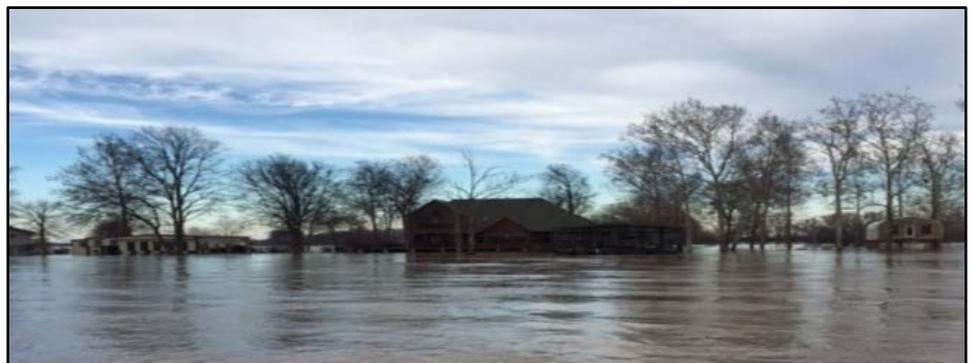
Elevated houses sits above the floodwaters during the Christmas flood event. Photo courtesy of Kathy Erwin

John and Kathy Erwin live along the Arkansas River, and were prepared. They had elevated their home above the Base Flood Elevation (BFE) as local code required elevating the property at least a foot above the BFE. While other homes in the neighborhood flooded, their home remained dry.

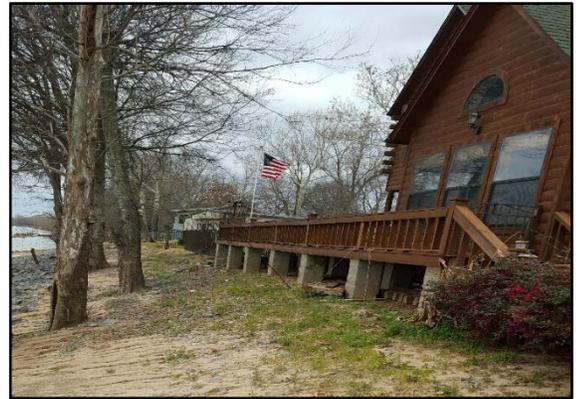
Front view of the elevated home on cinderblocks.  
Photo: Joyce Price/FEMA
