**Response to Allegations that  
a U.S. Customs and Border  
Protection Contractor  
Transport Detainees in  
Non-Air-Conditioned Vehicles**

SUBJECT: *Response to Allegations that a U.S. Customs and Border Protection Contractor Transports Detainees in Non-Air-Conditioned Vehicles – ~~For Official Use Only~~*

## **Results of Inspection**

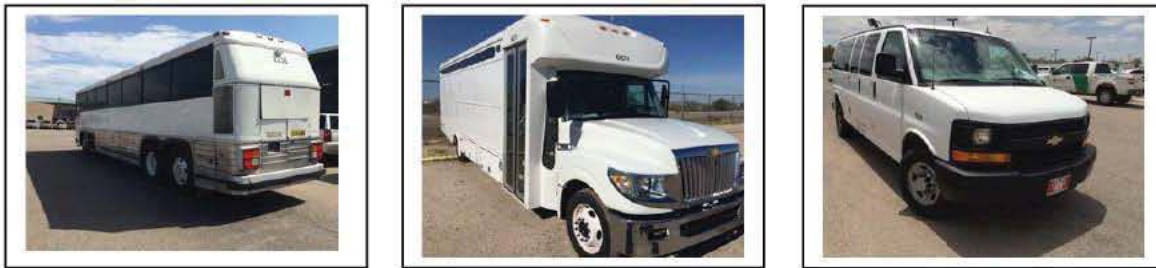
**Figure 1: Intercity Bus, Mid-Sized Shuttle, and Van**

The contract requires the contractor to transport non-violent detainees to and from CBP Border Patrol stations, Field Offices, Ports of Entry, highway checkpoints, processing centers, hospitals, courts, and detention facilities. CBP estimated the contractor would need to transport an average of [REDACTED] detainees per day. In the Border Patrol's Tucson sector, the contractor uses three types of vehicles, pictured in figure 1: intercity buses, mid-sized shuttles, and vans.
