Homemade Floodgates Succeed

Full Mitigation Best Practice Story

Guayama Municipio, Puerto Rico

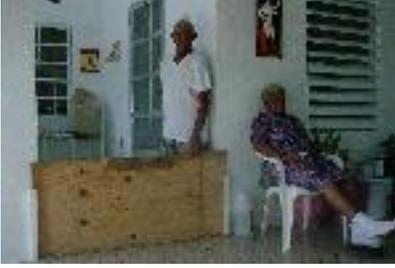
Flores and Diaz show their homemade floodgate.

“I thought of two metal slots, one on each side of the door, to slide a wood panel through them. Then, foam sealant is sprayed all the way around the panel, between the metal slot and the floor,” explained Flores. A friend of his, who is a blacksmith, created and attached custom-made metal slots to every outside doorway. The wood panels are three and a half feet tall, and the couple tries to keep them at hand. “We are two aging persons . . . we need the floodgates to be comfortably low: high enough to remain safe, but low enough to step over them. And it’s easier to move if they are lighter instead of heavier,” Flores explained.

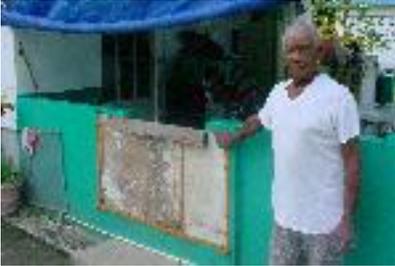
Flores in front of back porch floodgate.
